The Sinking of the Unsinkable

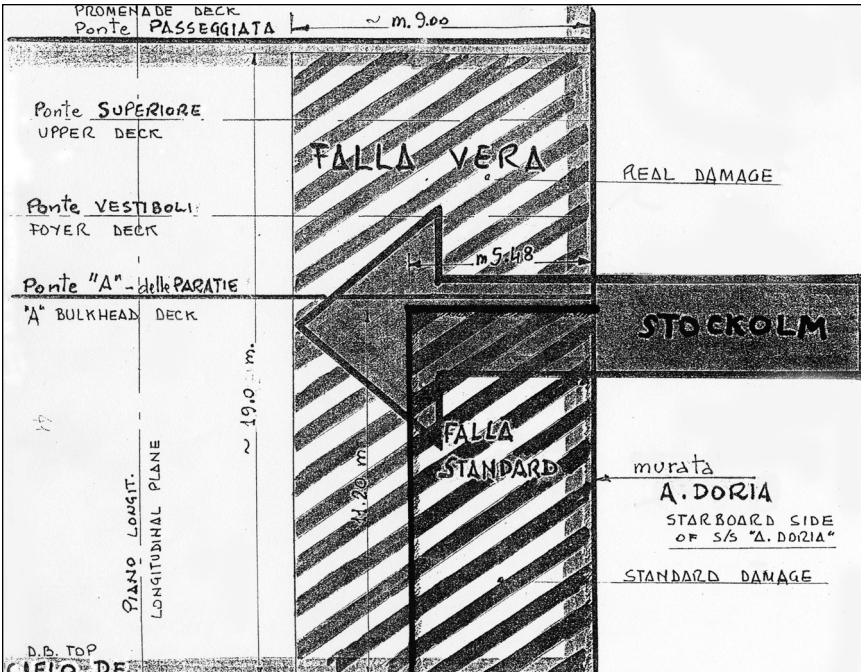
The *Stockholm* penetrated through one-third of the *Andrea Doria*. This compares with the collision norm of one-fifth. The amount of flooding was four times the norm. There was “continuous-type flooding” not only from the penetration but also from the ripping damage. This affected more than the two allowable compartments. (Courtesy of Francesco Scotto and the Round Table)

to the main bulkhead. It must be noted that the average penetration in a collision does not exceed one-fifth of the ship. In the case of the *Doria*, it was one-third.⁶ Therefore, when taking into account the ripping damage that caused continual and irregular flooding, it is clear to see why the list was on a continuum toward doom.

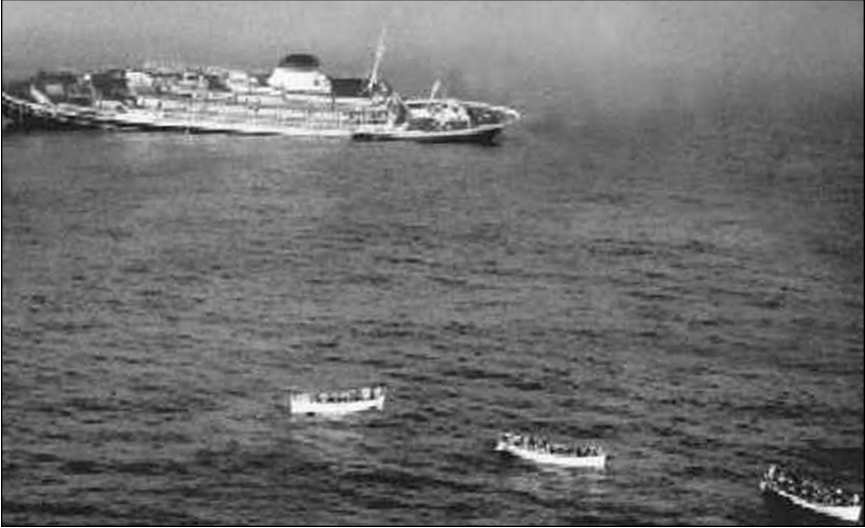
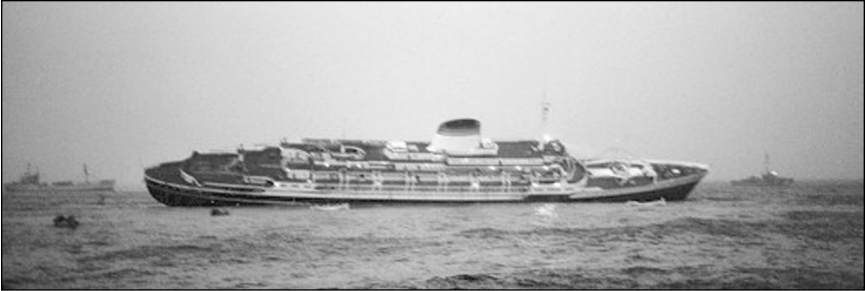
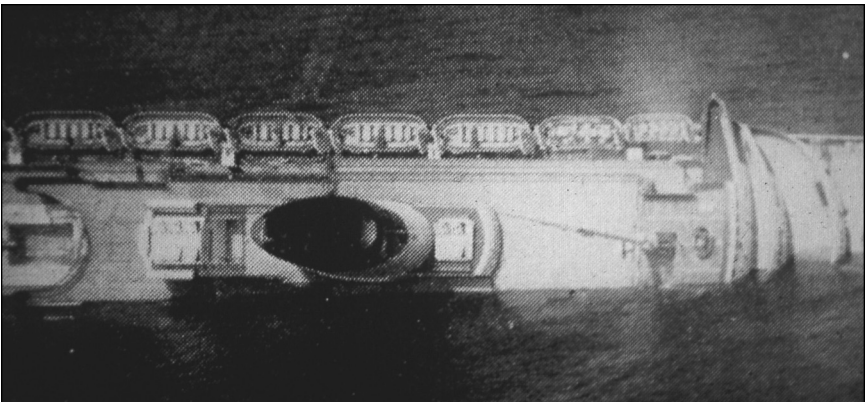
Facing page, top: In the earliest hours of daylight, *Ile de France* lifeboats transport passengers away from the sinking Italian liner. Middle: At daybreak, rescue vessels *Cape Ann* and the Coast Guard's *Private William H. Thomas* witness the *Doria* listing precariously on its starboard side. Bottom: The *Andrea Doria* capsizes on its starboard side and clearly shows all port-side lifeboats still steadfast on their davits.

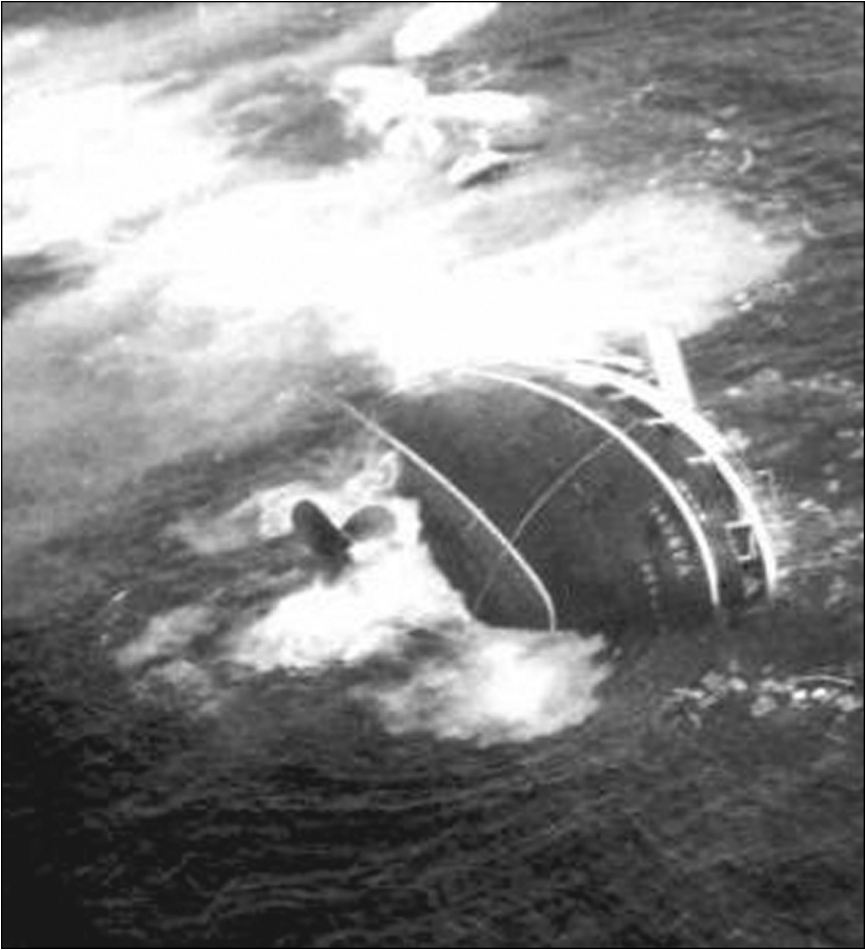
Above: The stern of the *Andrea Doria* with its port-side propeller was the last section of the luxury liner to sink. (David A. Bright Collection)
