## **Extending the Life of Hardwood Timber Bridges in Australia**

**IPWEAQ Conference FNQ Mission Beach, QLD**

**Dan Tingley Ph.D., RPEQ**

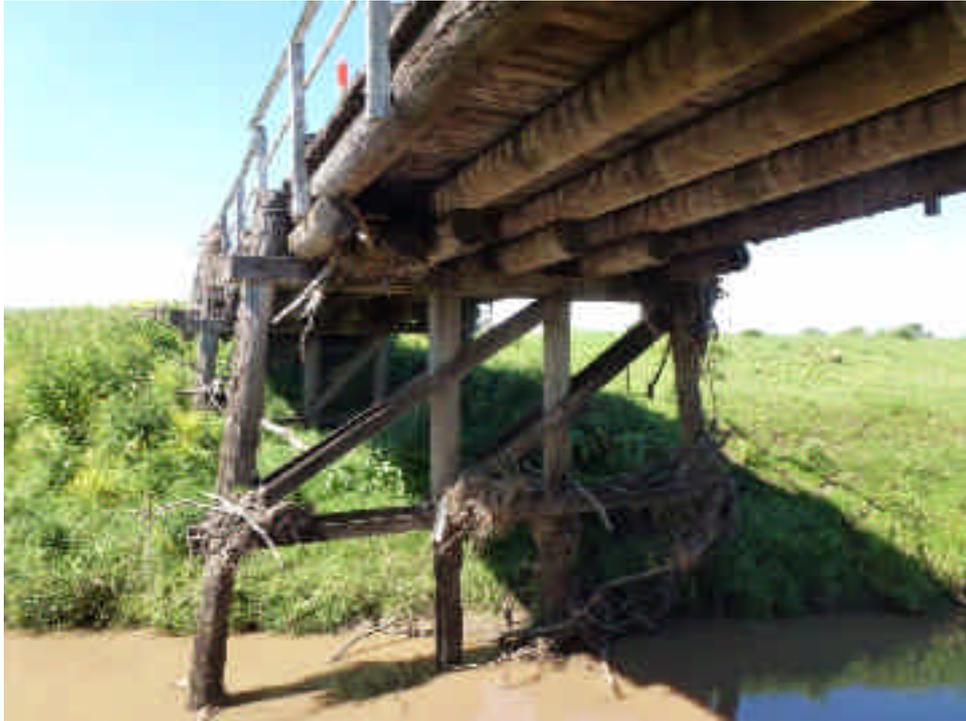
**Figure 10: Highway bridge built at the turn of the century in Lockyer Valley was closed to traffic. Ironbark logs worth an extremely high dollar amount. Not one single element in the whole bridge was degraded beyond repair. Poor inspection practices and understanding of timber bridge condition and composition led to premature closure of the bridge causing ratepayers to travel a 16km reroute.**

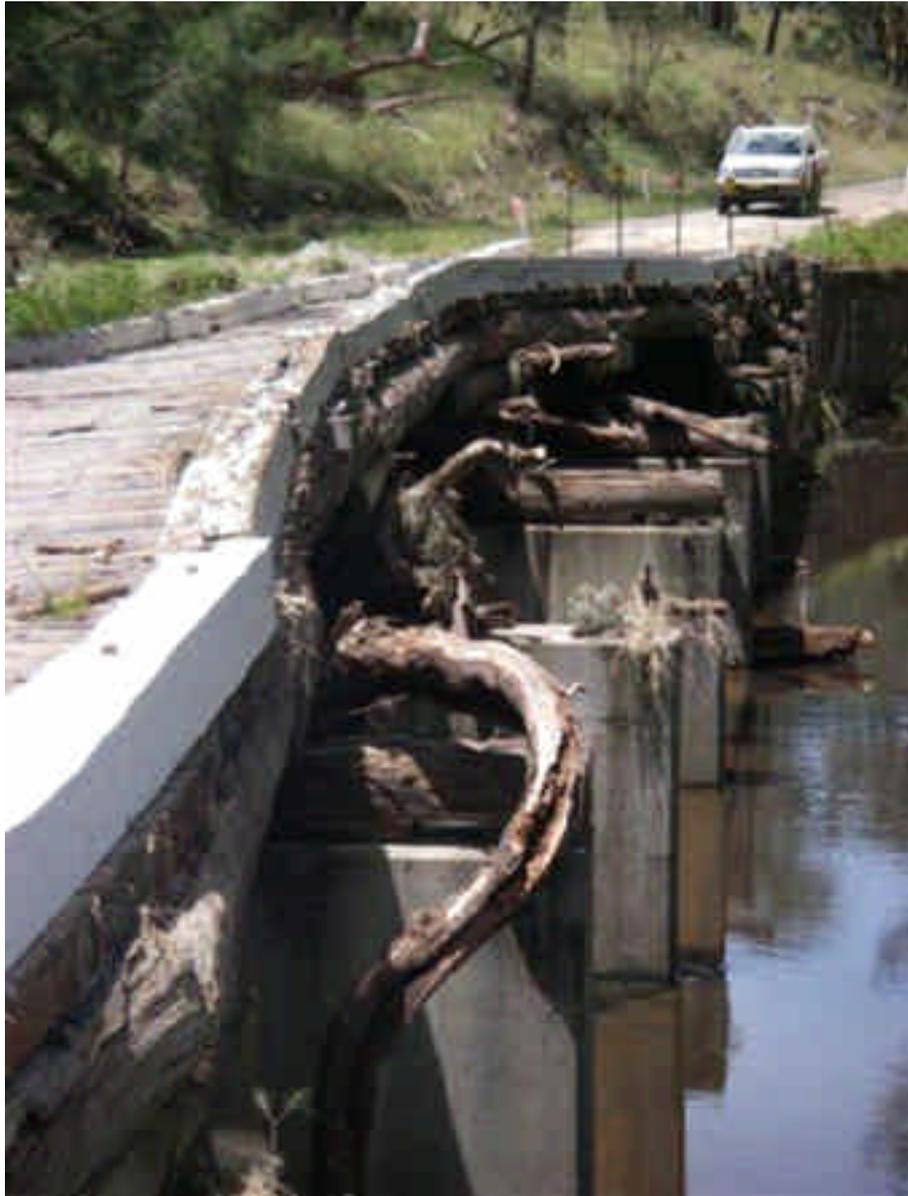
**Figure 12: Highway bridge built at the turn of the century. Log girder/log corbel superstructure where vertical through bolts led to accelerated decay in the girder, corbel to concrete head stock connection. When the flood waters came, it could not withstand lateral forces. Glen Innes area NSW.**

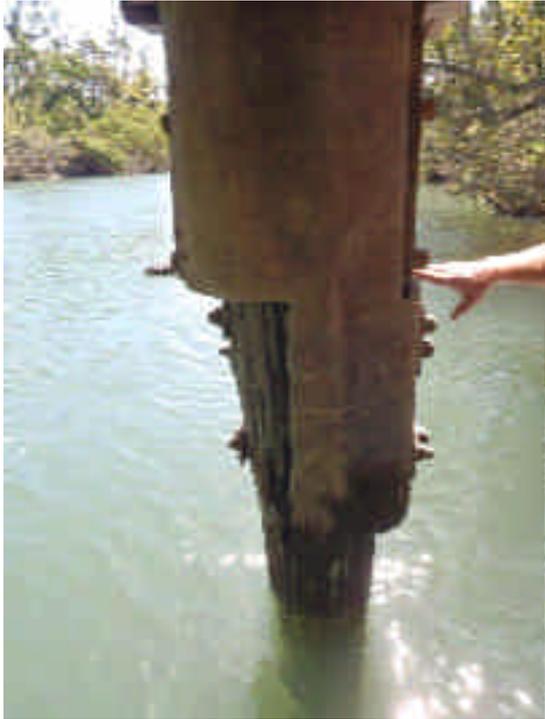
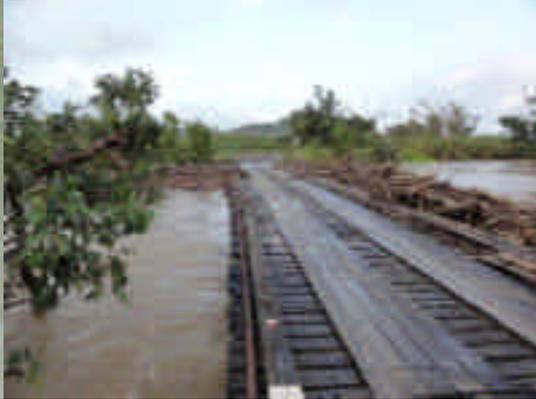
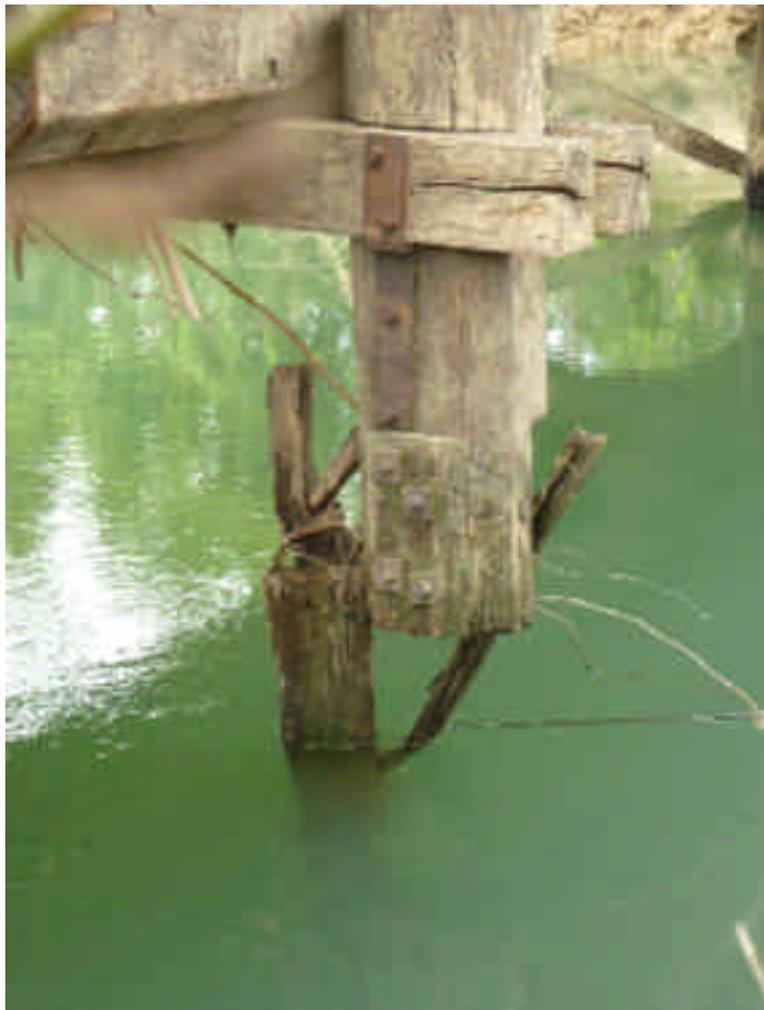
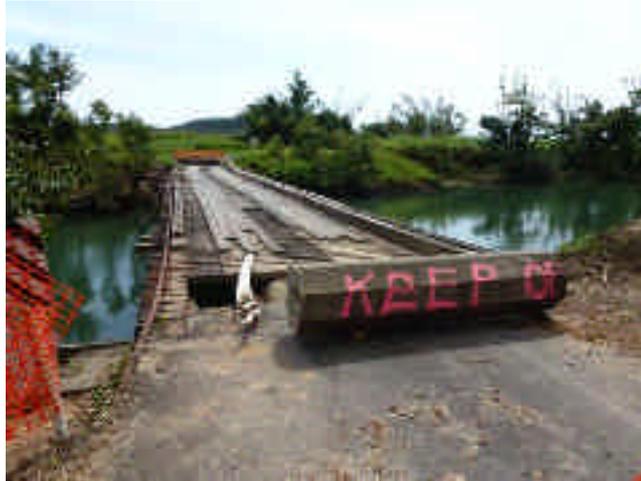
**Figure 13: Improper posting detail on a highway bridge built in Northern Queensland at the turn of the century (top photo left). Posting element size too large, lag joint which leads to reentrant corner cracking and lap joint in the wrong orientation to river flow. Second photograph (top photo right) shows the river flooding and debris forming against the bridge. Lateral loads increased during the flood and since the Global Stiffness testing did not isolate the weakest link created by the improper posting, the bad actor had not been fixed and the whole bridge was lost. The bridge analysis inspection method failed the local government. Bottom two photos show the bridge currently closed. It is to be demolished and must be replaced at a cost of 2 million dollars all caused by one improper posting and then inspection methods!**

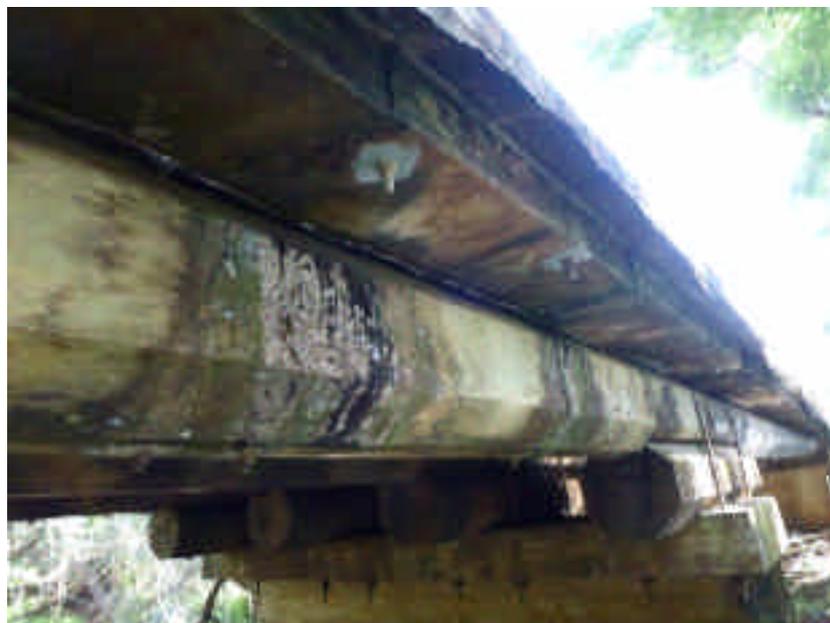
**Figure 14: Highway bridge with concrete piers built during 1930's. Log corbel and girders are less than 20 years old with a CCA treated plywood panel deck 10 years old. The deck is decayed and totally degraded requiring immediate replacement as vertical connectors through the deck have allowed leaching of the CCA from the deck panels. Northern Queensland.**

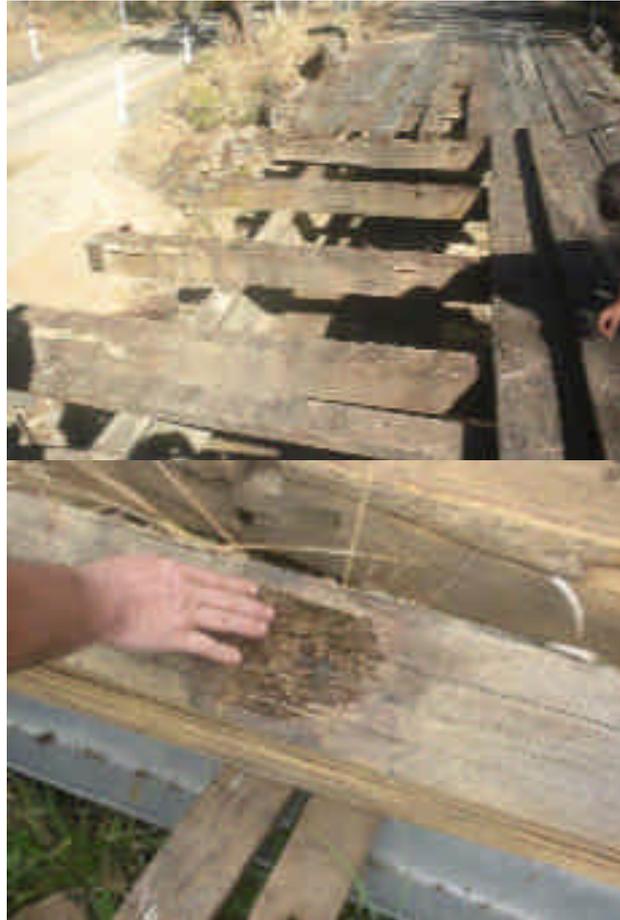
**Figure 15: Highway bridge built at the turn of the century in Southern Victoria with longitudinal deck on top of cross bearers and resting on RSJ's (top photo). Vertical fasteners which passed through the malthoid barrier into the cross bearers caused moisture to flow down the spike trace underneath the barrier which prevented the cross bearers from breathing and they all decayed (bottom photo). The \$4000/m3 Iron Bark cross bearer and deck system were destroyed in only 8 years because of poor construction and maintenance practice!**

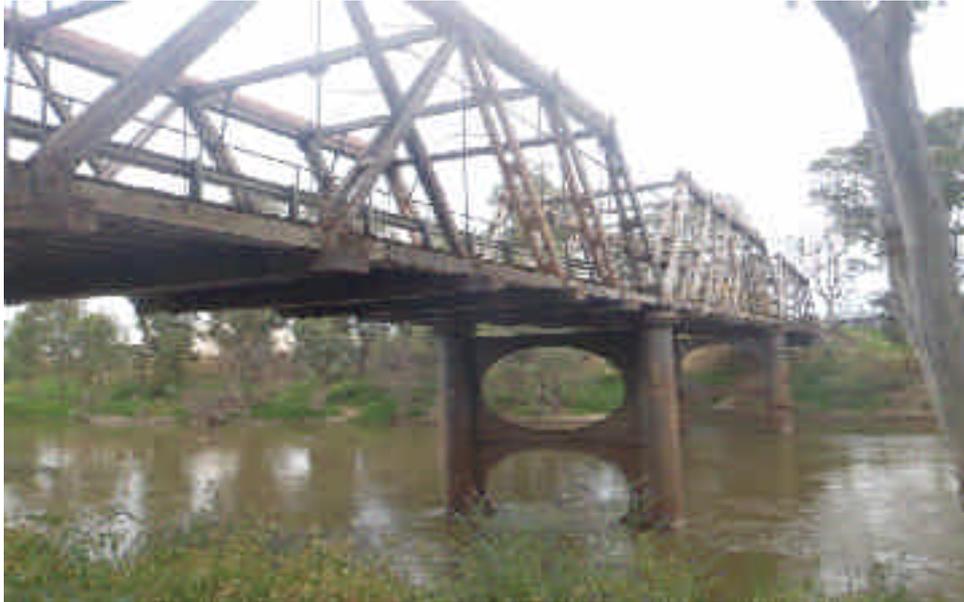
**Figure 16: Percy Allen three span (33 m per span) Highway Bridge built in late 1800's. Timber trusses prematurely decayed and degraded due to poor maintenance practices such as bent metal flashing, malthoid barrier, vertical connectors, and placement of a new plywood deck with the joints directly over the transverse girders so that water dropped directly onto the primary structural members below. Wagga Wagga NSW. The bridge is being demolished and this famous heritage icon is lost to the public forever.**

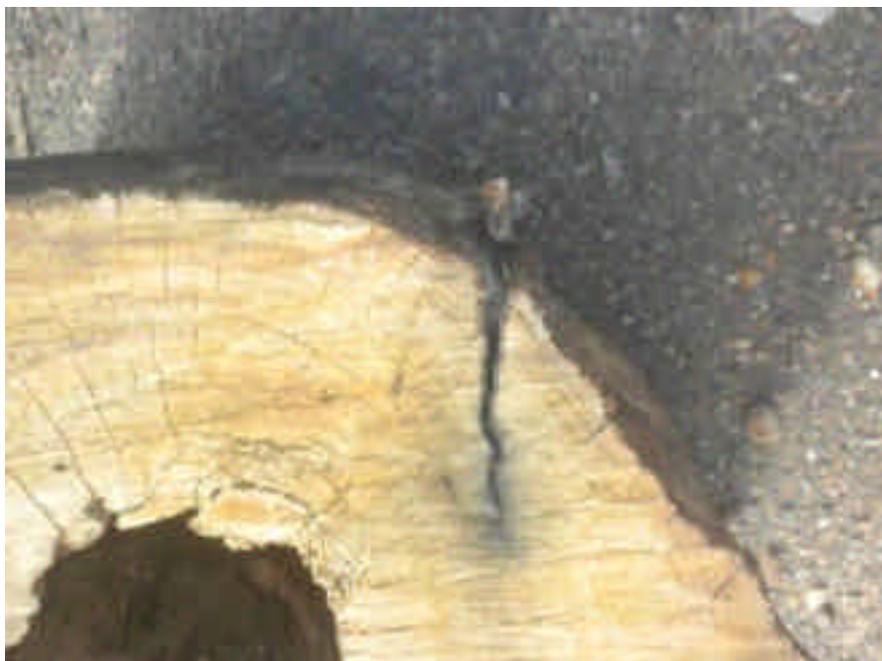
**Figure 17: Cavitated/piped timber pile section where the area at about 2 o'clock is decayed in the annulus and SG is significantly reduced. Also note in this area an old spike where there is ferric degradation and decay propagated by moisture content (MC) in the wood at the fastener caused by condensation off the spike.**

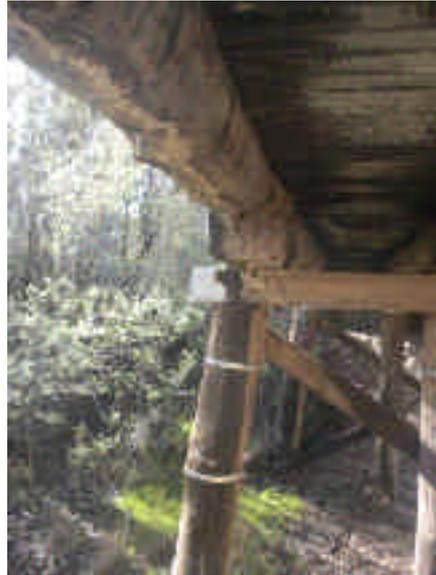
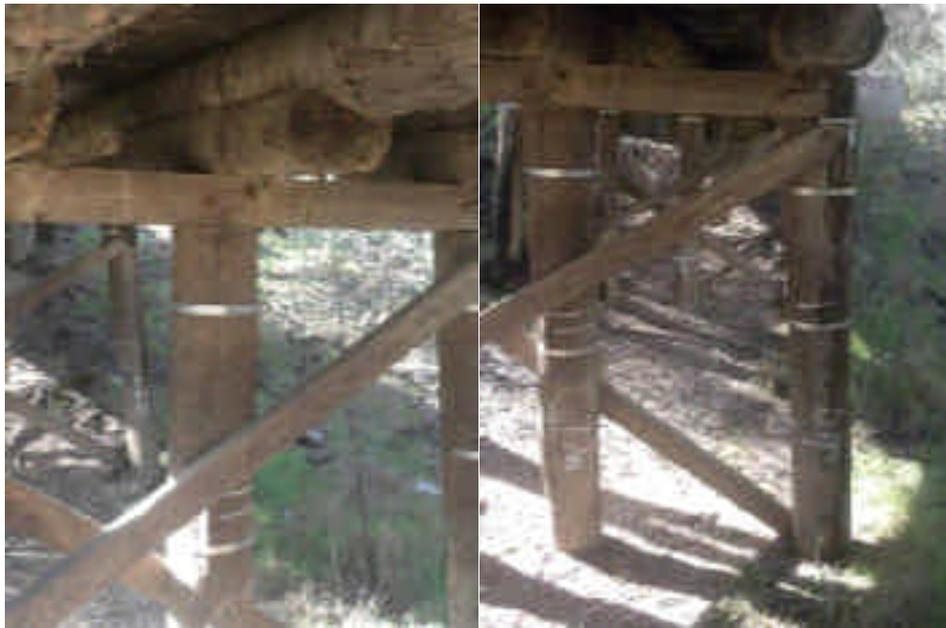
**Figure 18: Photographs of banded piles. See (a, b and c) above for band in Shackell's Folly bridge pile. If the wood expands due to the moisture, it will develop 1000 mpa in the band, well over its maximum stress capability. The thin gage banding intended to conform to the surface better still makes no contact and is loose! Totally ineffective for the intended purpose! Shackell's Folly Bridge is particularly interesting for the steel banding as the steel deck ballast tray is leaking and during the inspection there was ample water flowing onto the log piles causing them to swell, note the water on the cross head and log pile in (c) above. Further, this bridge has a steel ballast tray with vertical through connectors into the log girders similar to the vertical connectors into the cross bearers used in many timber bridges throughout Australia, which has led to decay in the centers of the cross bearers in many timber bridges.**

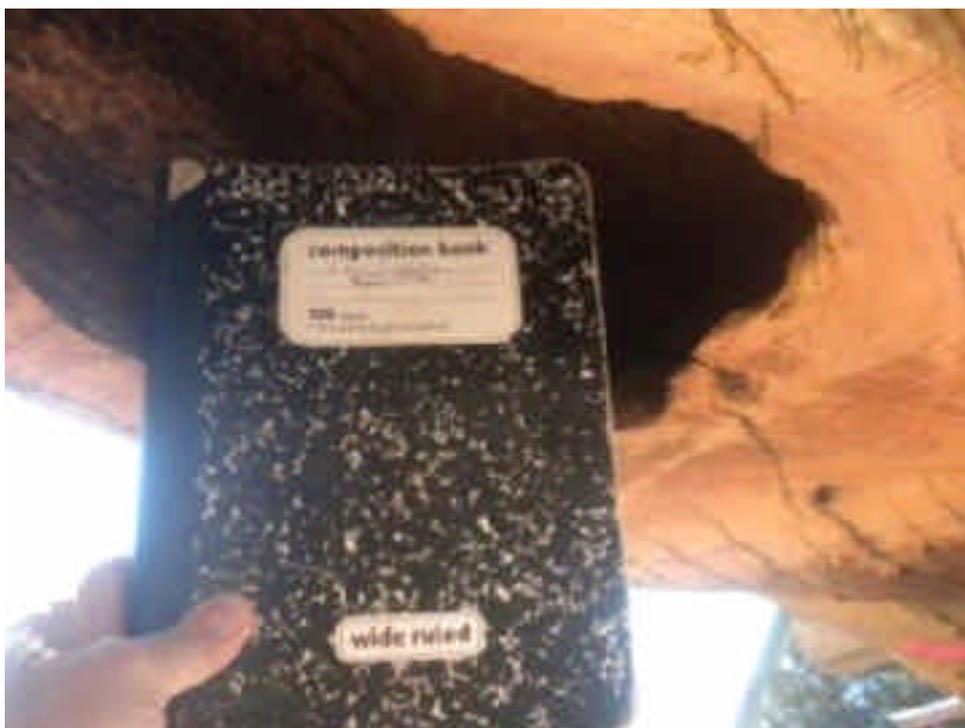
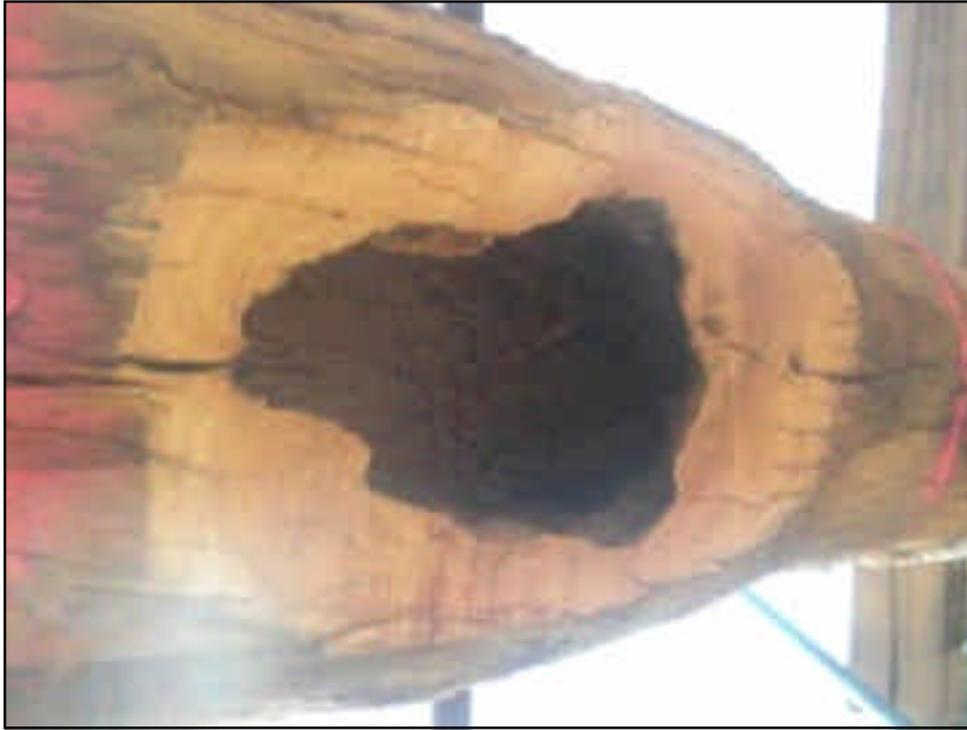
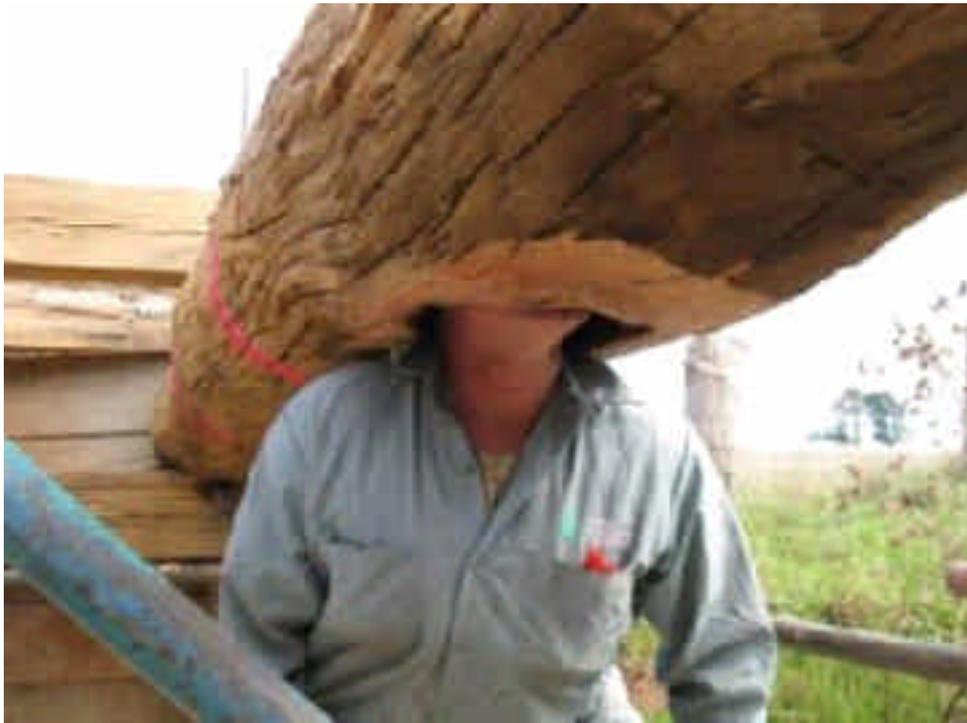
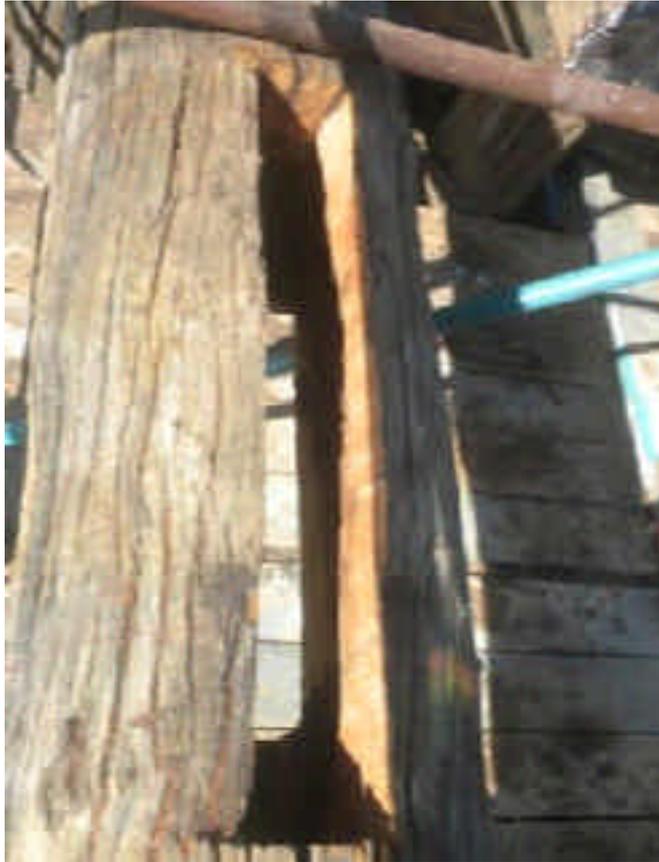
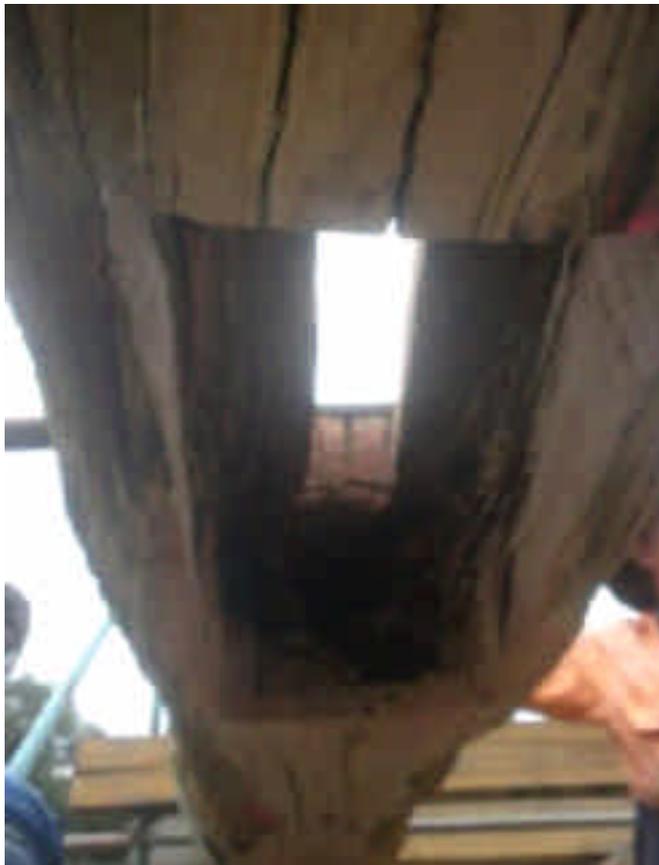
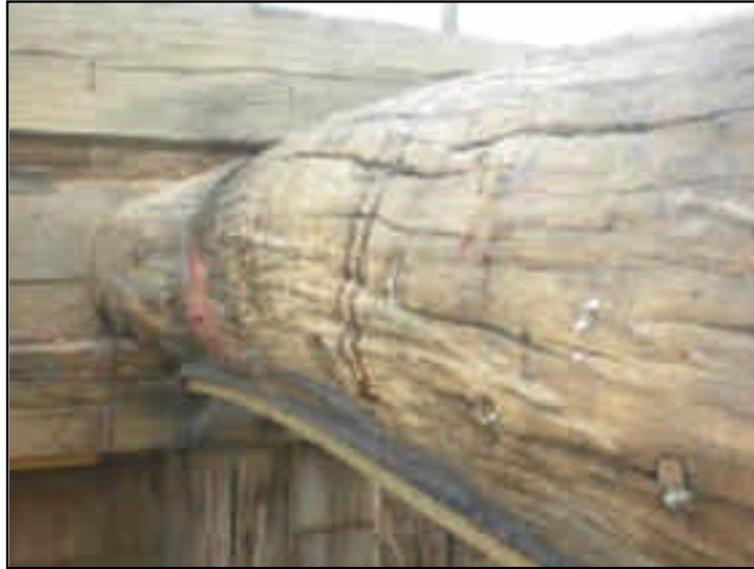
**Figure 19. Cavitated timber bridge girder (a, b and c) in place at Costello's Bridge in Mitchell Shire. In addition to the large cavity running 2/3 the length of the log, the annulus SG is significantly reduced. Decay propagated by constant elevated MC in the wood around the metal vertical through bolts was caused by condensation on the through bolt shank and shelf water following the bolt channel into the core of the log. This constant hydration source provided fertile ground for the decay fungal colony to grow. Such excessively decayed, cavitated, reduced SG annulus log girders can be retrofitted utilising keyways and new treated hardwood keys (d and e) and interior injection with fire proof polymers that slowly polymerize as they work their way into all the open cavities in the log. In addition, high strength fiber retrofits (f and g) are applied and diffused to prevent further decay from occurring in the annulus wood. Note the oak bungs in the side of the log plugging the hole where the diffusers are placed in the log annulus (f and g)**

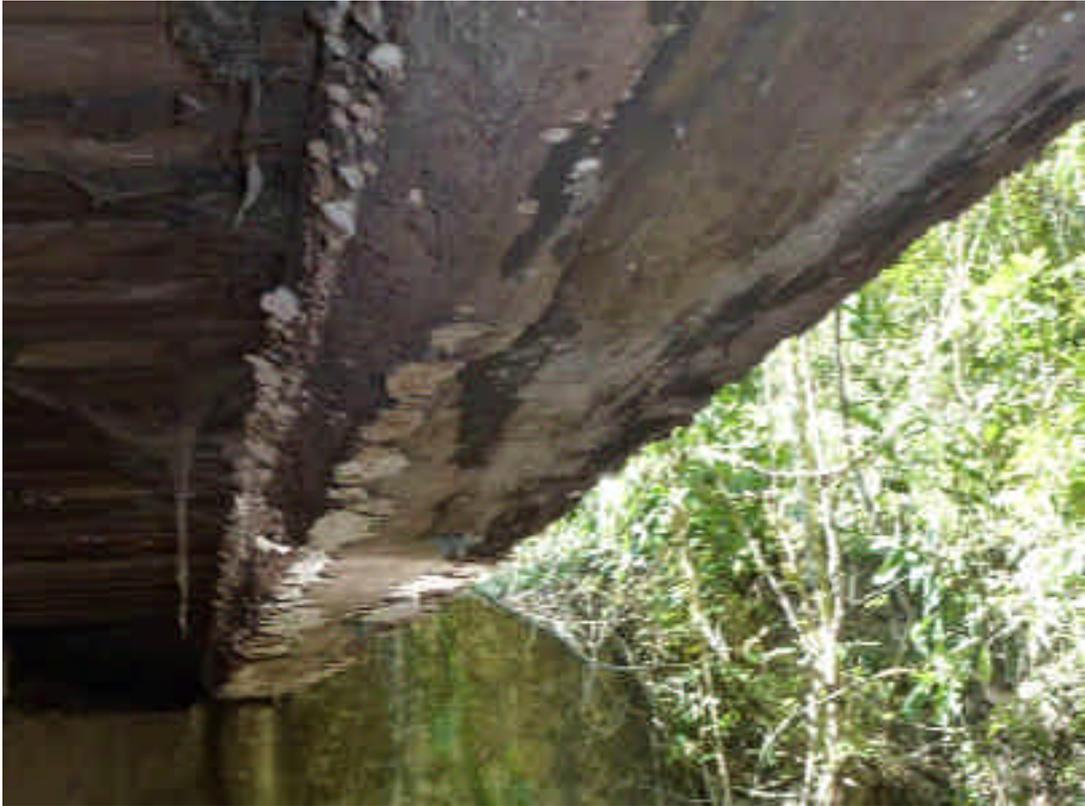
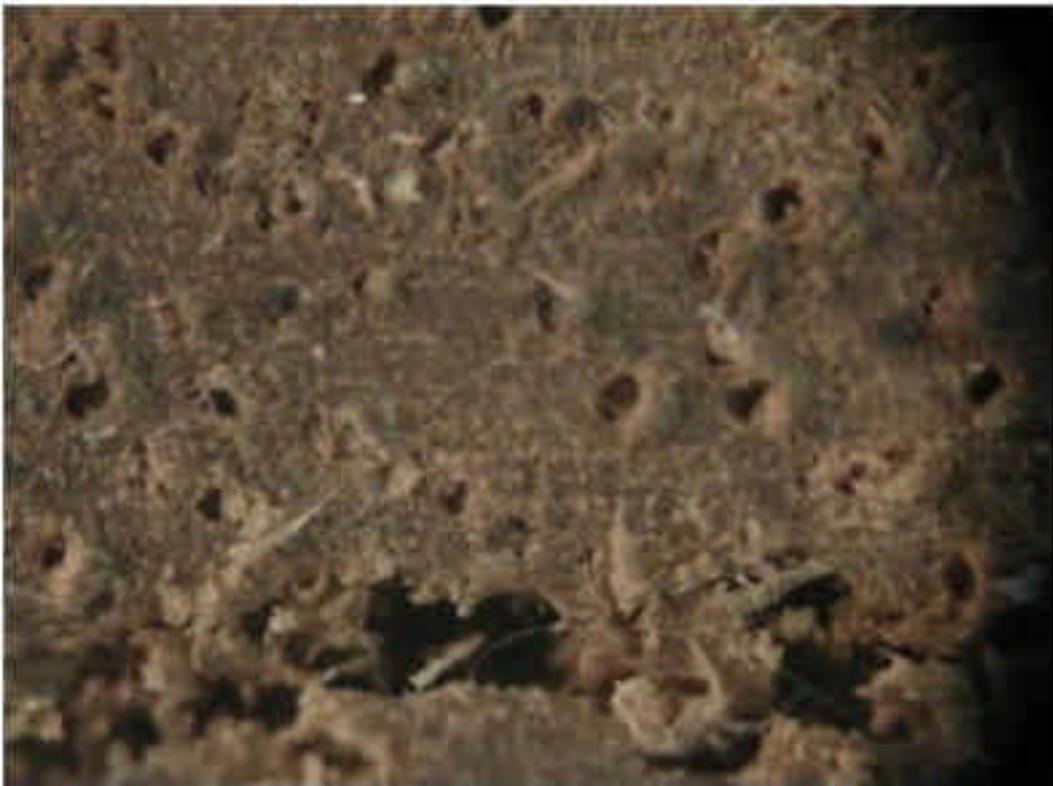
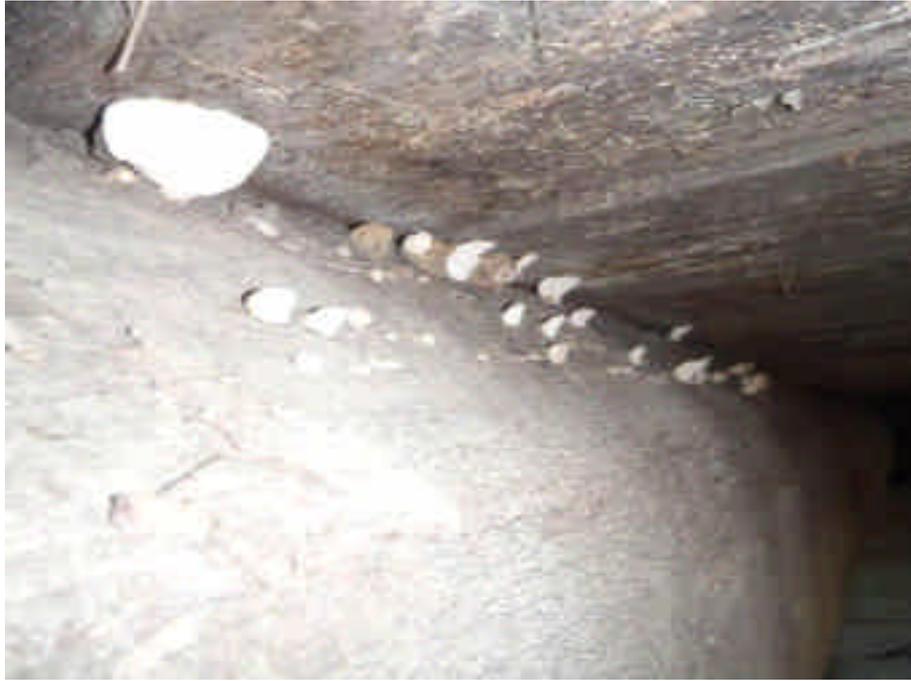
**Figure 19. Photograph of fruiting bodies (brown) on timber element in the tenth timber bridge found in the Kirrama range in CCRC (a). Note the shelf water from the leaking deck and shelf water from outside the deck rain shadow, falling on the outer timber log girder. This coupled with the girder being on the south side of the bridge, the uphill side and closer to moisture all led to increased levels of moisture and elevated decay conditions. Proper drainage techniques for decks and protection from the elements are important in timber bridges. Proper steps should be taken to allow water to move quickly away from timber bridge structural elements. See photograph in (b). (particularly interesting hyphae at 9 o'clock on left side of photograph coming out of pore and into another adjacent pore) above, taken with a microscope, of a wood core taken from a timber bridge in Murrindindi Shire in Victoria, where fungal hyphae can be seen growing through the large pores in the core cross section. These hyphae tips secrete enzymes on the wood that break the cellular structure down as discussed earlier. When fruiting bodies are evident, hyphae are present in the wood at work breaking down the cellular structure and causing loss of structural capacity. Photograph in c) above shows a log girder in Hamilton's Road Bridge with a fruiting body due to similar conditions discussed above.**

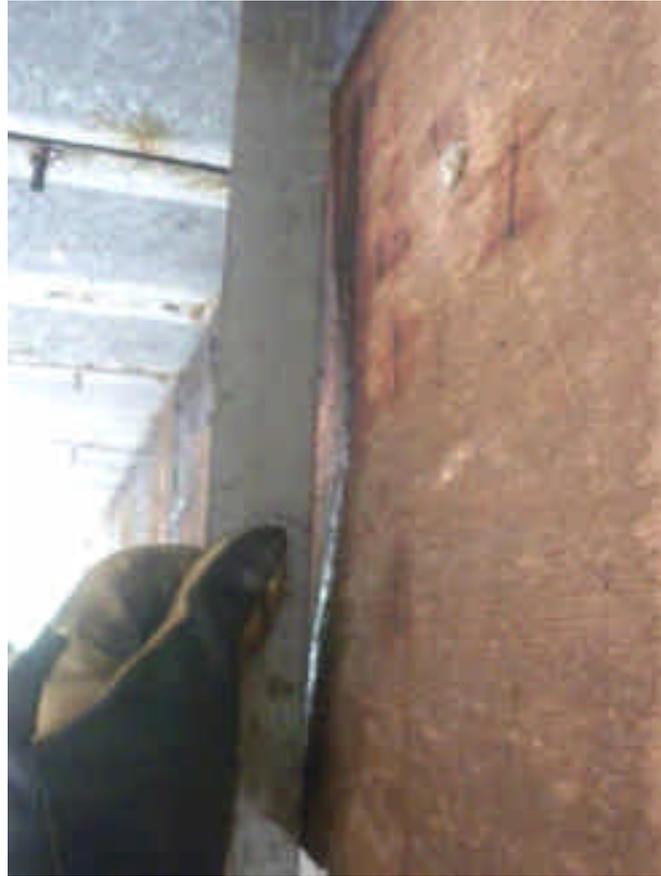
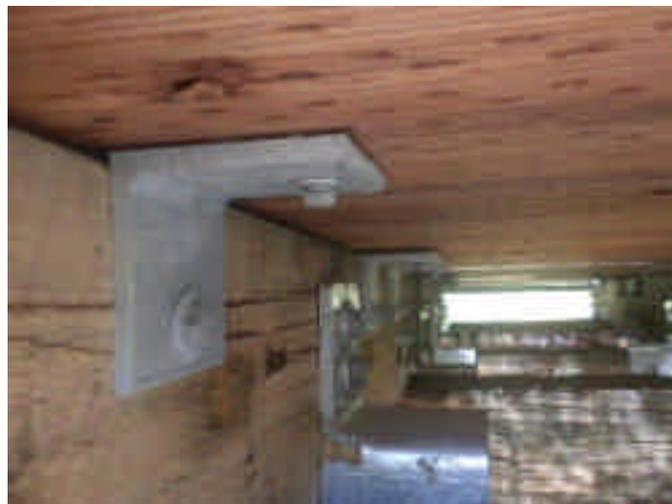
**Figure 20. Photograph of sunken face on a cross bearer in a timber bridge (a). This is strong evidence of decay from excessive water migration into the cross bearer vertically along deck spike traces. Even though hot petroleum jelly (see black stain beneath the square edge) was used, it is obvious how ineffective this method is in preventing decay caused by such improper timber construction practices. Proper deck clips fastened to the cross bearers with horizontal through bolts are required (b). Advanced decay of the type witnessed in the timber cross bearers causes significant loss of structural capacity.**

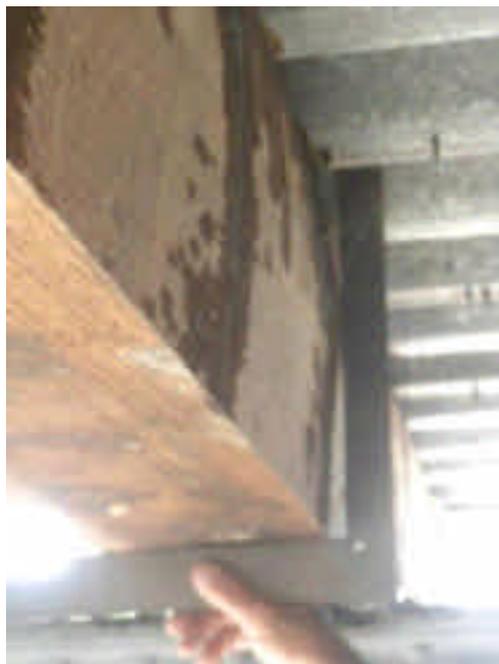
**Figure 21. A bulging face on a cross bearer in a timber bridge. This is strong evidence of decay from excessive water migration into the cross bearer along deck spike traces. Even though hot petroleum jelly (see black stain beneath the square edge) was used, it is obvious how ineffective this method is in preventing decay caused by such improper timber construction practices. Advanced decay of the type witnessed in the timber cross bearers causes significant loss of structural capacity. These cross bearers were only a few years in service but had their useful lifetime shortened by 80% or more because of poor connector installation practices.**

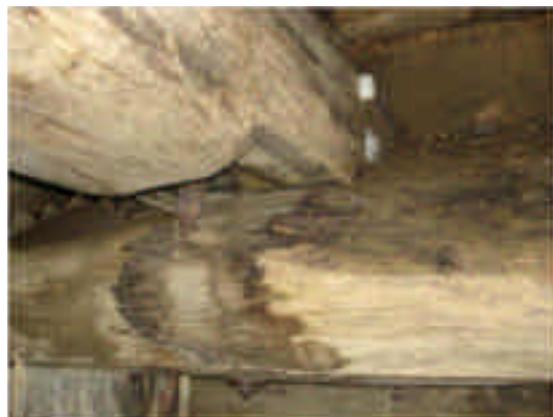
**Figure 23. Vertical through bolts have allowed moisture to penetrate from the bridge deck above, causing premature decay in the structural members below.**

Change vertical through bolting to horizontal bolting that does not pass through the upper surface. Examples of through bolt degradation are shown in Figures 23 and 24.

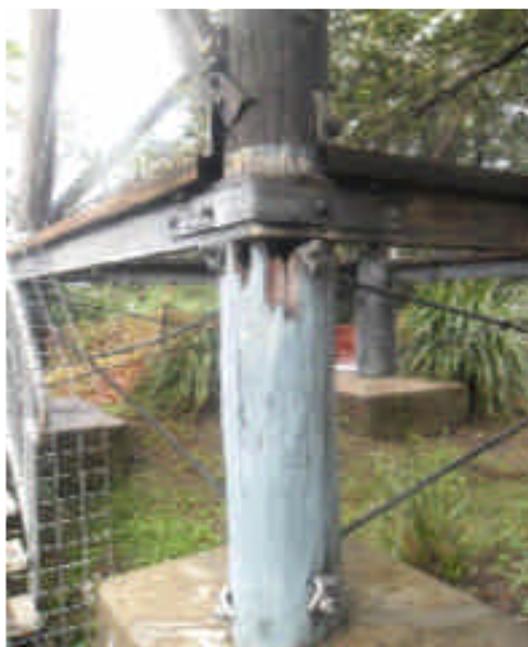
**Figure 24. Through connections all channeled water to the interior of this pile in a fire lookout tower. .**

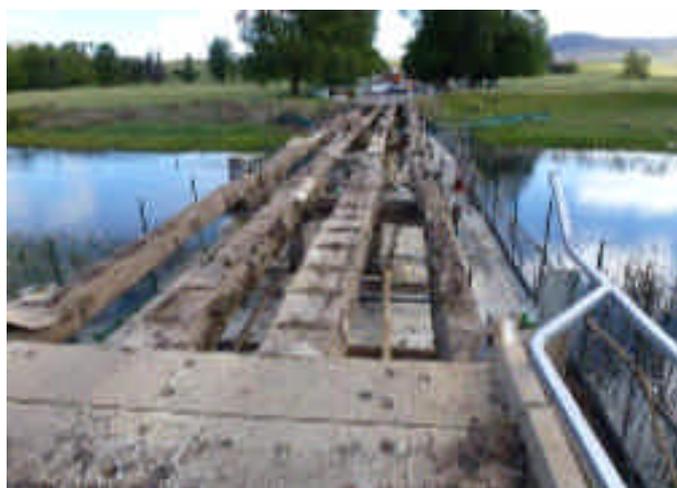
**Figure 25. Malthoid barrier was used between the girders and deck panels. Vertical fasteners through the deck panels penetrate the malthoid barrier, allowing water to follow the fastener through the barrier, trapping it in the girder below and causing decay. These girders were only a few years old when they failed.**

Stop the use of malthoid barrier that traps moisture on the top of the timber elements where it is unable to evaporate. The long term high MC causes excessive decay. See Figure 25 below.

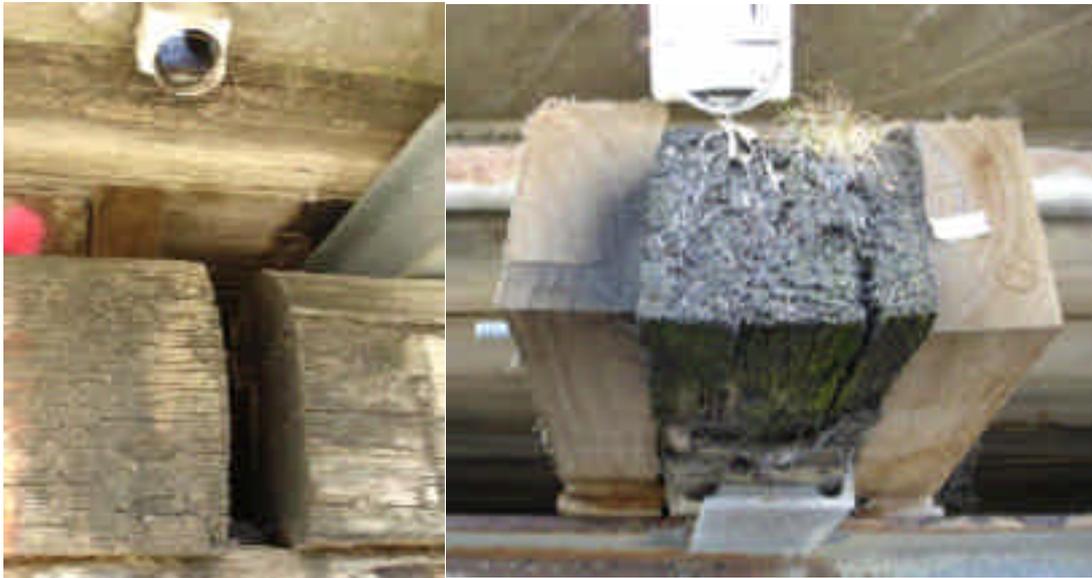
**Figure 26. Improperly placed downspouts caused accelerated decay in the structural members above. On the right, additional timbers were added without correcting the cause of the problem.**

Insure positive deck drainage that does not fall directly onto structural elements such as shown in Figure 26 below.

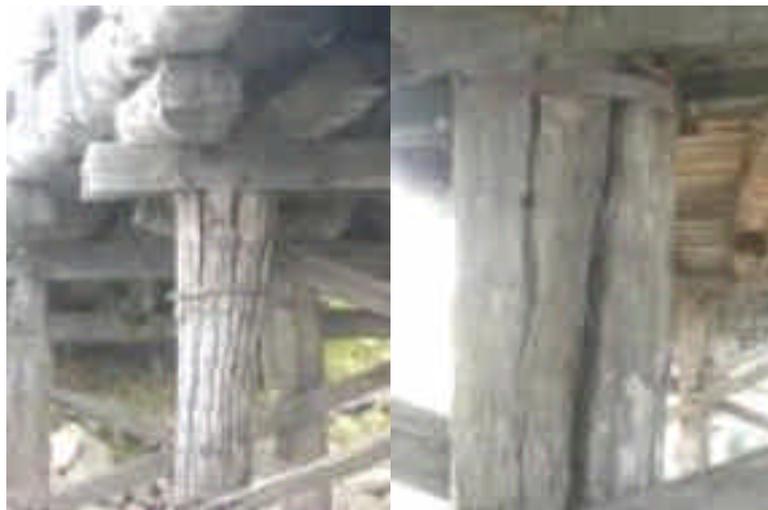
**Figure 27. Banded piles. When the wood expands due to moisture, it can develop 1000 Mpa in the band, well over its maximum stress capability, expanding the band. Piles are driven tip first, tapering down. When the moisture level changes, the bands become loose, sliding down the pile as shown on the left. The banding also does not stop the inward buckling of feathered, cavitared pile tops.**

Provide for moisture content induced dimensional change in timber elements, such as oval holes in side plates. Stop the use of banding to stabilise timber piles that are degraded with decay, splits, cracks and broomed/feathered tops as shown in Figure 27 below.

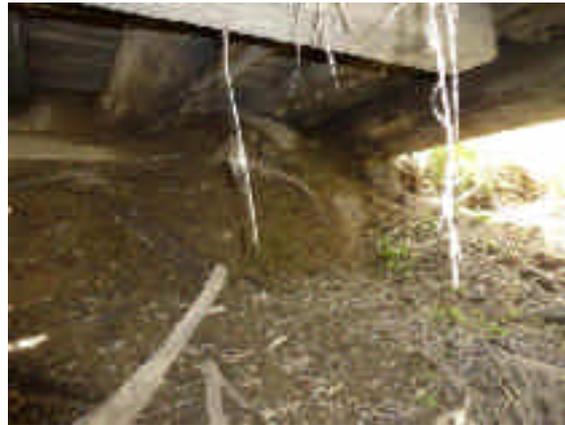
**Figure 28. Debris has built up around this abutment leading to higher moisture contents in the adjacent timbers and subsequent accelerated decay conditions. This debris should be cleared away from the timbers and abutment during routine regular maintenance.**

Provide clearance for timber members to breathe. Debris around the abutments is often left in place for prolonged periods of time as shown in Figure 28. This debris should be cleared away from the girders and abutments. It holds moisture around the timbers which leads to accelerated decay.

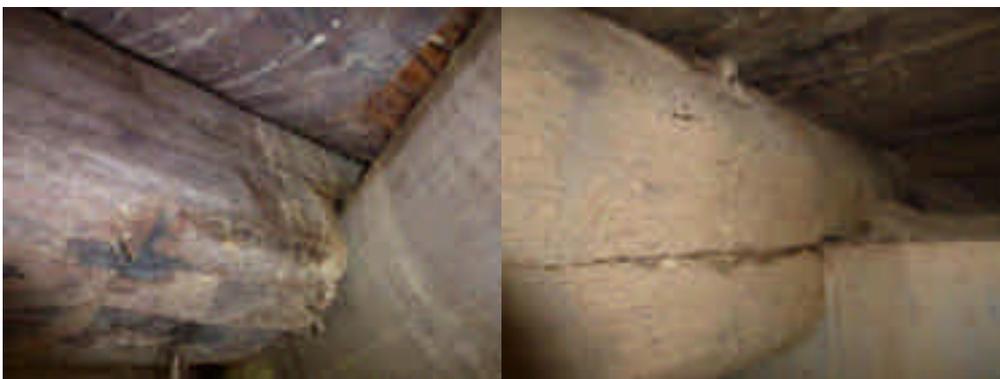
**Figure 29. Girder with a heavy notch way beyond allowable depth as per the timber design standard in Australia. Longitudinal tension perpendicular to grain and horizontal shear cracks are originating in the notch area. This girder will crack further along the grain and the grain is traveling upward, compromising the girder in a short period of time with continued use.**

Stop the use of heavy notching and slope cut notches with a minimum 1:6 slope to prevent stress concentrations and re-entrant cracking as shown in Figure 29 below.

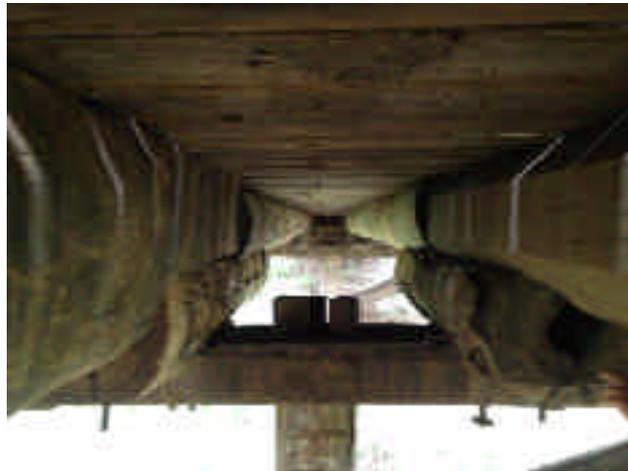
**Figure 30. Girders are placed more than depth  $D$  of the cross head away from the pile. The cross heads are deflecting and horizontal shear cracks are forming.**

Use properly sized timbers in pile bents and place loads within  $D$  of the pile to prevent horizontal shear cracking in undersized cross heads as is shown in Figure 30.

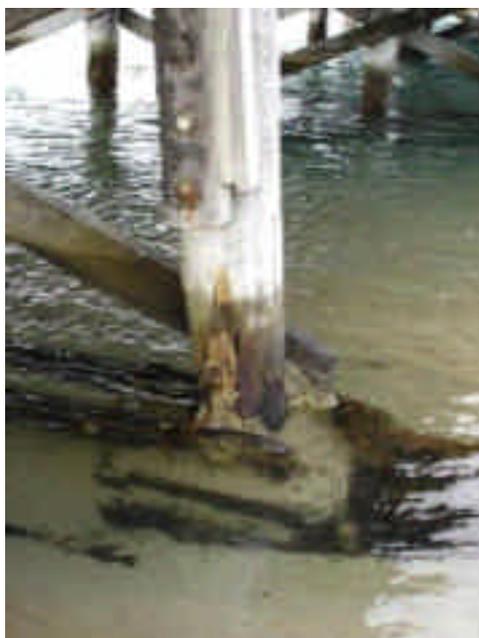
**Figure 31. The concrete jacket poured around this pile has done more damage than good, causing widespread rot in the timber members.**

Stop the use of concrete jackets which trap moisture around the timber members as shown in Figure 31.
