Property Summary

Dubbo Showground - Centenary Pavilion

33071

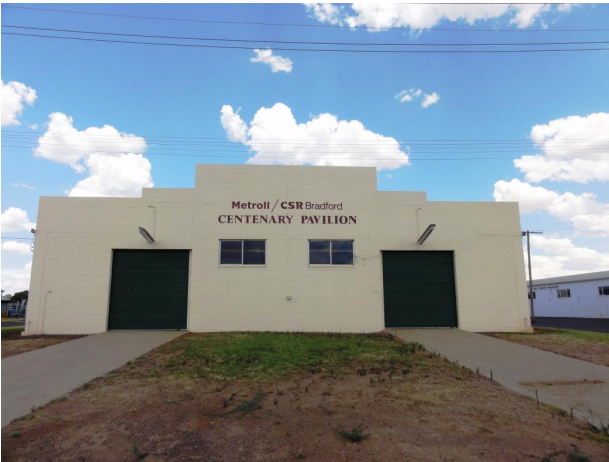
Bessa block walls with a row of single pane glass windows at top of wall. Steel framed metal clad roof and asphalt floor surface. 2 x vehicle roller doors at front and 2 x vehicle sliding doors at each side. Foil insulation installed under room in 2011. Main use: Hired to exhibitors for static displays, some sheep sales, ice skating & the like. Amount of use: 0 - 6 days per month
