THE TECHNICAL INVESTIGATION OF THE FIRE AT LONDON'S KING'S CROSS UNDERGROUND STATION

K. Moodie and
S.F. Jagger

Health and Safety Executive,
Research and Laboratory Services Division, Explosion and Flame Laboratory,
Buxton, England

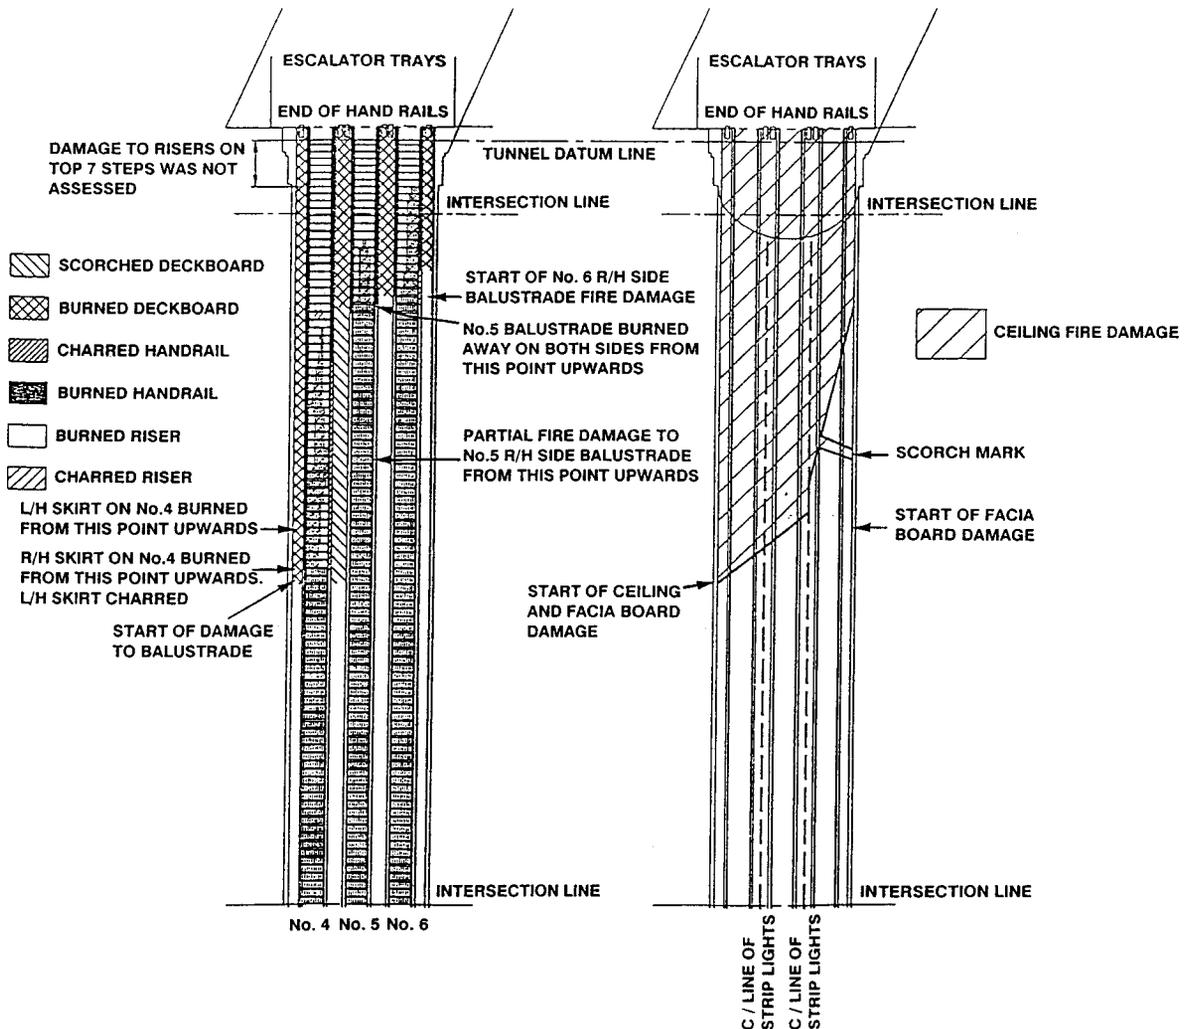
Figure 2. King's Cross Station Piccadilly Line fire damage, plan view.

The fire damage¹ extended upwards from a point some 22-23 m below the top of the Piccadilly line No. 4 escalator (see Figure 2). It progressively involved more of the available combustible material in the escalator shaft until practically all of the available fuel had been consumed near the top (throat) of the shaft. Also in this region, the fire damage was more extensive on the left hand side (looking up) of the shaft, as illustrated in Figures 3a and 3b, which show respectively the fire damage viewed from below the seat of the fire and the fire damage to the ceiling at the top of the escalator tunnel.

The salient features of the damage to the ceiling and paint are shown in Figures 2 and 3a. Scorching of the paint started abruptly some 22-23 m down the tunnel on the left hand side, with minimum blister damage to the paint below this point. The line of scorching travelled diagonally across the ceiling from the left hand

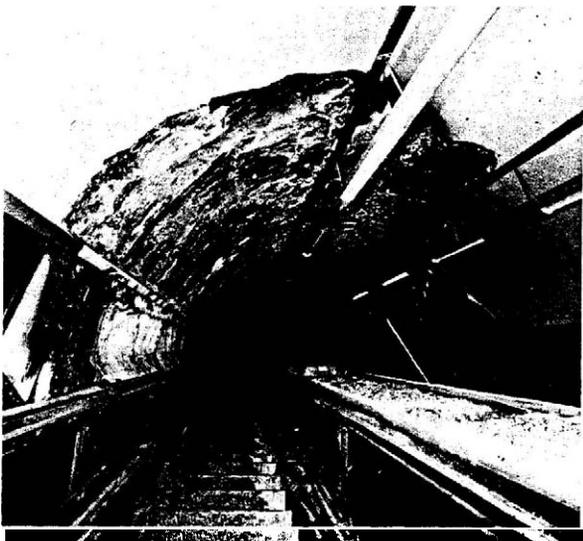
Figure 3a. General view of the damage in the Piccadilly Line escalator tunnel.

side facia over to the right hand side facia. Towards the top of the tunnel the ceiling damage was more severe, particularly on the left hand side, with most of the paint missing, and in some areas layers of plaster also appeared to have fallen. There were two rows of suspended fluorescent lights along the length of the tunnel ceiling which had suffered minimal fire damage.

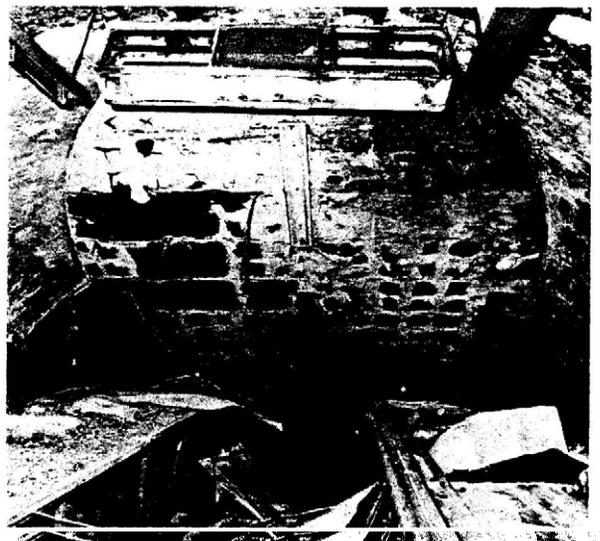
Figure 3b. Fire damage to ceiling in the throat of the escalator tunnel.

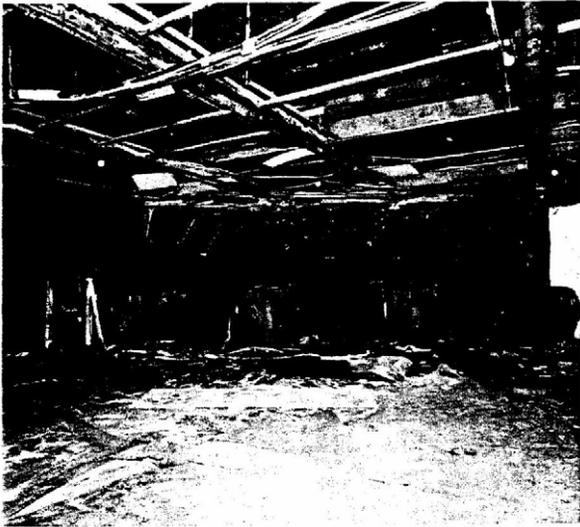
The fire damage continued through the ticket hall as shown in Figures 4a and 4b, where again most of the available fuel had been consumed, although to a lesser degree than in the throat of the tunnel. The fire damage in the passageways leading from the ticket hall became progressively less the greater the distance from the

Figure 4a. Fire damage at the top of the Piccadilly Line escalators

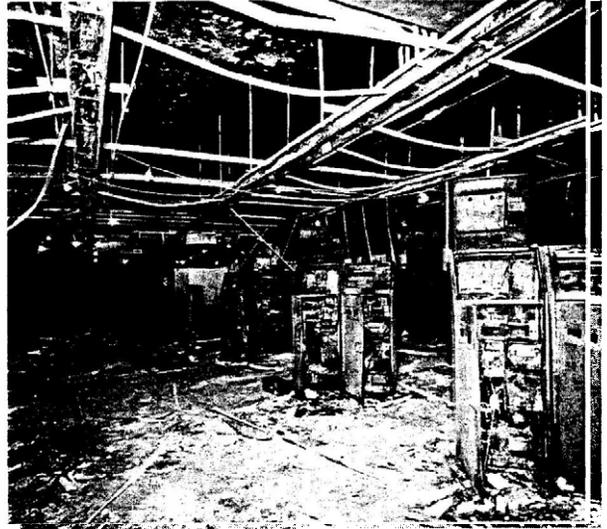
Figure 4b. Fire damage to the ticket machines in the ticket hall.

There was a ticket office in the centre of the ticket hall which was severely fire damaged. It had been constructed from a wooden/steel frame covered in 12 mm plywood finished in melamine. The majority of the fire damage occurred on either side of the ticket office corner nearest the Piccadilly line escalator. Most of the wooden components in this area were either burnt away completely or were more severely damaged than on the rear or other side wall. Most items within the ticket office had suffered some degree of fire damage; for instance, aluminium-based components near the top of the floor-mounted ticket machines had melted, whilst rolls of tickets at the bottom were only scorched. A number of wooden items had been burning and were charred. Wooden drawer fronts were charred, but inside and to the back of the drawers undamaged wood was clearly visible. Items that were near to the floor below the window level appeared to have suffered less damage than those above window level.
