Behavior of Full-scale Frames with Slim Floor Slab Construction under Exposure in a Fire Resistance Furnace

YULI DONG*

KULDEEP PRASAD

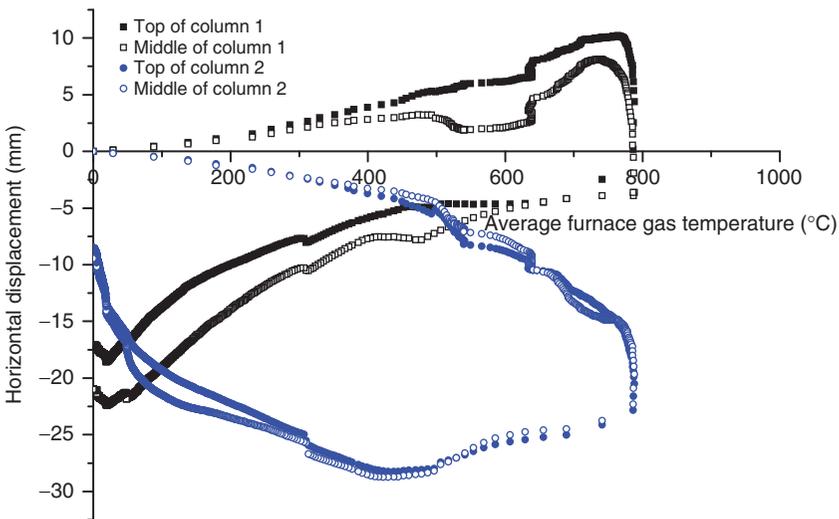
The horizontal displacements at top and mid-height for column 1 and column 2 plotted as a function of the average furnace temperature are shown in Figure 8, while the same horizontal displacements are plotted as a function of time in Figure 9. As the composite floor slab expands, columns 1 and 2 are pushed apart in opposite directions. Results indicate that the horizontal displacements increased linearly until the average fire temperature reached 450°C. During this initial heating phase, the deformation of columns 1 and 2 was outwards and symmetric and the displacements at top and at mid-height of columns were almost equal. When the average furnace temperature was below 450°C, the temperature gradient in the concrete slab and the floor beam was such that it induced bowing of the floor slab downwards towards the furnace. Since the column temperature was only

Figure 8. Horizontal displacements measured for columns 1 and 2 as a function of average furnace temperature. (The color version of this figure is available online.)

As the average furnace temperature rose above 450°C, the displacements become asymmetric and highly nonlinear. This is attributed to thermal degradation of material properties at high temperatures as well as to the combination of moment and axial force of steel column. Figure 9 clearly shows buckling of column 1 at ~73 minutes after ignition, which results in an asymmetry in the displacement curve. At this point, the maximum horizontal displacement at the top of columns 1 and 2 are 10.0 and 19.0 mm, respectively. Although the loading on both columns was similar, column 1 buckled before column 2 due to slight imperfections in the loading. Once column 1 buckled, the furnace was shut-off, and as a result, buckling of column 2 was prevented. In Test 3, column 1 buckled first, and the movement of the test frame was towards column 2. On the other hand, in Test 1, column 2 buckled first, and the movement of the test frame was towards column 1. In both Test 1 and Test 3, run-away failure was predicted as both columns moved in the same direction. Column failure in Test 1 occurred at 61 minutes after ignition, while in Test 3, failure was observed at 73 minutes after ignition. Comparison of the results for Tests 1 and 3 indicate that the fire resistance of a slim floor slab construction is at least as good, if not better than that of a conventional floor construction. During the cool down phase, the displacement for

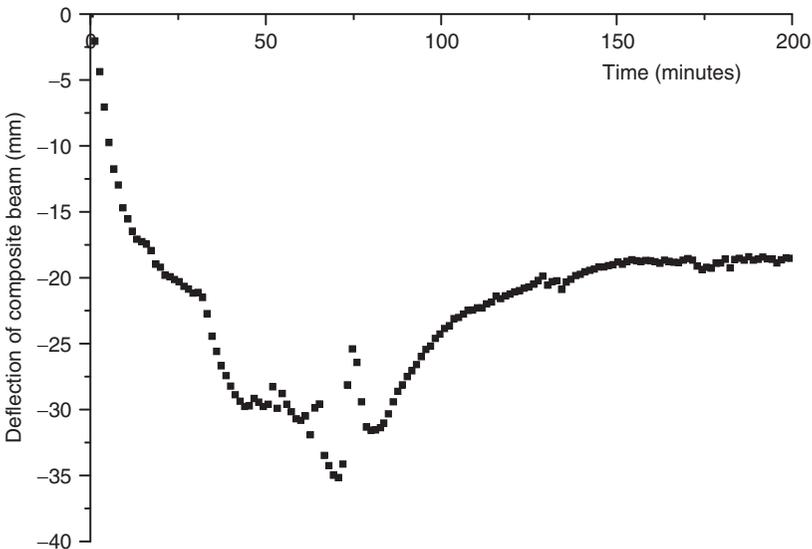
As the composite floor was heated, the floor sagged due to loss of material stiffness and constrained thermal expansion. The main reason for the sagging was the thermal gradients in the section. The mid-span deflection of the composite beam plotted as a function of time is shown in Figure 10. The floor deflection increased linearly during the heating phase until the average furnace temperature reached 450°C. Beyond 450°C, the behavior of the floor slab was highly nonlinear and asymmetric. The floor deflection was 35.3 mm at 73 minutes after ignition. At the point when column 1 buckled, the deflection changed dramatically. After the furnace was shut-off, the deflections reduced and a residual value of 18.7 mm was observed for the mid-span deflection at the conclusion of the test.

Figure 10. Vertical deflection of composite beam (mid-span location) plotted as a function of time.

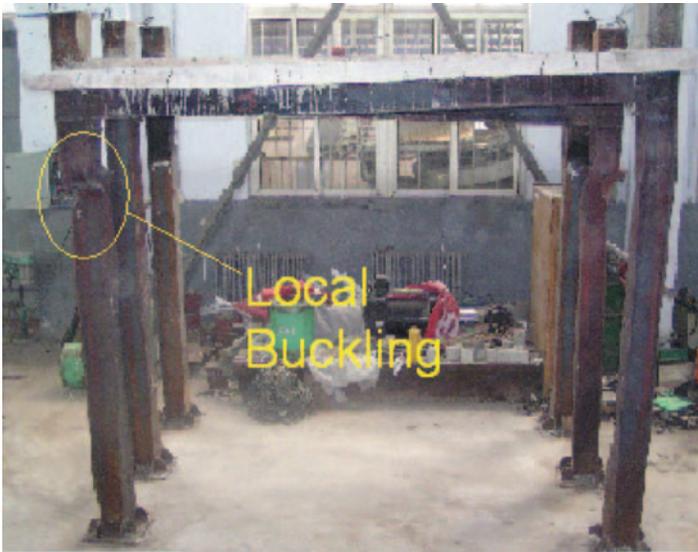
Once the furnace temperature reached its ambient value, the frame was removed from the furnace and examined for visual signs of local failure. Figure 12 shows a photograph of the test frame after it was removed from the furnace. This photograph corresponds to the last sub-figure in Figure 11. Visual observations clearly indicate the formation of a plastic hinge on column 1 close to the connection with the composite floor. Test 1 indicated a similar kind of failure on column 2. Occurrence of the column local buckling was attributed to flanges lost their stability in the vicinity of the connections at the high furnace temperatures. Since the beam-to-column connections were protected from furnace heating and the composite beam was stiffer

Figure 12. Photograph of the frame at the conclusion of the furnace test showing the formation of local buckling on column 1 close to the connection. (The color version of this figure is available online.)

than the column, plastic hinge formed in the column underneath the joint. The photograph also indicates bowing of the column and vertical deflection of the composite beam.

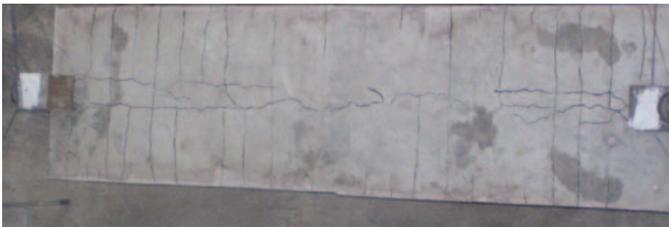
Figure 13 shows the formation of cracks in the RC floor slab, observed when the frame was removed from the furnace for inspection. Cracks along the width of the slab were concentrated near the beam-to-columns connection, while fewer cracks were observed in the mid-span section. Inspection of the concrete slab at the conclusion of Test 1 had also indicated concentration of cracks near the beam-to-column connection. In addition, the concrete slab in Test 1 indicated the presence of diagonal cracks, near the beam-to-column connection. Such diagonal cracking was not observed in Test 3. In Test 1, the steel beam was connected to the slab through shear studs, while in Test 3, the steel beam was embedded in the concrete slab and was welded to the reinforcing bars. The presence of diagonal cracks in Test 1 and not in Test 3, can be explained by the manner in which load is transferred from the beam to the slab for composite action. In a conventional slab construction, stresses are concentrated in a small region around the studs, and are not distributed uniformly through the width of the slab, resulting in the diagonal cracks. When the beam was embedded in the slab and was welded to the re-inforcing bars, as in a slim floor slab construction, the load transfer was more uniform through the width of the slab. This results in perfectly parallel cracks running along the width of the slab as seen in Figure 13. It was also noted that more cracks were observed in Test 3 as compared to Test 1. Comparison of the crack pattern in the concrete slab following Tests 1 and 3 indicates that the composite floor action was achieved to a higher degree in a slim floor construction as compared to a conventional floor slab construction.

Figure 13. Photograph of the reinforced concrete floor slab at the conclusion of the furnace test. (The color version of this figure is available online.)

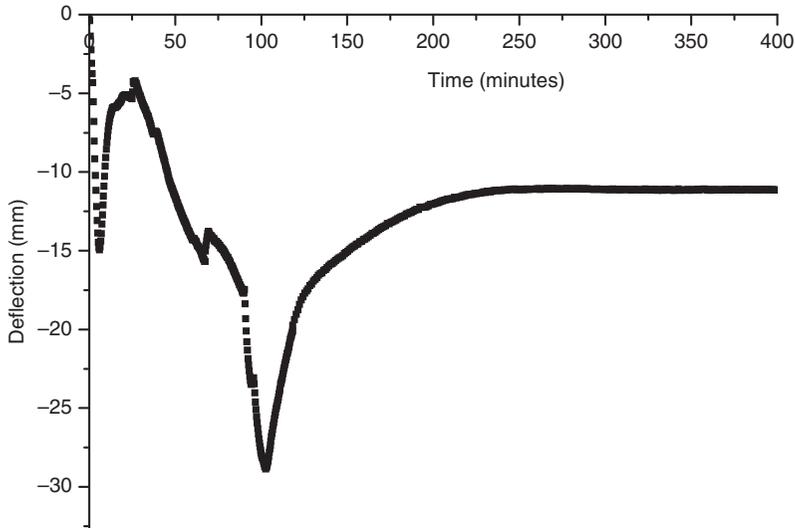
Figure 17 shows the composite beam vertical deflection plotted as a function of time. The reader is referred to [16] for a discussion of how the deflections were computed from the results of the displacement transducer. As observed for the columns, the deflections increased linearly until 490°C. Beyond 490°C, beam deflections were highly nonlinear, and were dominated by high temperature material nonlinearities and the

Figure 17. Vertical deflection of composite beam (Test 4) plotted as a function of time.

restraining action of the columns. There was a short reversal in beam deflection observed between 7 and 27 minutes after ignition. This reversal was likely due to the restraining action provided by the columns (the columns were protected in Test 4, and were at a lower temperature). Such a reversal in beam deflection was not observed in Test 3, since the columns in that test were not protected and did not provide the same level of restraining action on the beam. Detailed numerical modeling of this experiment will help in further understanding the observed reversal in the beam deflection curve, shown in Figure 17. Beam deflections reached a maximum deflection value of 28.9 mm during the cool down phase, well after the furnace was shut-off. A residual value of 11.1 mm was observed at the end of the cool down phase. The vertical deflection plot shows a trend that is similar to that obtained in Test 2.

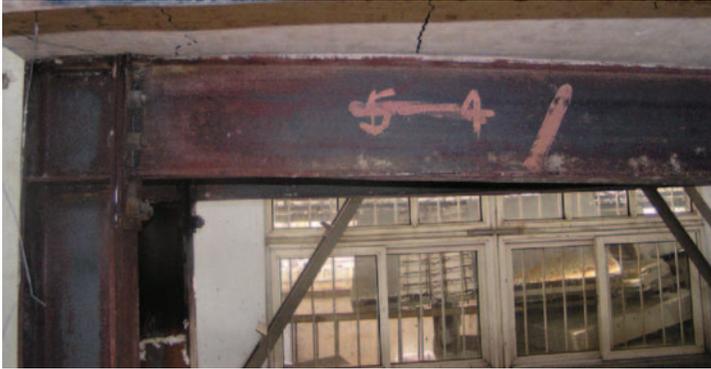
Figure 19. Photograph of the frame at the end of Test 4 showing local buckling of the steel beam. (The color version of this figure is available online.)

Following the cool down phase, the frame was removed from the furnace and was visually inspected for signs of local failure. Figure 19 is a photograph of the frame after it was removed from the furnace. Since the columns and the beam-to-column connection were protected from furnace heating, Figure 19 shows local buckling on the beam web at about 100–600 mm from the end plate close to column 1. Examination of the concrete slab also indicates the presence of cracking similar to that observed in Test 3.
