A methodology to determine pre-crash fuel quantity from post-crash fire thermal damage to an aircraft structure

N Alvares¹ and AC Fernandez-Pello²

Abstract

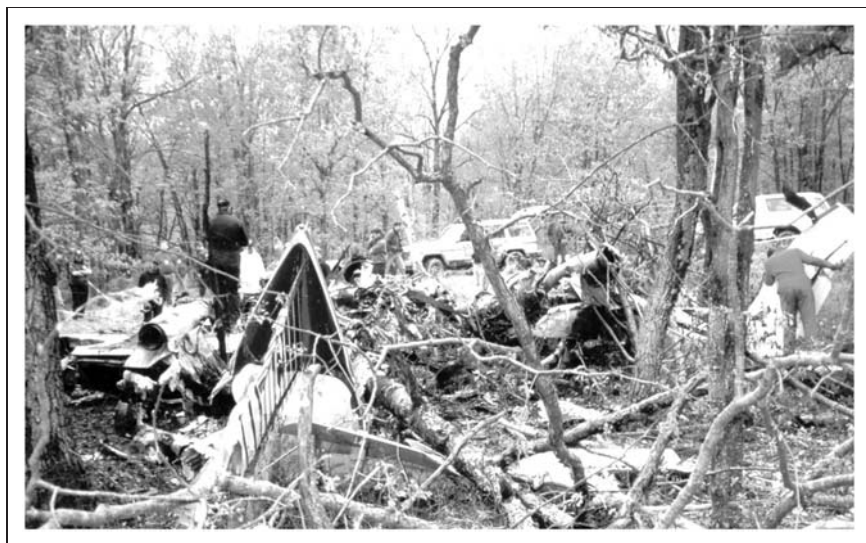
Figure 3. Wreckage site photograph, aft view. Reproduced from the NTSB [1].

The smoke plume from the crash guided rescue personnel to the crash site, which was near the top of a mountain. The aircraft hit the ground at a steep angle in an extreme left bank. At impact, the aircraft rotated such that the wreckage was found facing in the approach direction. All airplane parts except for the tail section were found in relatively normal configuration and location. The tail section was upside down but still connected to the main fuselage by control cables. Figure 2 is the NTSB sketch of the wreckage distribution and Figures 3 and 4 are photographs of the wreckage looking from rear and forward directions, respectively. Note that wreckage is resting on a pile of boulders.

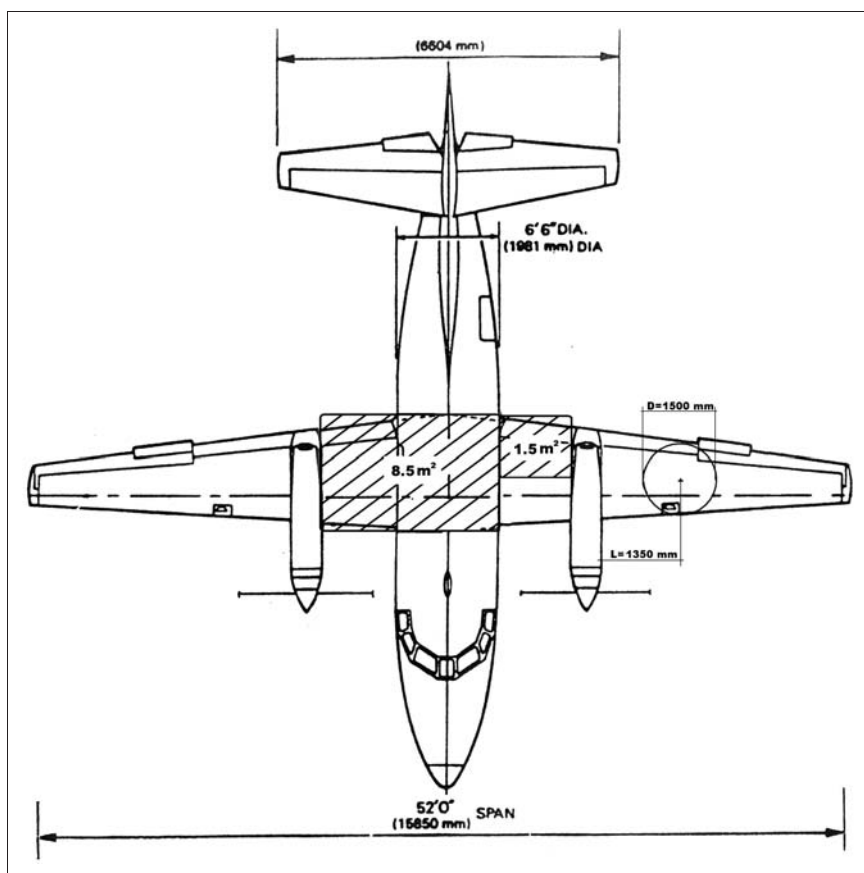
Figure 5. Major fire destroyed areas outlined on plan view of Jet Stream Aircraft.

The extent of thermal destruction to the aircraft structure is outlined on the plan view of the Jet Stream 3101 in Figure 5. Because so much of the structure was destroyed by the impact and fire and the inspection facility was limited in area, documentation photographs of the evidence show only limited elements of the damage. Figure 8(a) shows the bottom of the portion of the right wing that survived the fire. There were no recognizable components of structure that survived the accident between the engine station of the right wing and inboard connection between the left wing and cabin. Figure 8(b) is a photograph of the reconstructed left wing that was assembled from recovered elements of the wreckage. The mid-span void in the reconstruction is surrounded by incipiently melted Aluminum caused by the post-crash fire that surrounded the wing. Radiant heat effect (incipient melting of aluminum skin and paint degradation not associated with direct flame contact) to the outboard surface of the forward portion of the engine nacelle is an indication of the thermal intensity of the fire plume.

Other possible ignition sources could be friction sparks produced when steel surfaces scraped across rocks or hot engine parts. A conservative estimate of the thermally destroyed portions of the fuselage and inboard wing areas shown in Figure 5 is 10 m^2 (108 ft^2). Similarly, the thermally destroyed area in the middle section of the outboard left wing is greater than 1 m^2 (11 ft^2).

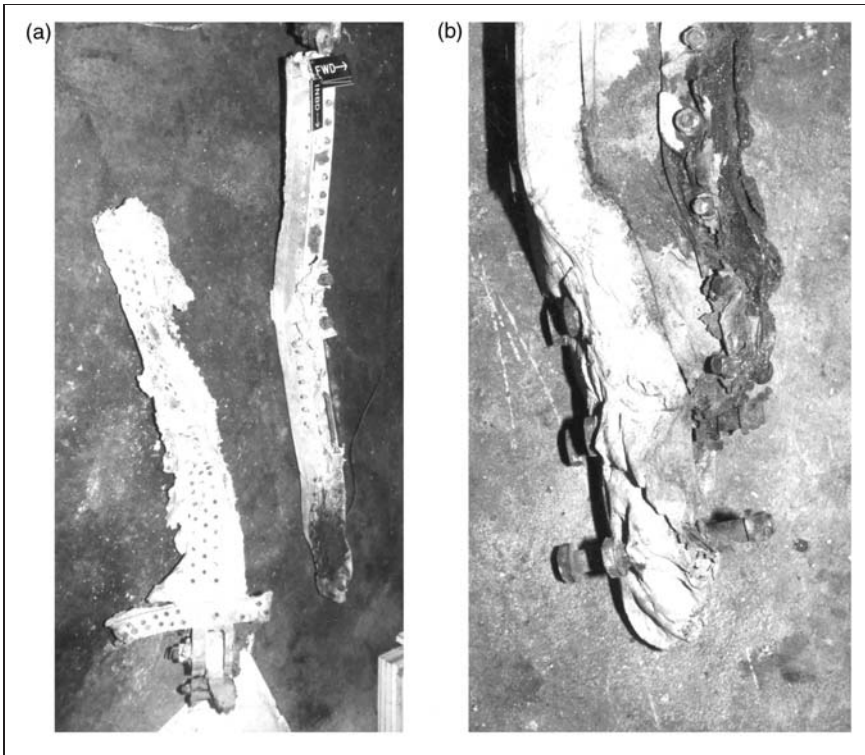
The only recognizable components from the inboard wing and fuselage region of the aircraft that was recovered and preserved at the wreckage storage site were portions of the main spar carry through beams that were part of the fuselage structure of the aircraft. Figure 6(a) shows a portion of the spar caps for these beams. Figure 6(b) is the melted element of one of the beams where the un-melted dimensions are approximately 72 mm (3 in.) per side. The temperature response of these Aluminum beams exposed to a fire of the size consistent with the destroyed area in the center of the aircraft can be calculated using a standard lumped capacitance heat transfer equation and the thermal properties of 2024 Aluminum. This relationship is shown in Equation (1):

Figure 6. (a) Wing spar carry through segments; portions of the spar caps. (b) Melted end of one of the spar cap segments shown in Figure 6(a).

Using Equation (3), the time required for an element that is the thickness of the spar cap (76 mm) of the spar carry through beam to reach melting temperature can be calculated to be 874 s (14.5 min).

The melted end of this beam was located near the center of the most heavily burned-out (10 m²) area of the aircraft. The average fuel-burning rate for large fuel pool fires is 0.06 kg/m²s. With these data, the amount of fuel required to cause this

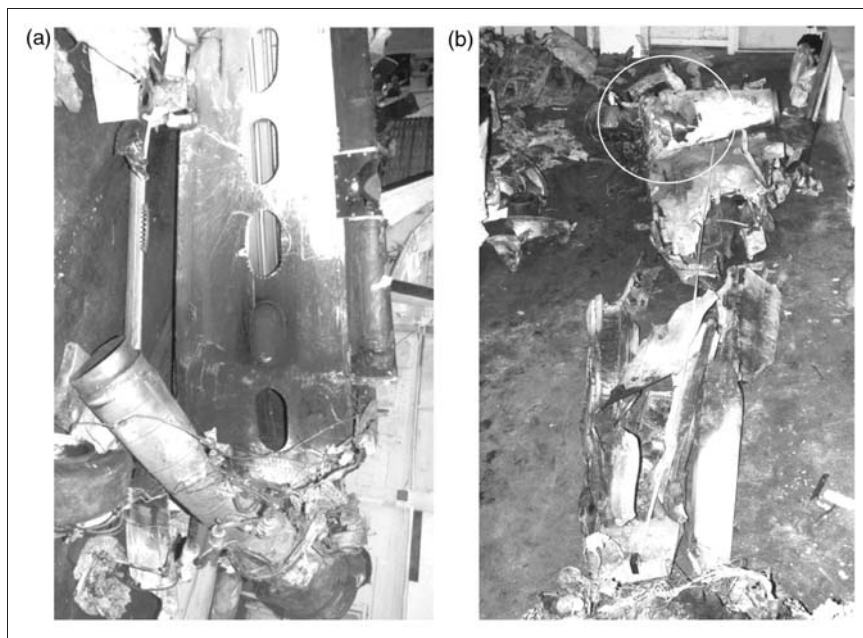
Fire damage to the outboard left wing, shown in Figure 8 appears to have been caused from fuel that spilled independently from outboard left wing fuel cells.

Figure 8. (a) Section of bottom right wing from engine station to outboard. Leading edge to right side of photograph. (b) Photograph of top left wing from tip to engine nacelle. Leading edge to left side of photograph.

An interesting area of thermal damage was sustained on the outboard vertical surface of the aft engine nacelle. This area (circled in Figure 8(b)) was degraded by thermal radiation since spared surfaces and structures around the degraded area show no evidence of flame exposure. To estimate the quantity of fuel that caused this damage to the outboard surface of nacelle, experimentally derived equations from reference [7] were used to estimate the radiant heat flux from a range of potentially possible fire plumes to the surface of the nacelle. The time required for radiant flux to raise the temperature of the nacelle to melting temperature was then determined, using Equation (2). The fire plume size was estimated by assuming a base diameter of 1.5 m, which is consistent with the most thermally eroded area of the outboard wing, defined during the wreckage inspection. Finally, the quantity of fuel consumed was calculated.
