## Perforación en aguas profundas

# Deep Water Horizon Accident Timeline

# Eight Barriers Were Breached

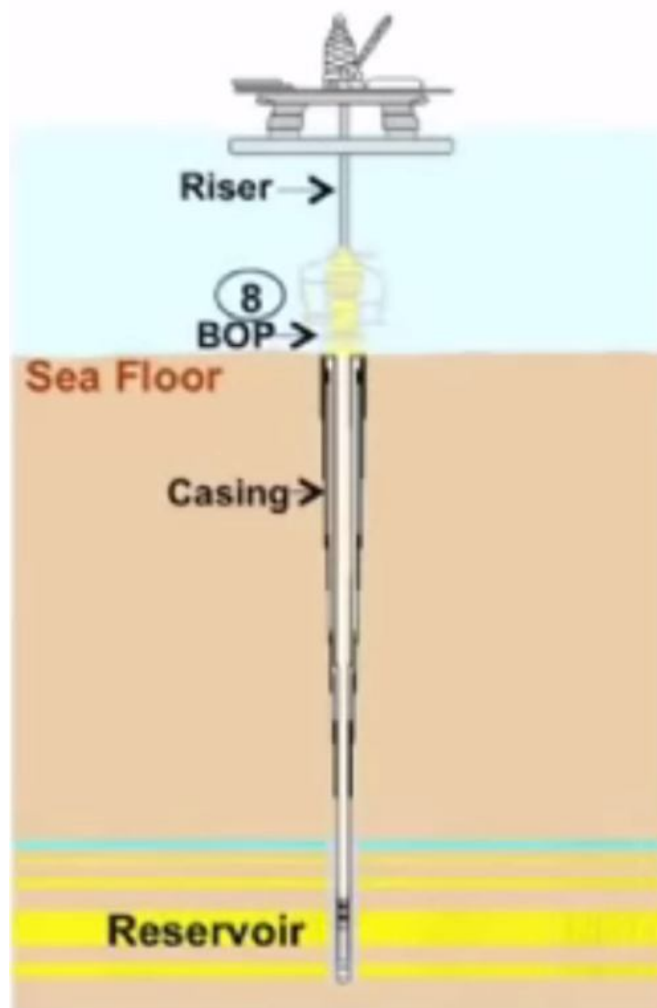
- ① Annulus cement barrier did not isolate hydrocarbons
- ② Shoe track barriers did not isolate hydrocarbons

- ③ Negative pressure test was accepted although well integrity had not been established
- ④ Influx was not recognized until hydrocarbons were in riser
- ⑤ Well control response actions failed to regain control of well

- ⑥ Diversion to mud gas separator resulted in gas venting onto rig
- ⑦ Fire and gas system did not prevent hydrocarbon ignition

- ⑧ Blowout preventer (BOP) emergency modes did not seal well

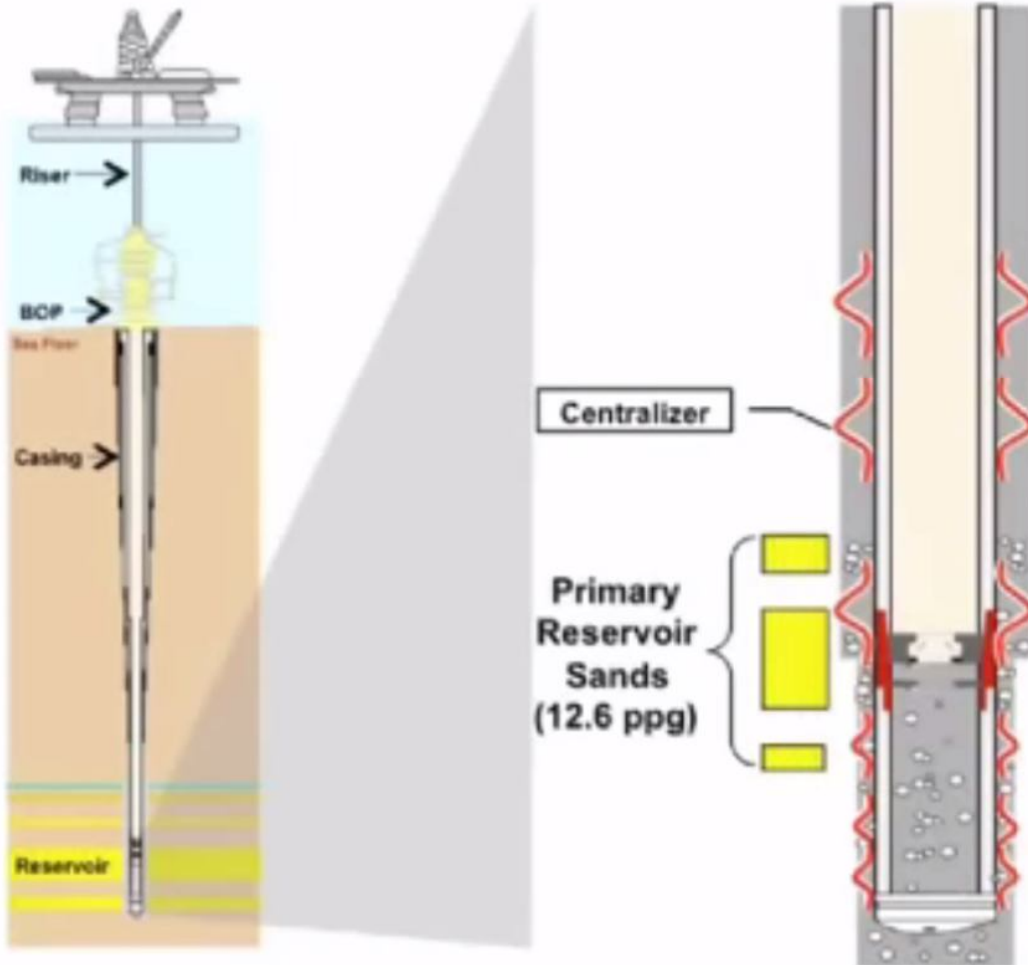
## Key Finding #1

### Annulus cement barrier did not isolate reservoir hydrocarbons

- High percentage of nitrogen made it difficult to create a stable foam
- No fluid loss additives in cement
- Small volume of cement in relation to displacement volume
- Cement lab tests were not comprehensive

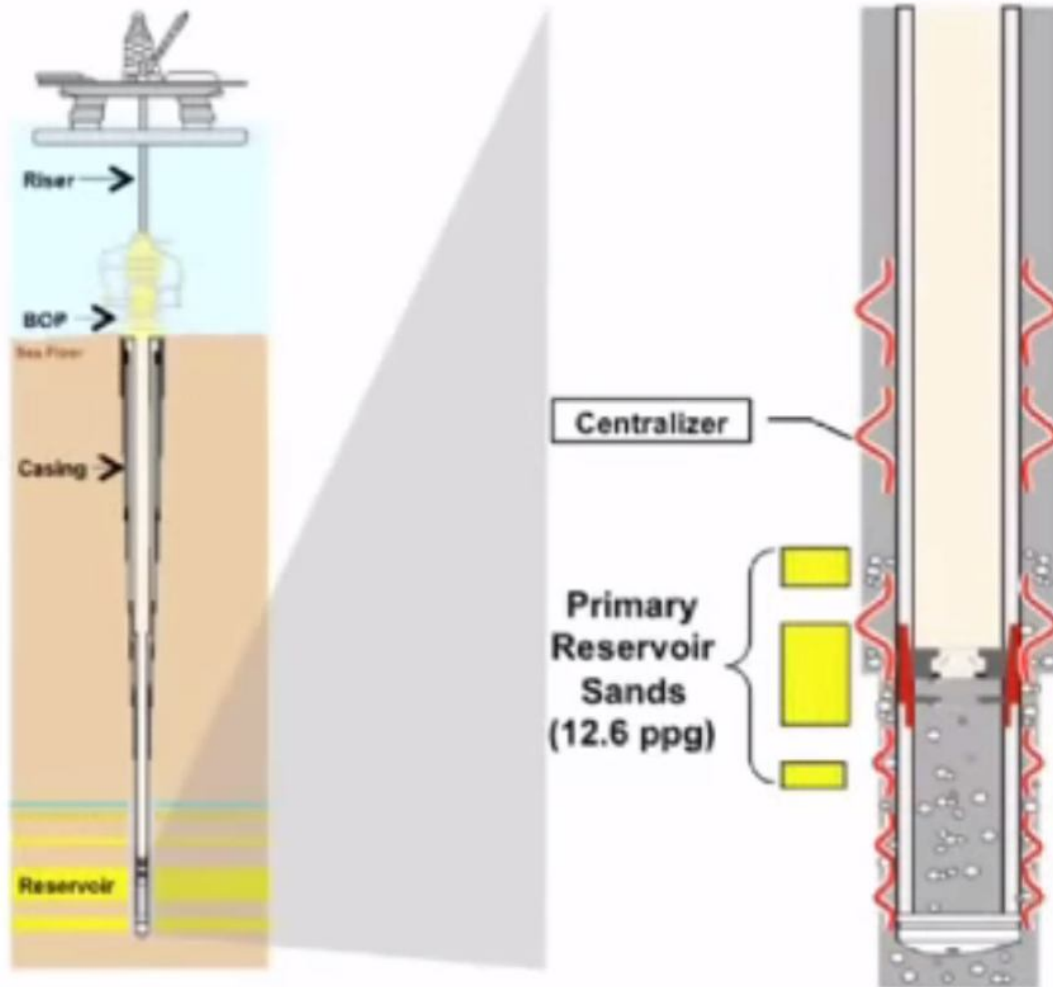
## Key Finding #1

### Annulus cement barrier did not isolate reservoir hydrocarbons

- Foam slurry was likely unstable and resulted in nitrogen breakout
- Casing was well-centralized across the primary hydrocarbon zones

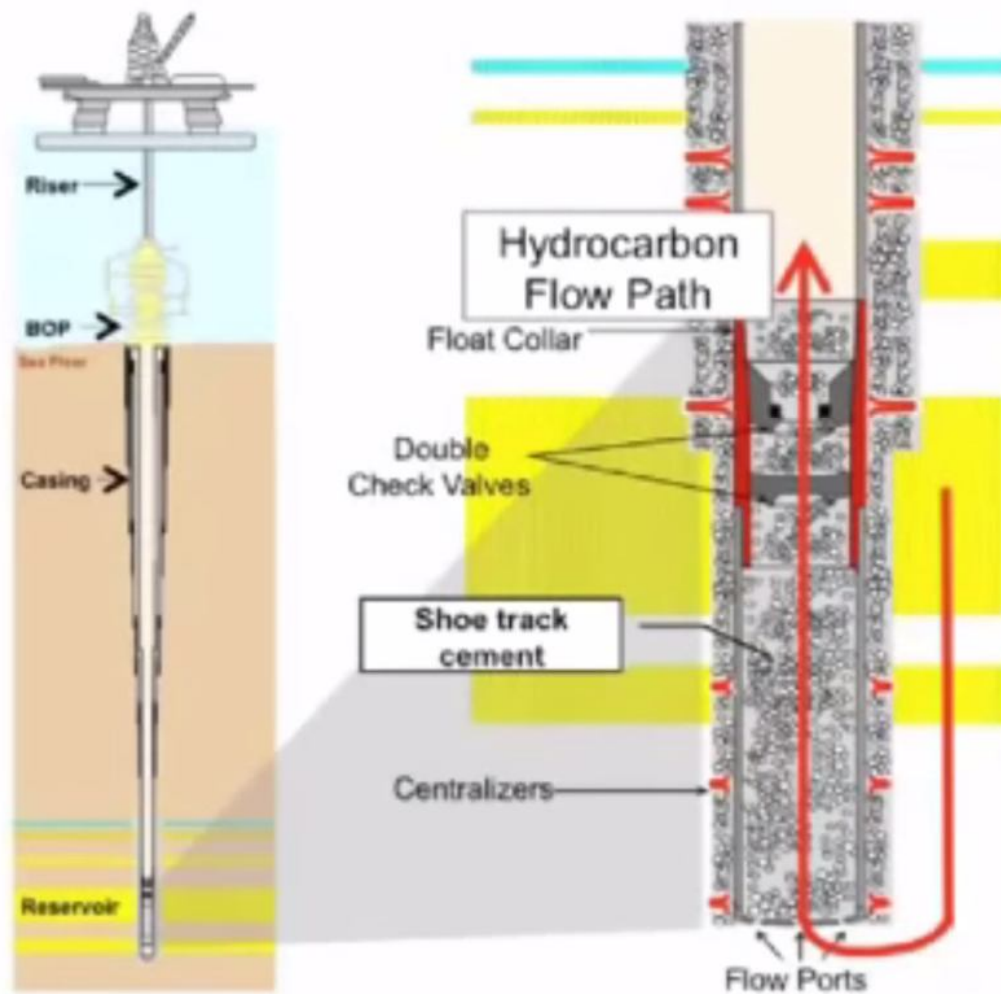
## Key Finding #2

### Shoe track mechanical barriers did not isolate hydrocarbons

- Shoe track cement failed to prevent influx
- Float collar valves failed to seal
- Flow came through the shoe track at the bottom of the casing

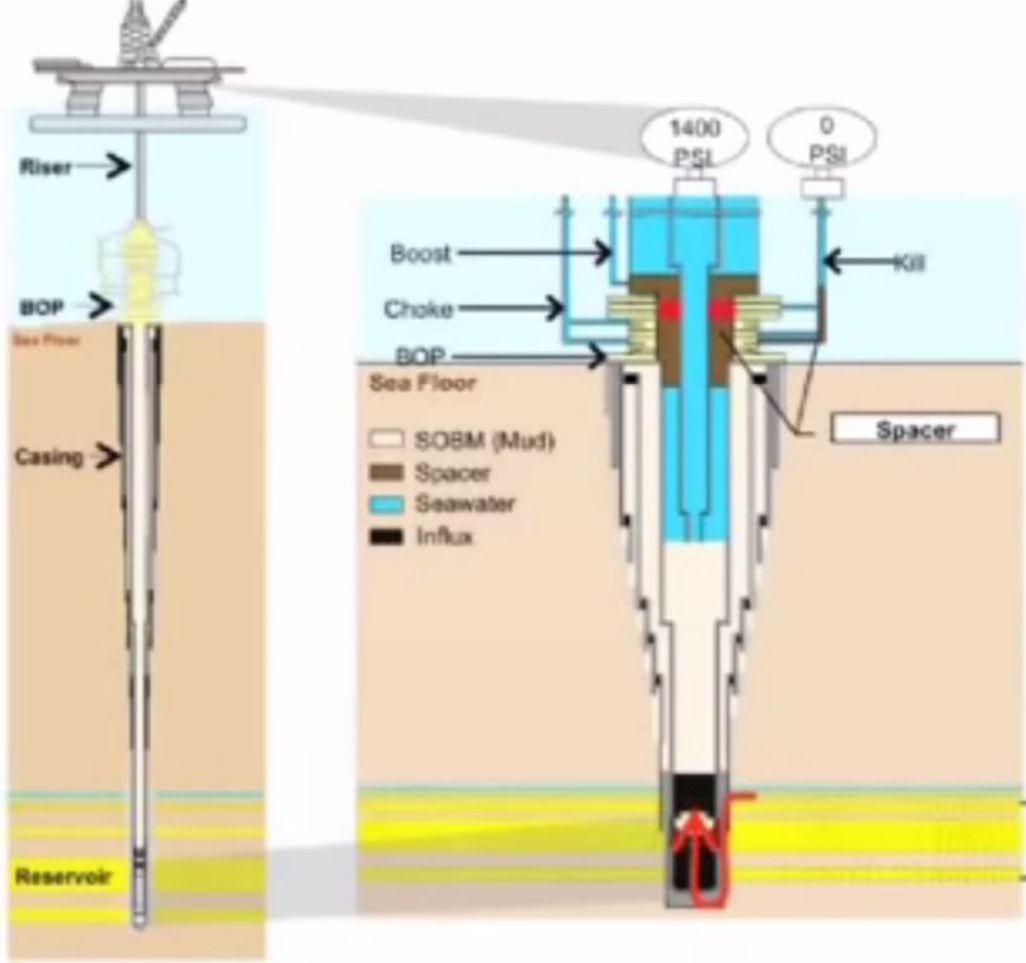
# Key Finding #3

Negative pressure test was accepted, although well integrity had not been established

- Viscous spacer flowed across BOP, possibly inhibiting kill line pressure readings

- Bleed-off volumes indicated communication with reservoir

- Abnormal pressure attributed to "bladder effect"

- Test incorrectly deemed successful

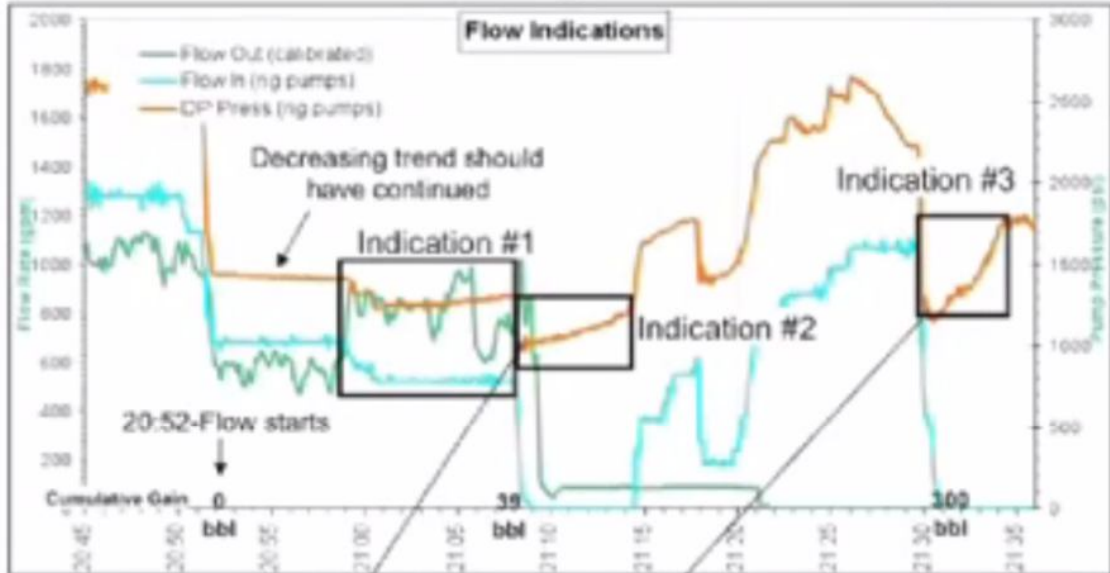
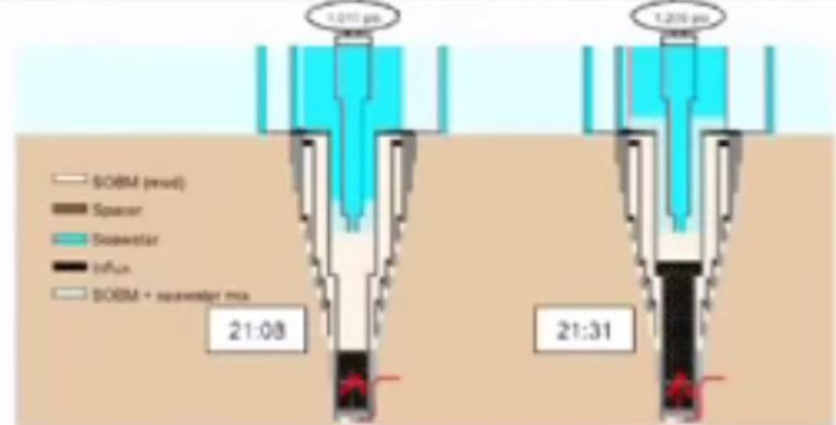
# Key Finding #4

The influx was not recognized until hydrocarbons were in the riser

• Flow indications

- #1: Drill pipe pressure increased by 100 psi, expected decreased – ~39 bbl gain from 20:58 to 21:08
- #2: Drill pipe pressure increased by 246 psi with pumps off
- #3: Drill pipe pressure increased by 556 psi with pumps off - ~300 bbl gain

• No well control actions taken

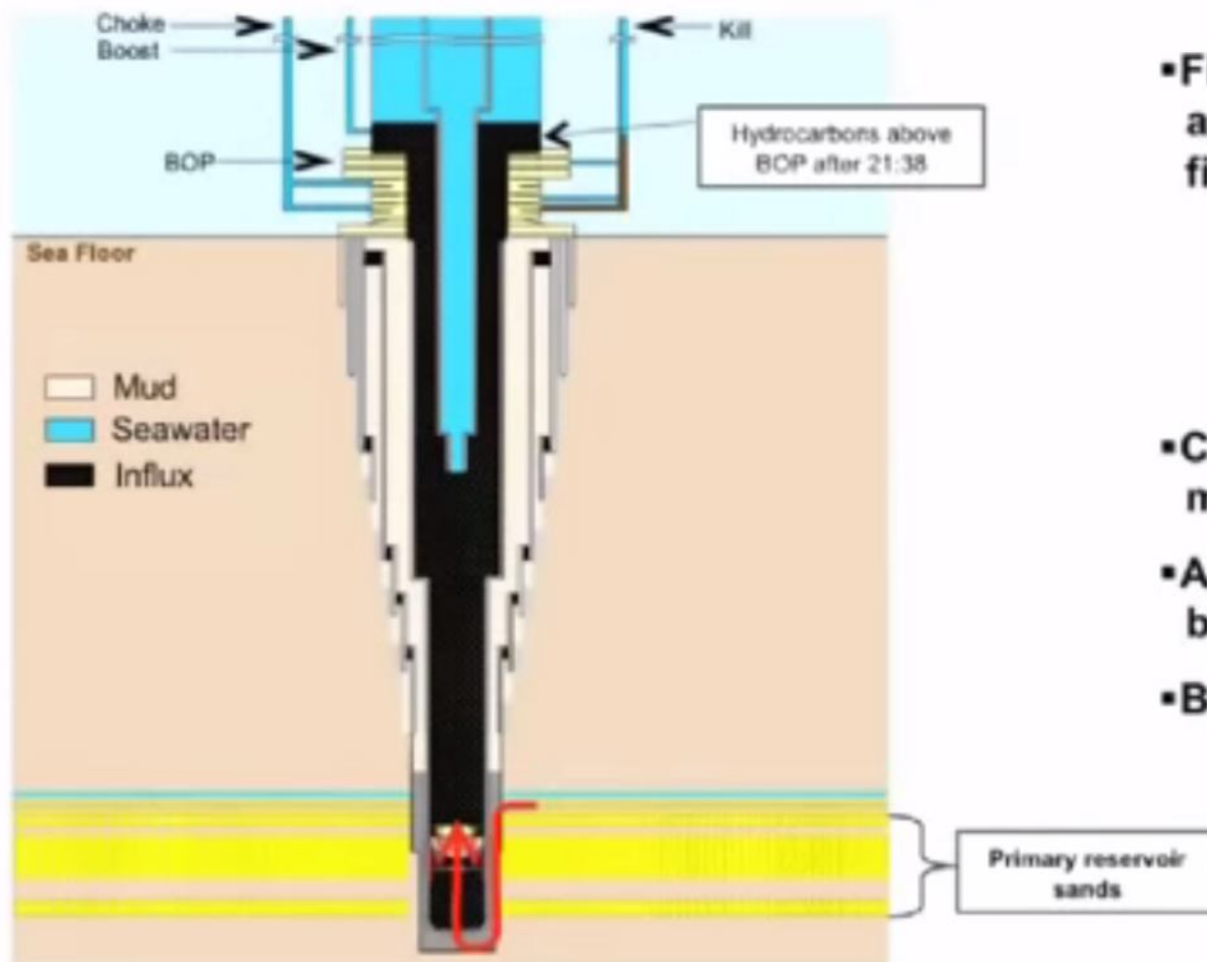
## Key Finding #5

### Well control response actions failed to regain control of well

- First well control response approximately 40 minutes after first indication
  - Hydrocarbons above BOP after 21:38
- Closed diverter and routed flow to mud gas separator
- Annular preventer was activated, but did not seal
- BOP sealed six minutes later

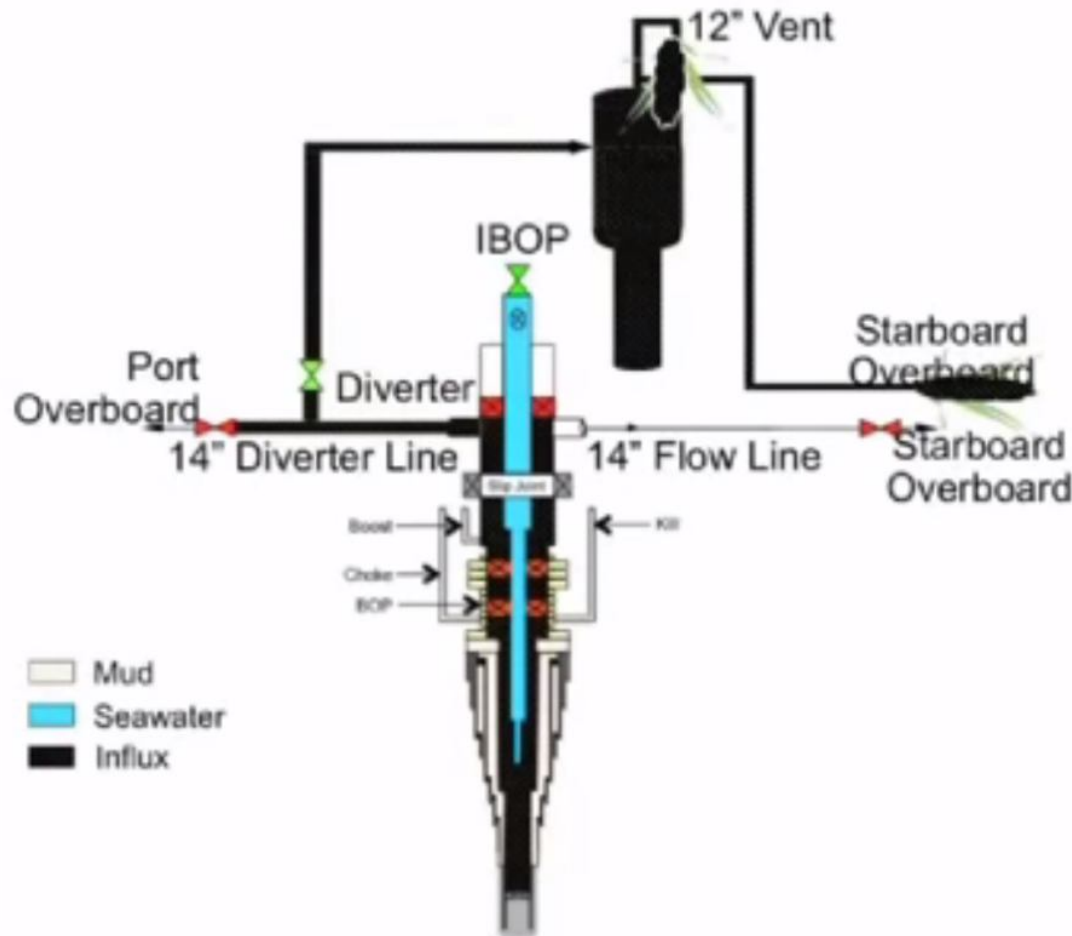
## Key Finding #6

### **Diversion to mud gas separator resulted in gas venting onto rig**

- Hydrocarbons diverted to mud gas separator versus routing overboard

- Surface gas handling system overwhelmed

- Combustible gas vented onto rig, enveloping possible ignition sources

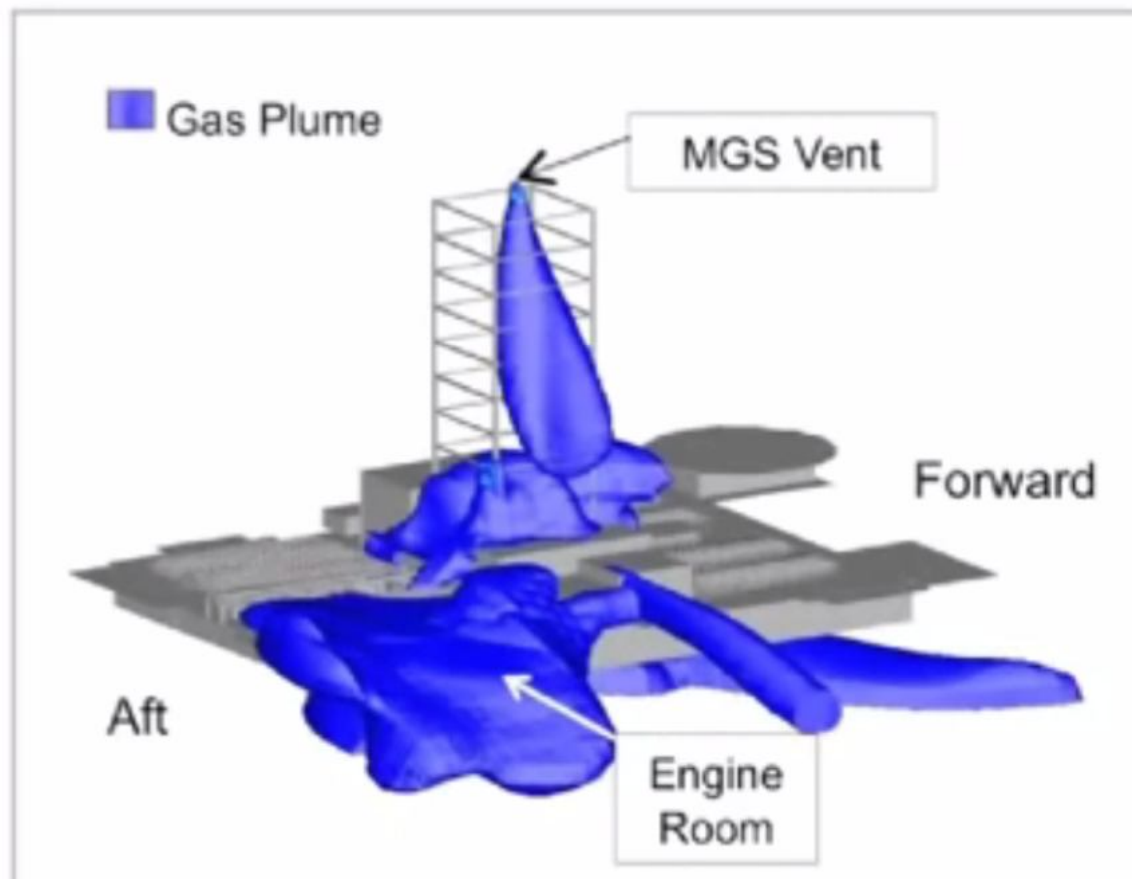
## Key Finding #7

### Fire and gas system did not prevent hydrocarbon ignition

- **Gas dispersed rapidly across rig**
  - Gas entered engine room through air intakes
  - Engines went into over-speed
  - Engines were one potential source of ignition

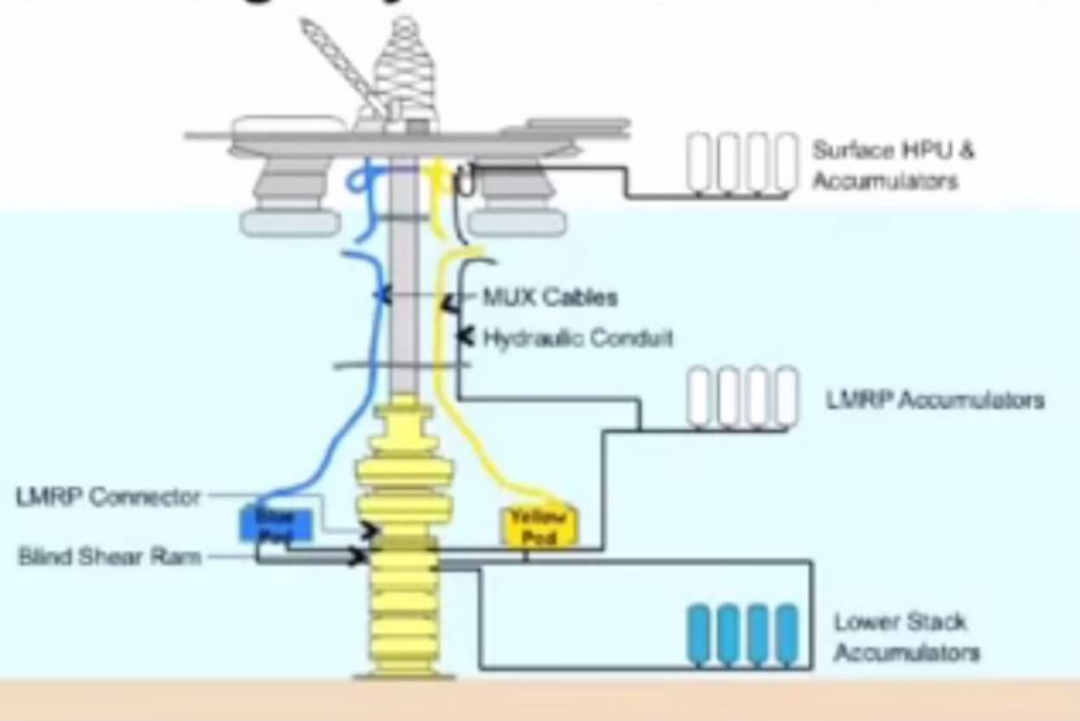
## Key Finding #8

### BOP emergency mode did not seal well

- **Initial explosions and fire**
  - Damaged MUX cables and hydraulic line
  - Resulted in failure of the emergency disconnect system

- **Automatic Mode Function did not complete due to:**
  - Defective solenoid valve
  - Insufficient charge on batteries

- **Post-accident ROV intervention likely activated blind shear rams**

- **Potential weaknesses in testing and maintenance of BOP**
