A Dramatic Example of the Effects of
Construction Defects

- Shanghai, China on June 27th, 2009
- Lotus Riverside residential complex
- Yes, that is actually a 13 story building lying on its side
- The complex fell due to errors in construction

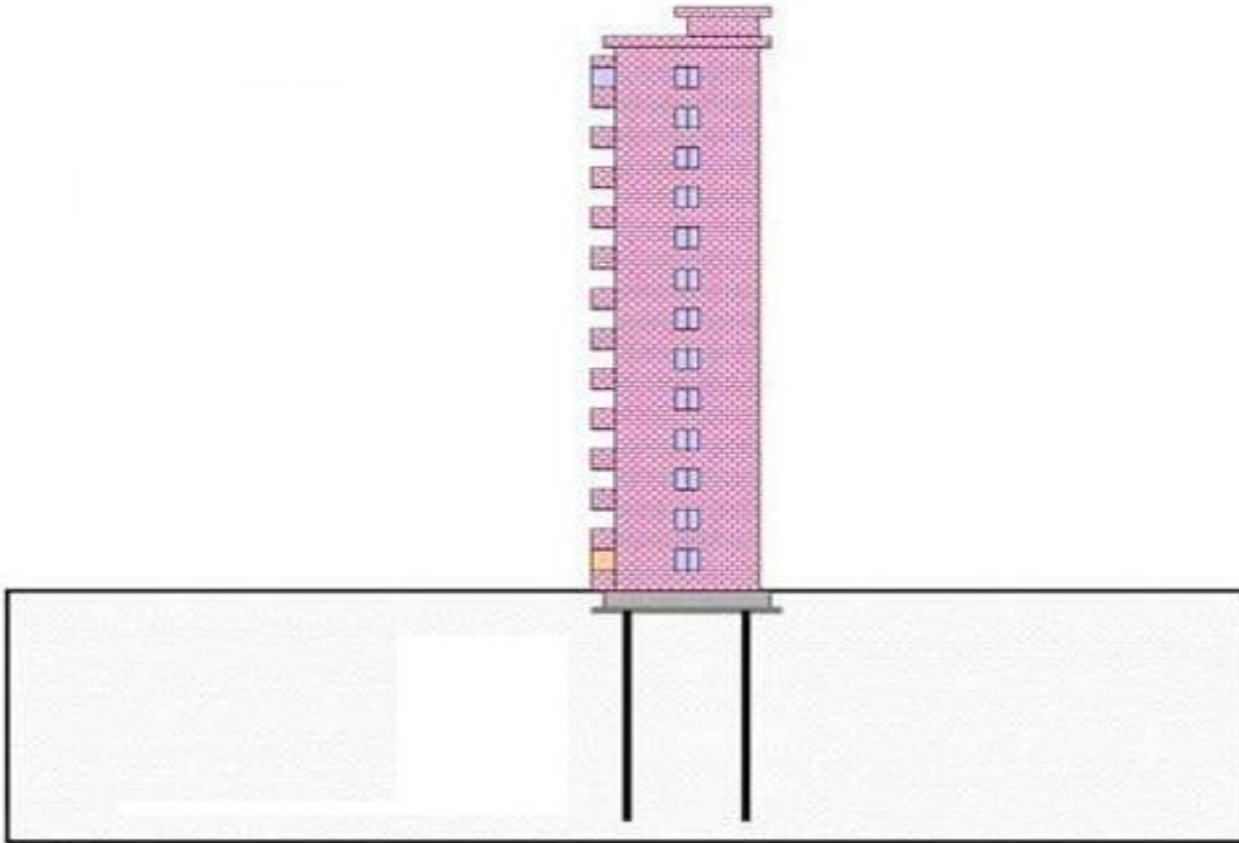
- First, the apartment building was constructed

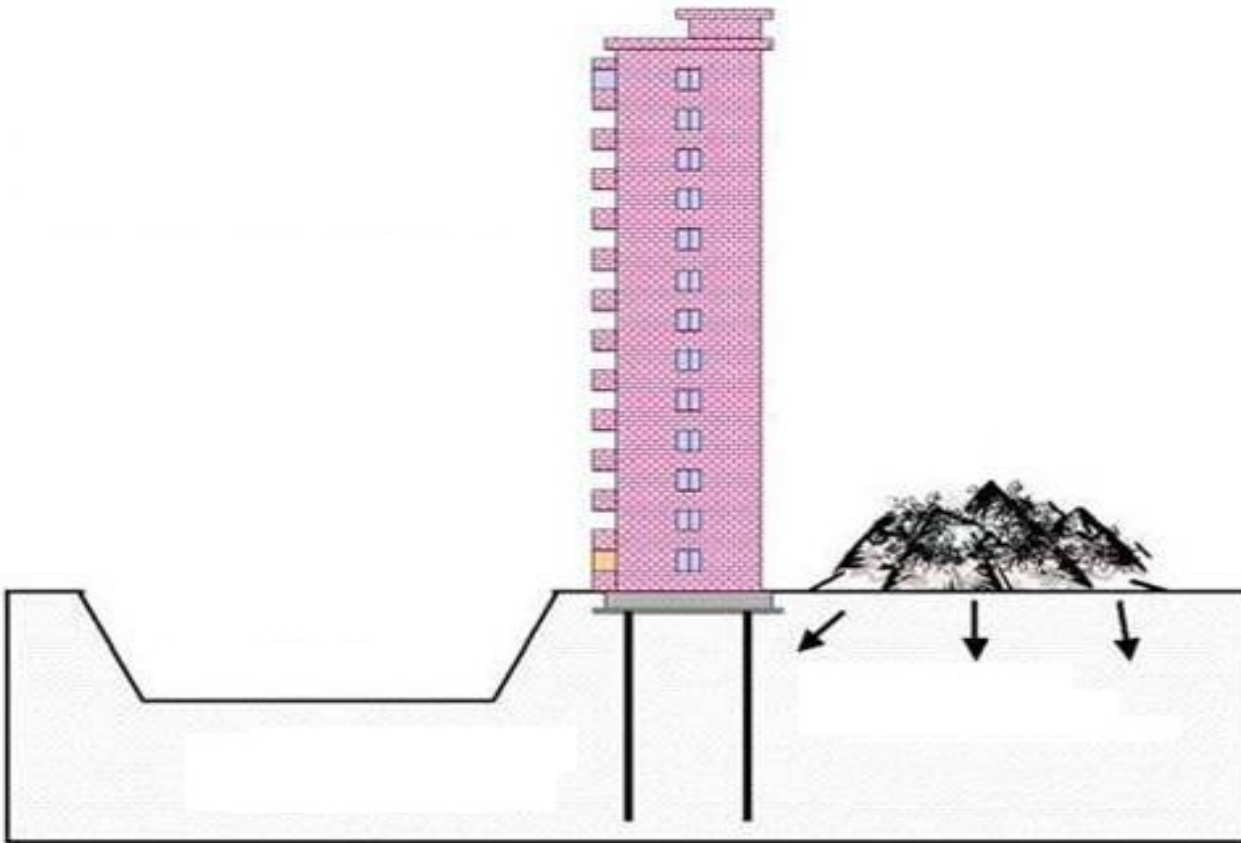
- Then the plan called for an underground garage to be dug out on the south side to a depth of 4.6m
- The excavated soil was piled up to the height of 10m on the north side of the building, putting pressure on the ground below it

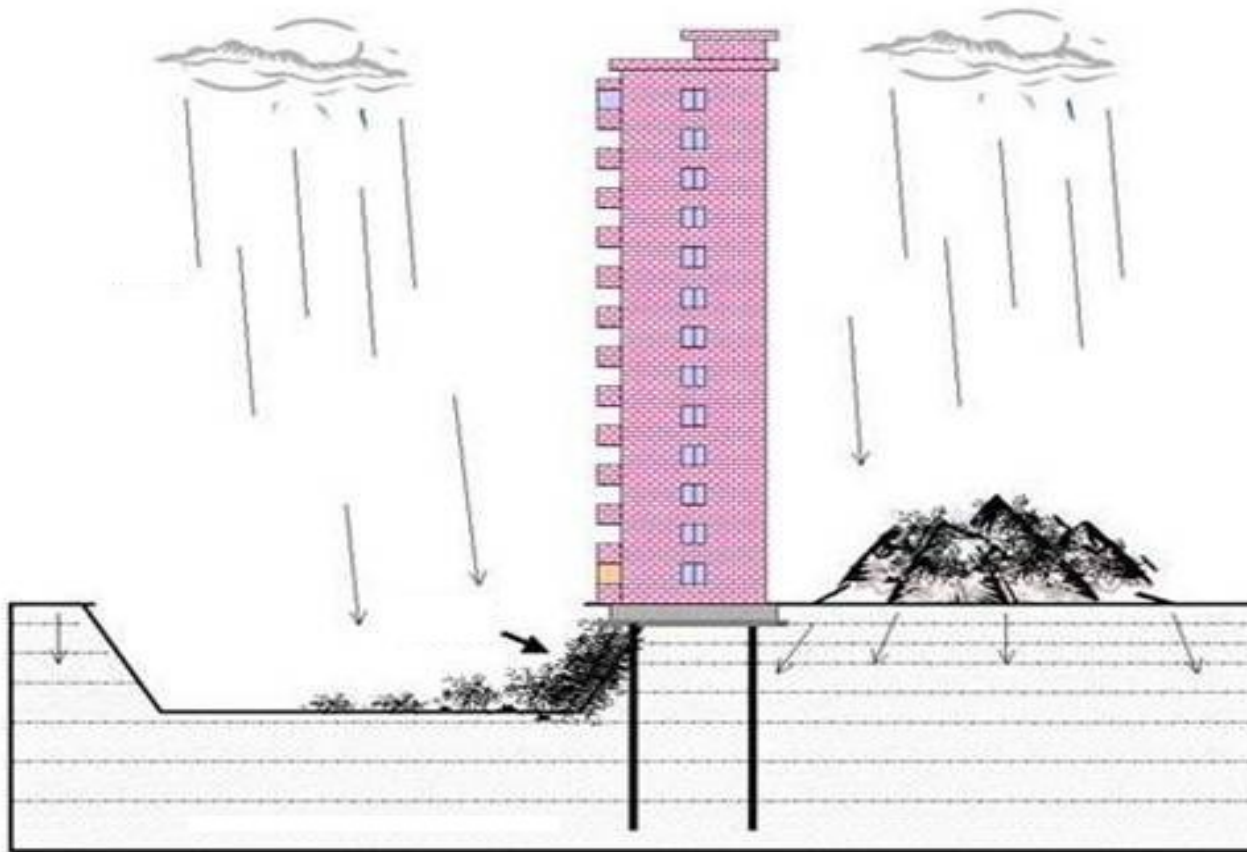
- Heavy rains caused water to seep into the ground
- This weakened and eroded the soil on the sides of the proposed parking garage

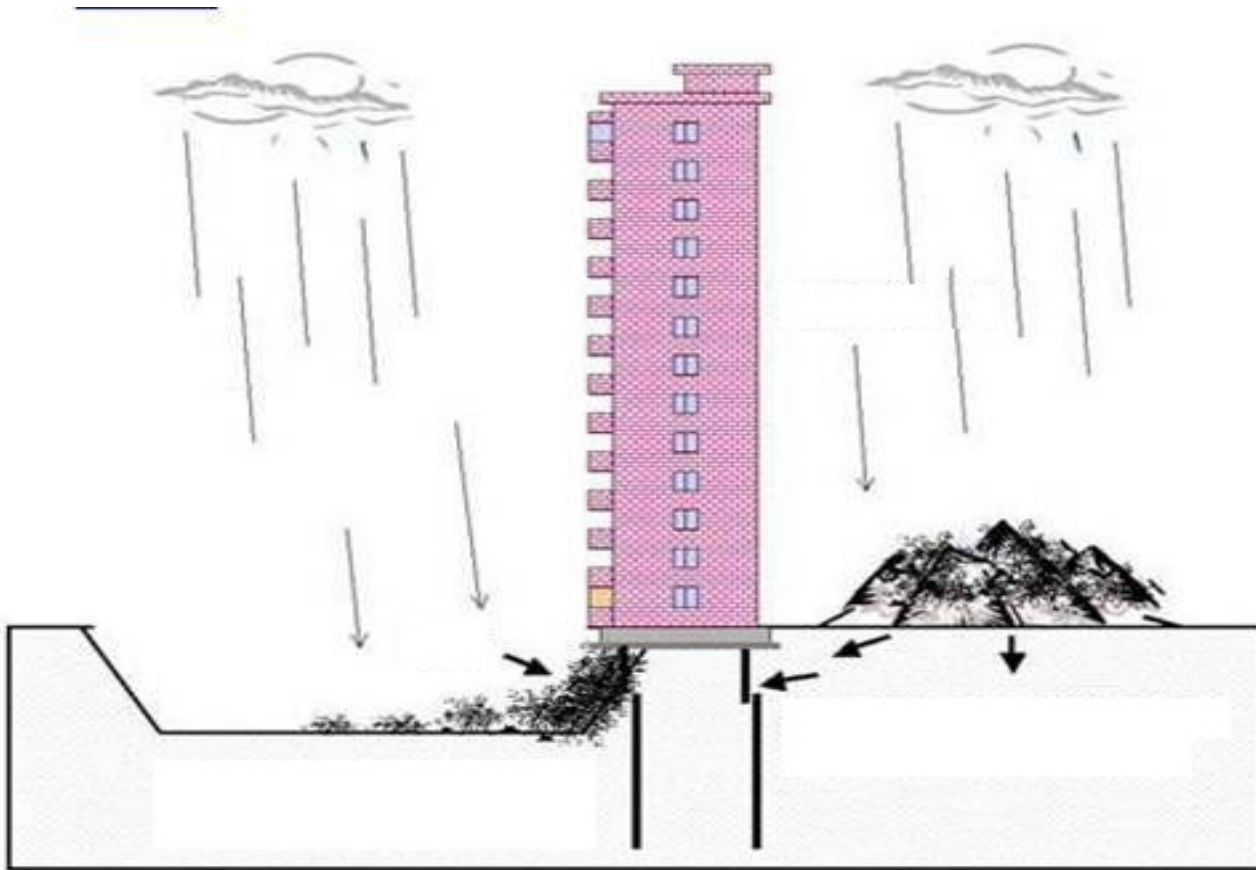
- As a result of the uneven lateral pressure, the building began to shift and tilt.

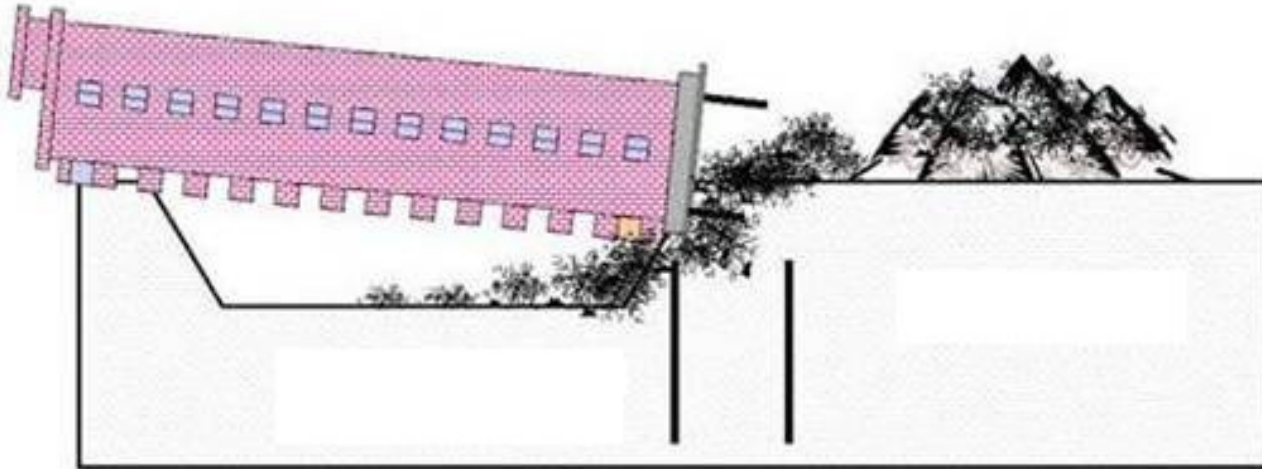
- The result was a net lateral pressure of 3,000 tonnes from north to south
- This pressure was greater than what the pilings could tolerate and they therefore snapped
- Thus was born the eighth wonder of the world

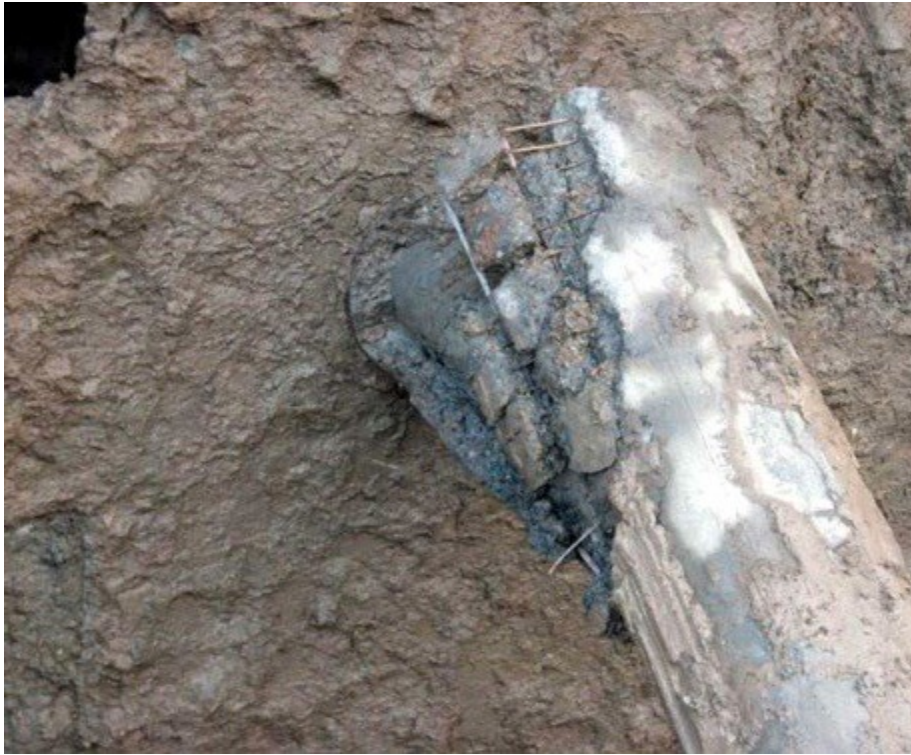
13 Stories, on grade, with no basement, and tied down with hollow pilings with no rebar and significant uneven lateral pressure. The results are no surprise.
