Pelamis - Care of the Marine Environment from concept through to implementation.

Andrew Scott – Business & Project Development Manager

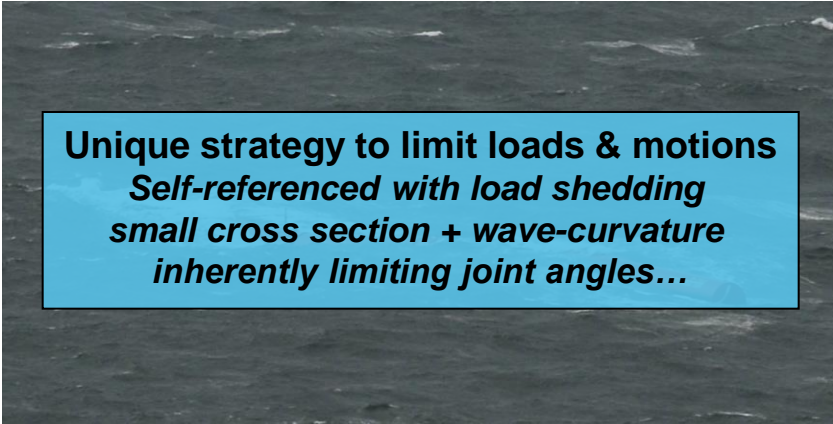
Survivability principles

Unique strategy to limit loads & motions
*Self-referenced with load shedding
small cross section + wave-curvature
inherently limiting joint angles...*

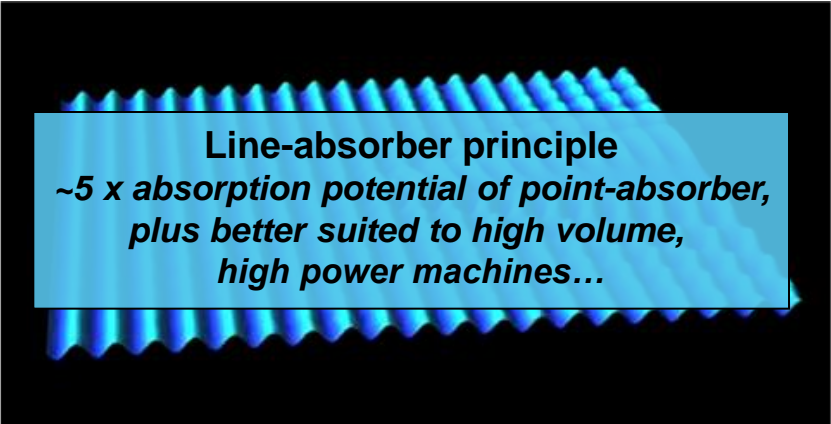
Absorption principles

Line-absorber principle
*~5 x absorption potential of point-absorber,
plus better suited to high volume,
high power machines...*

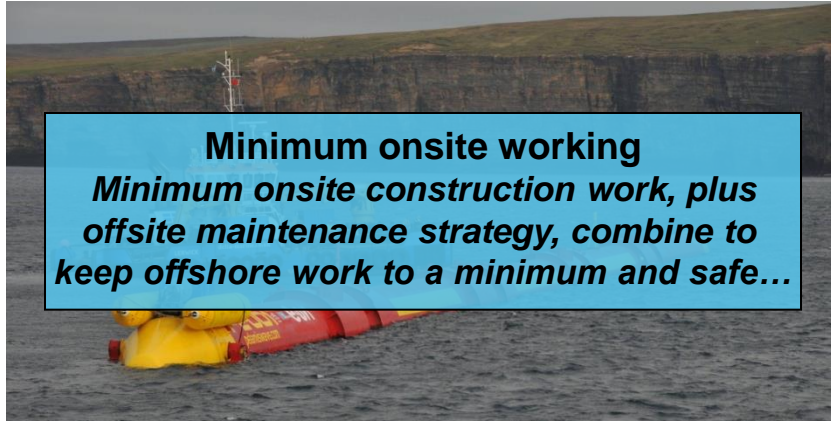
Construction and O&M strategy

Minimum onsite working
*Minimum onsite construction work, plus
offsite maintenance strategy, combine to
keep offshore work to a minimum and safe...*

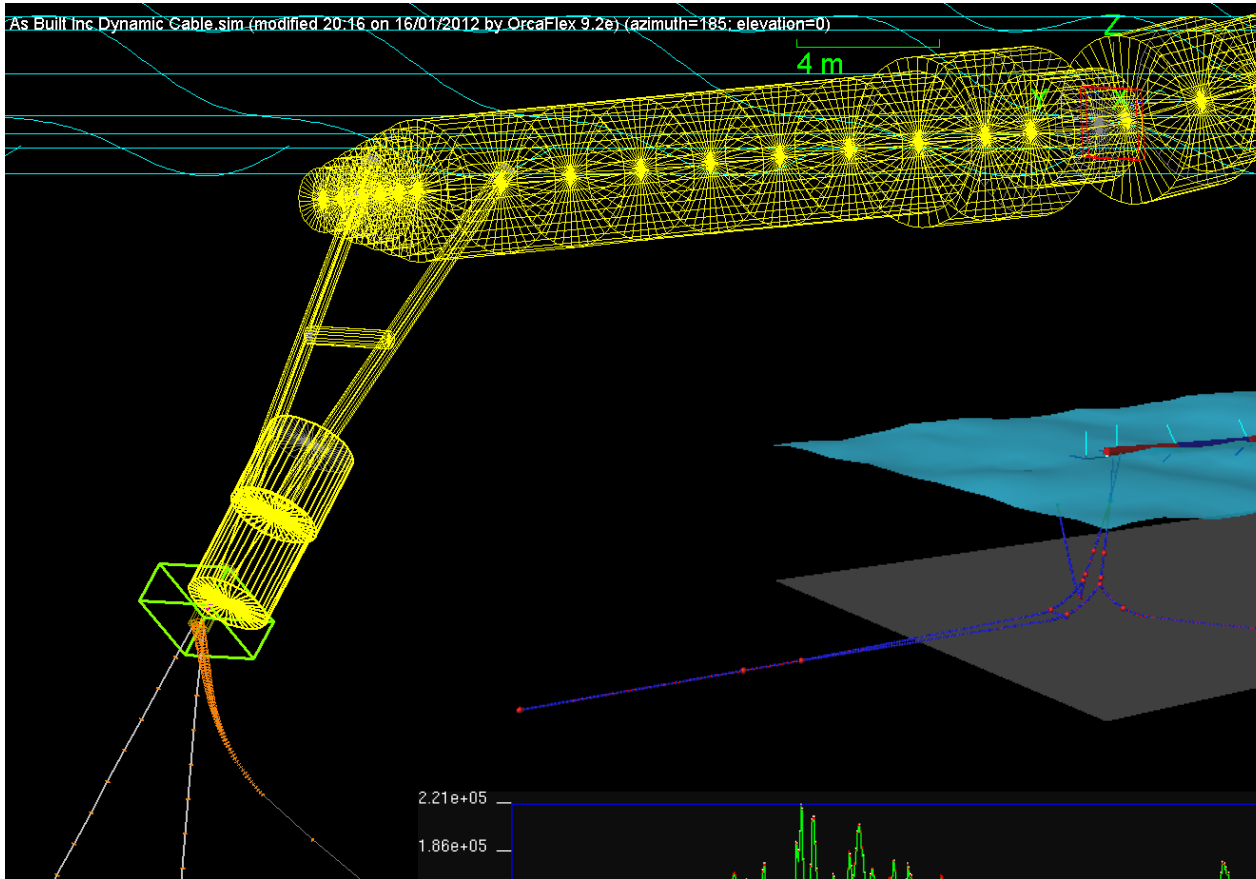
OrcaFlex & PWP-PELs for Numerical Dynamic Analysis

Numerical models are checked against each other and against scale model tank-test results

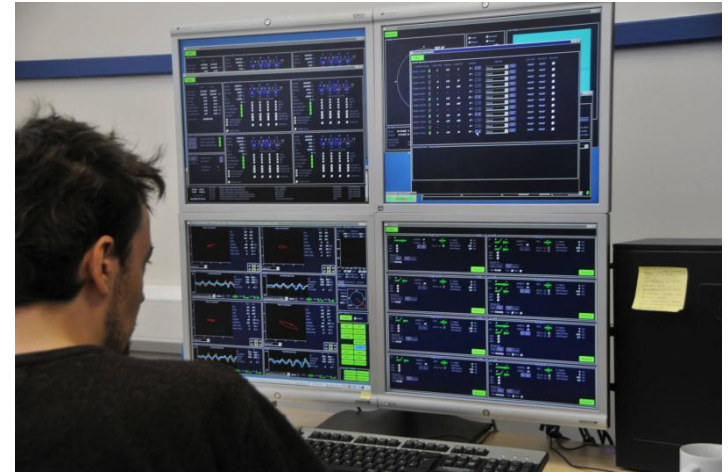
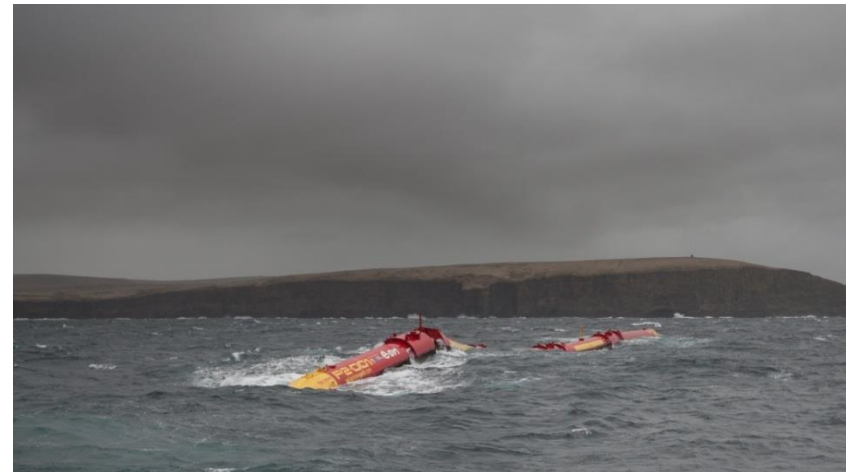
Work-Up Programme

- Risk reflective testing and demonstration philosophy. [Not deploy and hope!]
- Full time engineering monitoring of all machine diagnostic signals to analyse trends, behaviour and identify system and component reliability.
- Machine cleared in step-wise process for gradual increase in operational conditions.
- Paralleled with detailed full system “forensic” style inspection of key components and systems.

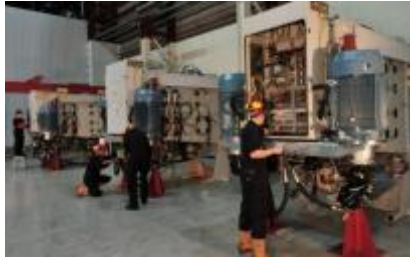
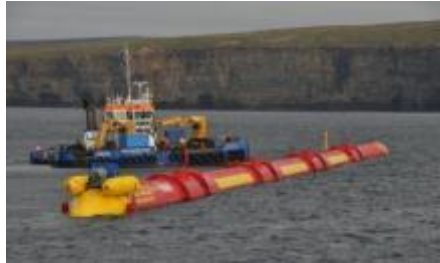
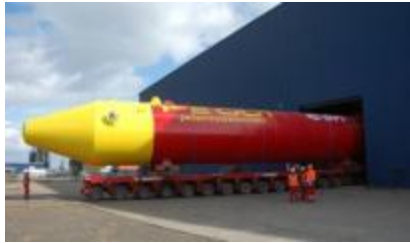
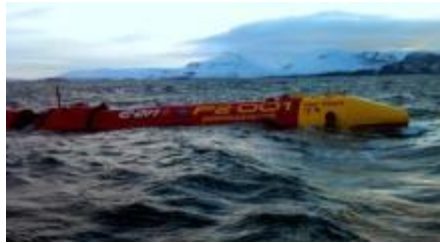
Pelamis – Cost of Energy Drivers

VALIDATED ASSUMPTIONS

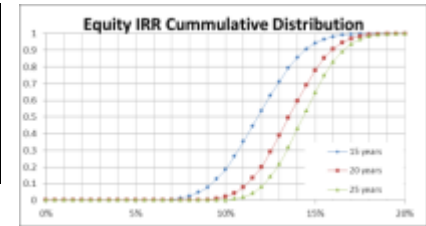
Run iterations		
Progress	Iterations	Update rate
2000	2000	500
Machine option		4

select above option	Perf (kW ann avg)		Machine installed cost (£m)				Rating	CF	notes
	mean	stdev	lower	mode	upper				
1	162	0.082	3.02	3.20	3.42		0.5	32.4%	
2	273	0.082	3.39	3.62	3.89		0.8	34.1%	Concrete
3	202	0.082	3.59	3.82	4.07		0.6	33.7%	
4	345	0.082	4.06	4.32	4.61		1.0	34.5%	Concrete

MONTE CARLO INPUTS							
PARAMETER	Generated	Expected	LOWER	MODE	UPPER	MEAN	STDEV
Annual average Shetland (kW)	359	345					
Machine installed cost (£m)	4.323	4.330	4.058	4.322	4.611	345	0.082
Spare (£m)	0.87	0.83					
Project development (£m)	1.05	1.00					
Availability	92.9%	93.0%	0.91	0.93	0.95		
Transmission efficiency	97.5%	98.0%	0.97	0.98	0.99		
£m/MW Balance of plant	0.30	0.30	0.25	0.30	0.35		
£/MWh (equivalent 5 x ROCs)	320.4	320.0	300	320	340		
O&M (£/machine/yr)	50	50	45	50	55		
Grid charges, TNuS etc £/MWh/yr	131	125	80	100	195		
Other operating costs £/MWh	150	200				200	20
Annual insurance (% capex)	1.3%	1.2%	0.01	0.012	0.014		
Annual lease costs (% sales)	0.33%	0.34%	0.0033	0.0034	0.0035		
Decommissioning (£/machine)	0.11	0.10	0.05	0.1	0.15
