## **Extending the Life of Hardwood Timber Bridges in Australia**

**IPWEAQ Conference FNQ Mission Beach, QLD**

**Dan Tingley Ph.D., RPEQ**

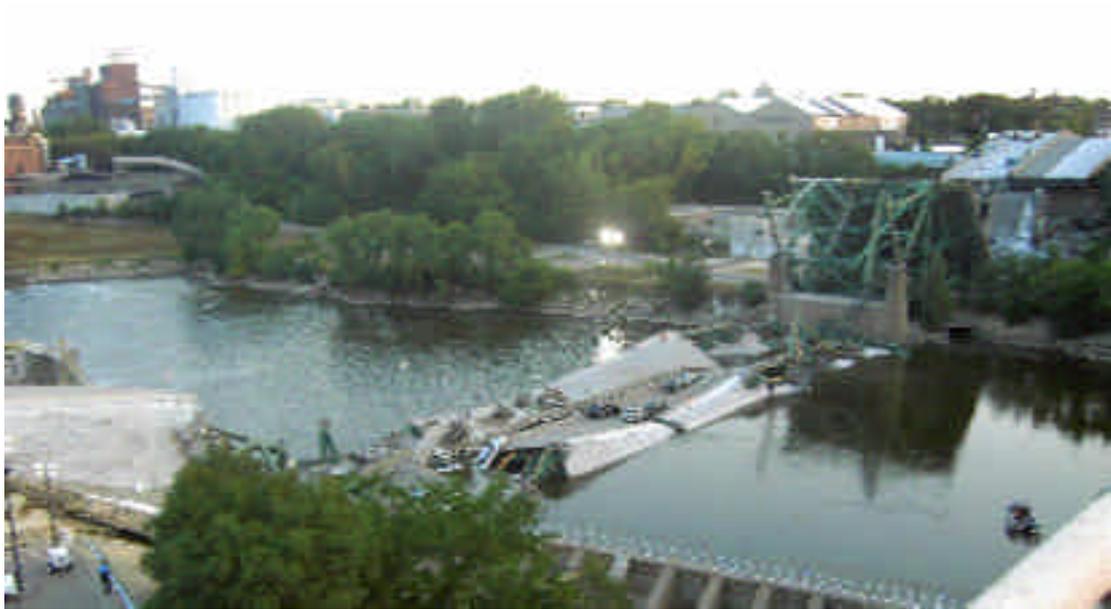
**Figure 1: I35 Steel Truss Bridge over Mississippi failure Minnesota August 2, 2007. Bridge constructed 1963 to 1967. Thirteen people died, 98 injured, 38 million dollars in compensation paid.**

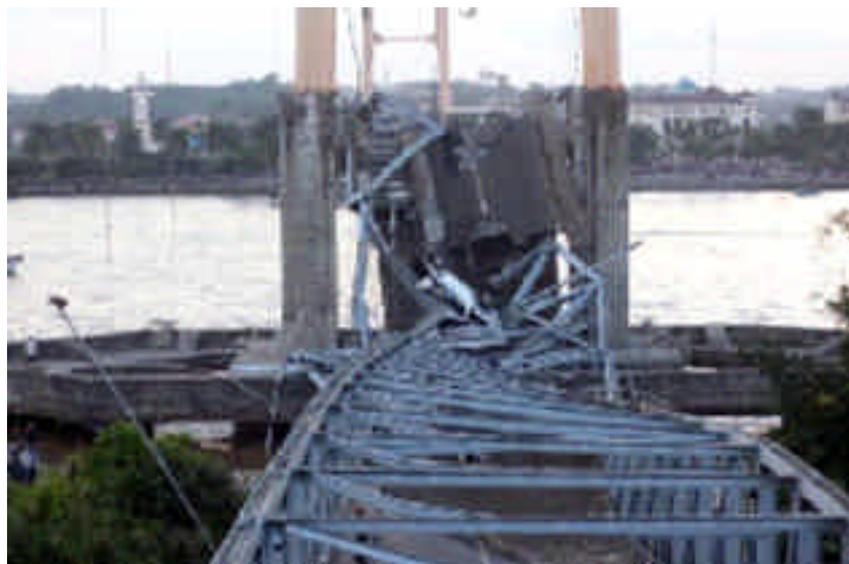
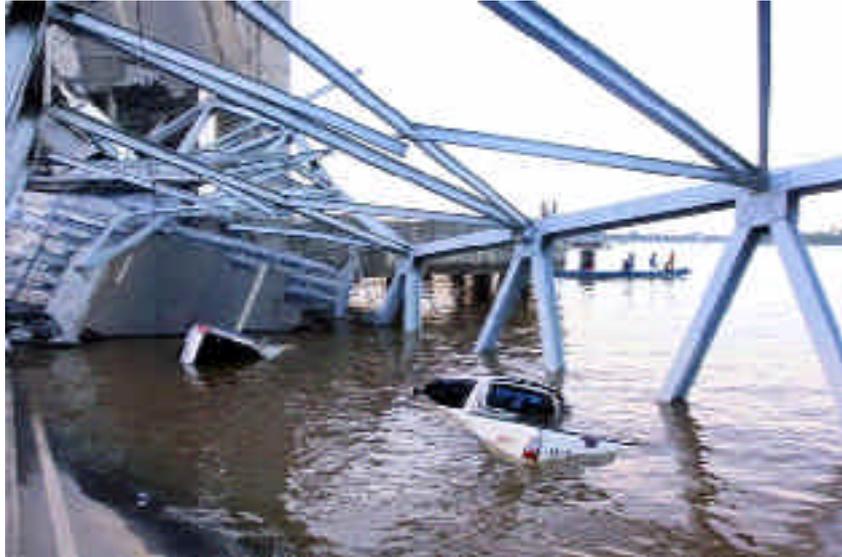
**Figure 2: Photographs of the steel truss Mahakam II Bridge built in 1996 in Kutai Kartanegara, East Kalimantan which failed in November 2011. Four people died and 40 missing.**

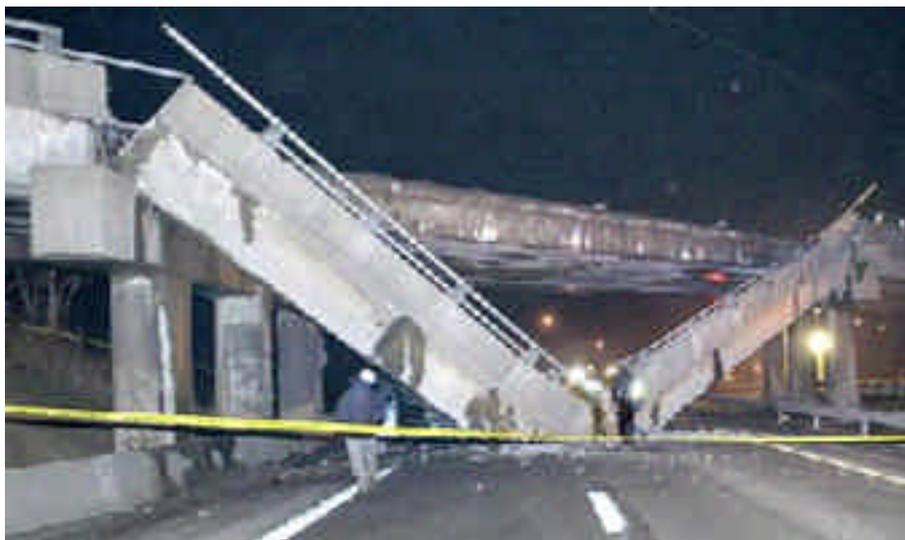
**Figure 3: Concrete Overpass Bridge I70, PA, USA.**

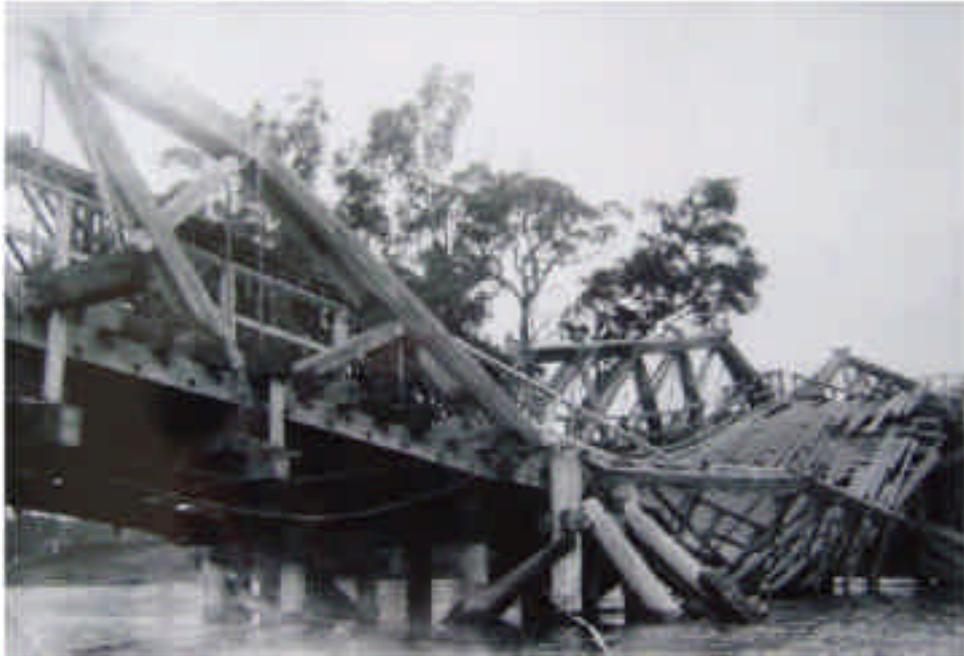
**Figure 4: Timber truss Tuross River Bridge built in 1896 in near Bodalla, NSW failed in 1954. Stranded 200 people.**

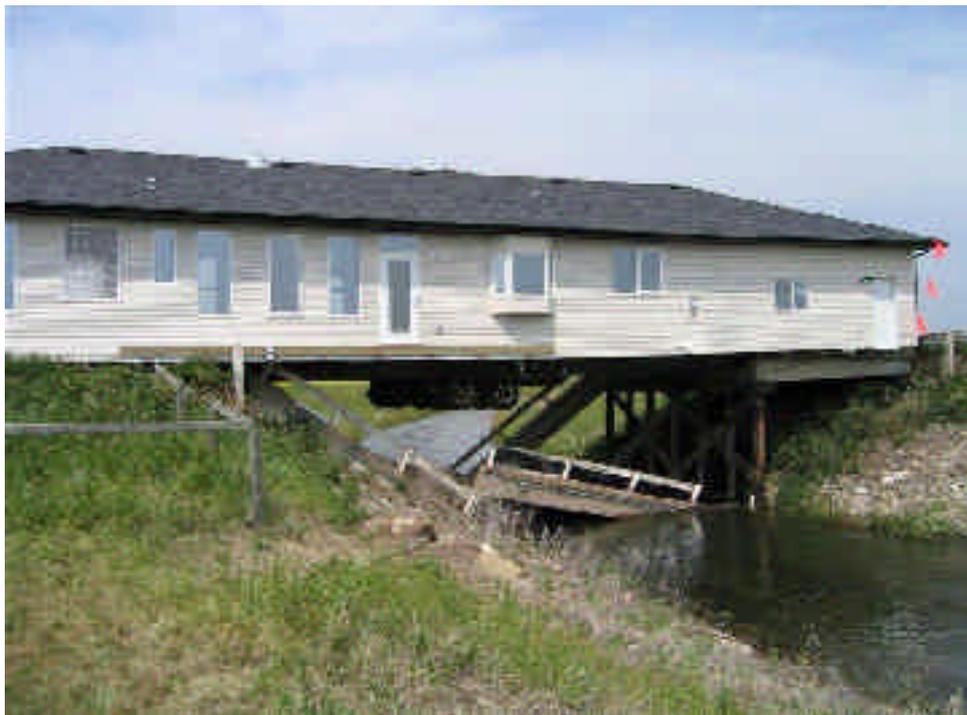
**Figure 5: Timber pile bent/cross head concrete T section deck failure due to collapse of a timber pile bent near Brisbane Australia.**

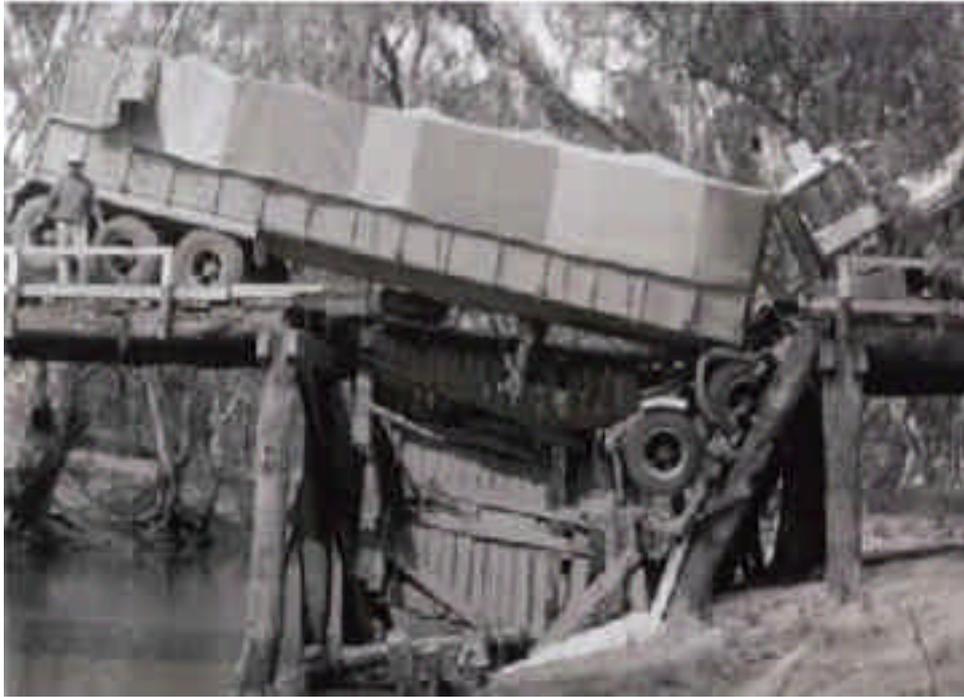
**Figure 6: Douglas Shire (Northern Queensland, Australia) log girder timber bridge failure**

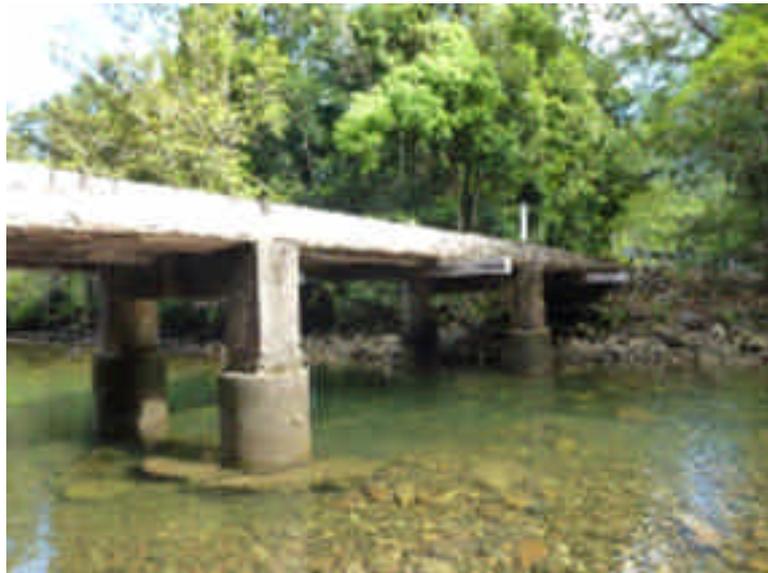
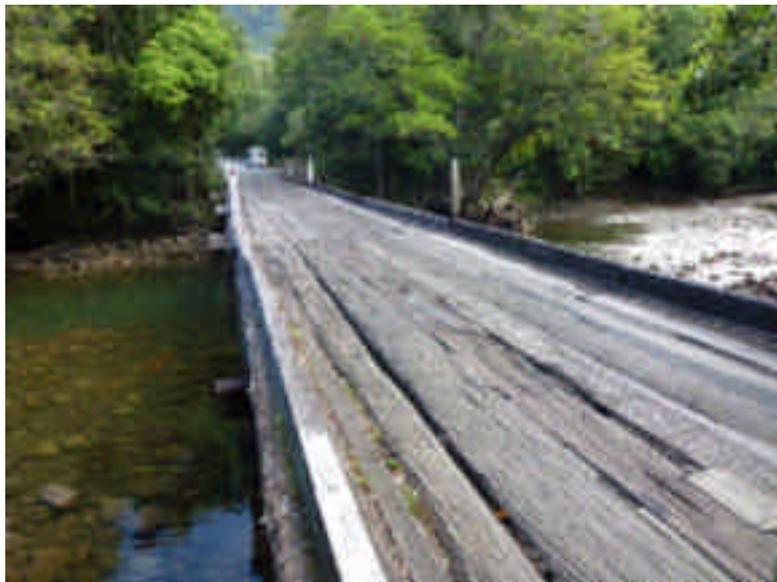
Figure 7 are still in service and have not decayed. They were exposed and able to breathe since a concrete or timber deck had not been spiked to the girders. The bridges shown in Figure 8 are no longer in service and they are 1/3 the age. The same log girder curtain construction was utilized in the bridges in Figure 8 built in 1987. However, a concrete deck was placed on top of the curtain and the attachment method led to accelerated decay and the bridges had to be removed from service.

**Figure 7: Noah River Bridge on the road to Cape Tribulation (Northern Queensland), log girder curtain bridge built by the US Army Core of Engineers during the second world war with improperly installed transverse diaphragm beams. Lower photograph shows the logs serving as a wearing surface. They have been allowed to breathe and are still in good condition.**

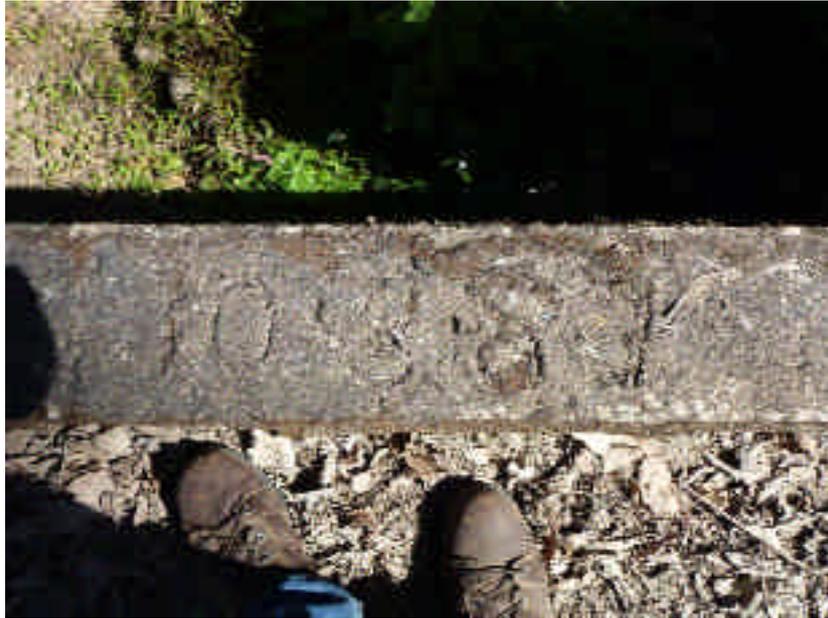
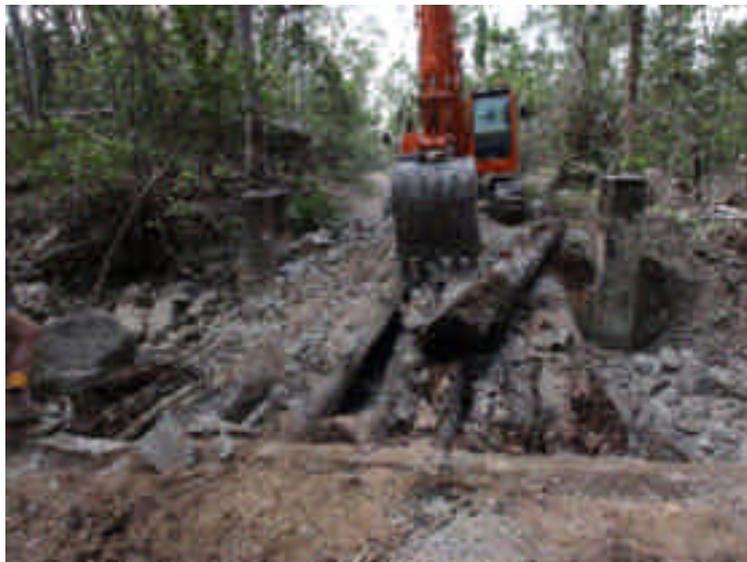
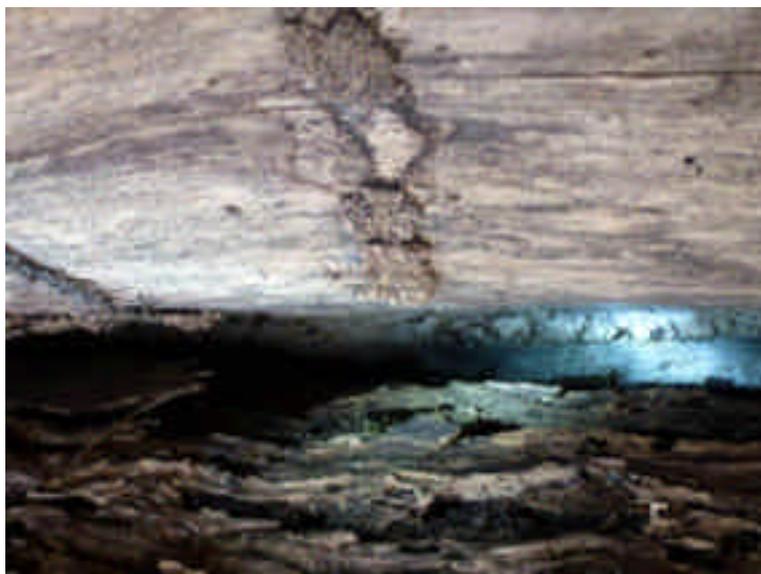
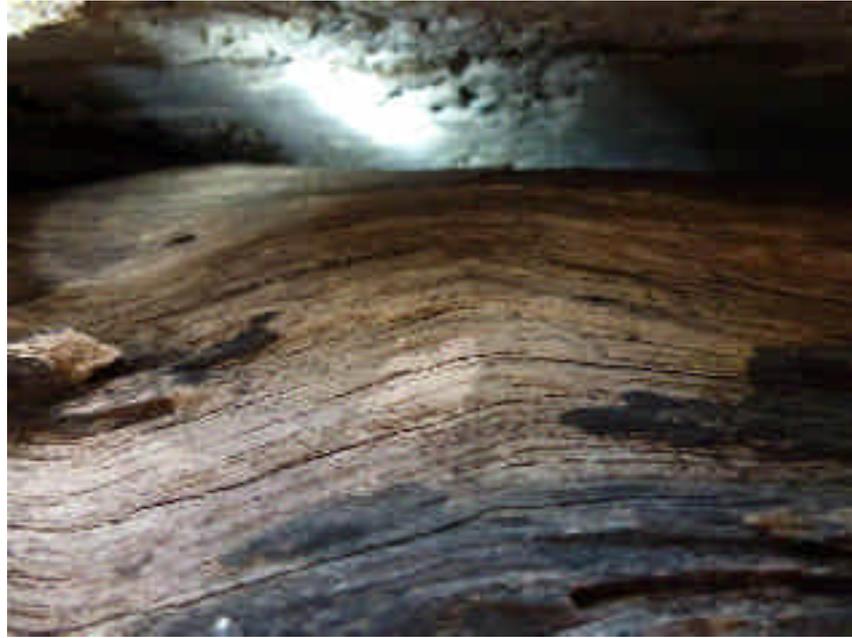
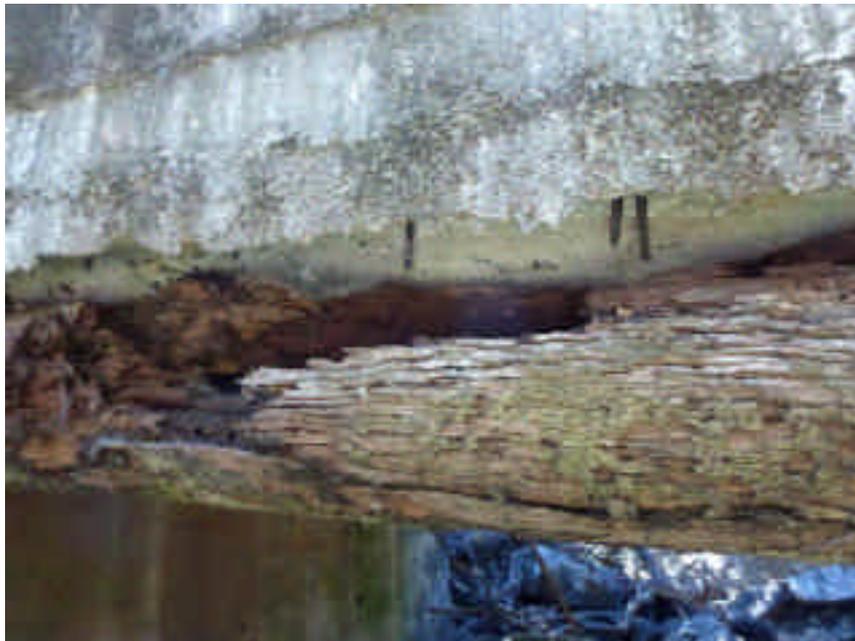
**Figure 8: One of 11 Kirrama Range Road Bridges (northern Queensland) built in 1987 (top). Log girder curtain bridge with a concrete deck that was connected to the logs with spikes and rebar into the timbers and a poly malthoid barrier between the concrete and timbers that caused the timbers to decay aggressively. Second photo shows bridge being removed to keep traffic off of it. The 11 bridges were closed to traffic due to decayed elements collapsing. Improper construction techniques shortened the life of the bridge by 75%. The girder to concrete interface in the photographs above shows where the top portion of the log sapwood is completely decayed and out of service. It has disintegrated and shrunk away from the concrete by as much as 75 mm in some areas. Obviously plane sections don't remain plane anymore and these bridges are not satisfactory to carry loads. The concrete decks could fail catastrophically at any time.**

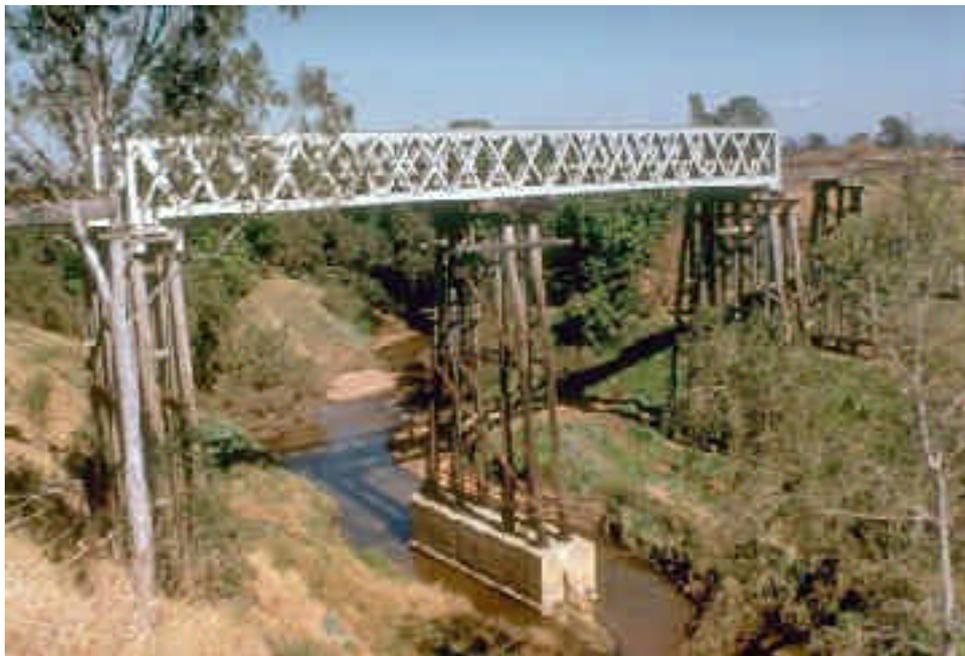
**Figure 9: Lockyer Creek RR bridge, built at the turn of the century, has side cast iron through truss center span and log girders resting on tall (20 m) timber pile bents and frame bents.**

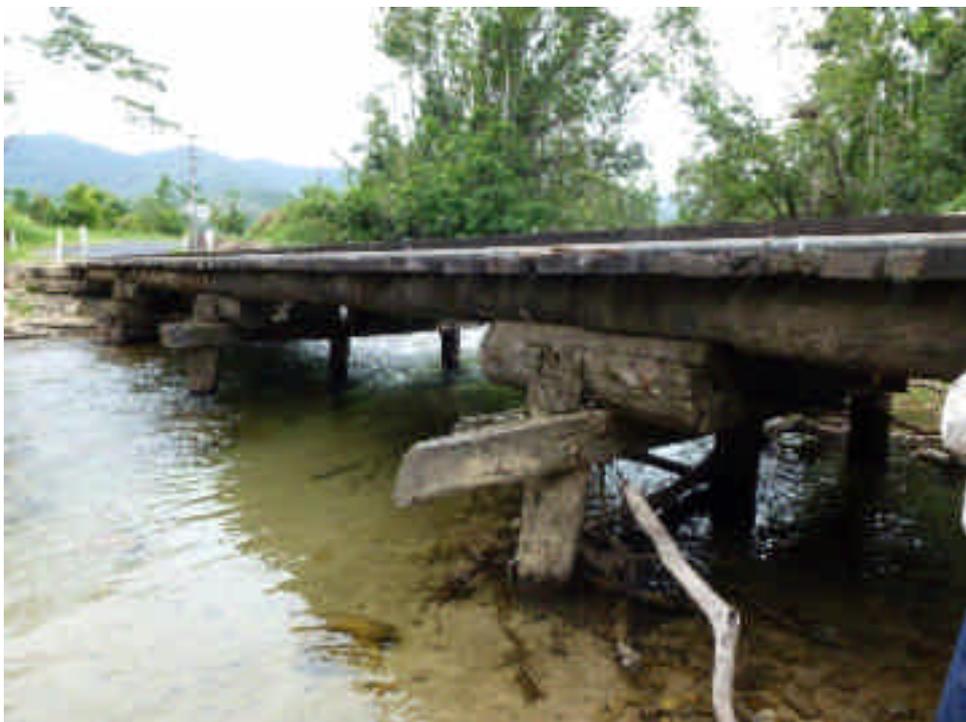
**Figure 11: Highway bridge built at the turn of the century, combination of composite steel I beams, log girders and timber pile bents. Northern Queensland.**

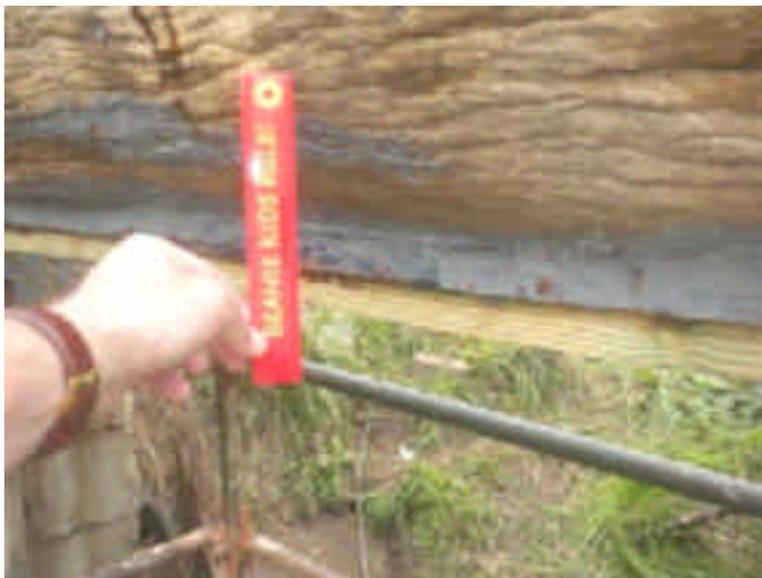
(g)

In addition to timber piles, the effect of SG reduction in the annulus can have very detrimental effects in round log girder performance in bridges. See Figure 19 below where a round log girder in a log girder/log corbel bridge in Mitchell Shire (Costello's) had received a clean bill of health in a Level III report and was found to have a very high Stress Wave Time across the diameter (8-9,000 ms) by WRD inspectors. When the round log girder was prepared for application of the retrofit lamination by removing a slab from the bottom face, a branch butt end was removed with a chain saw. When the branch butt end was removed a very large cavity that ran 2/3 of the length of the girder was exposed with an annulus that had a SG reduced by nearly 35%. In addition the annulus thickness at the bottom in the high tensile bending stress zone was thinned to 15 mm due to the cavity growth. This girder barely held its own dead weight and fortunately was a side girder or it would have collapsed under low traffic loading of 1T or less. Other such girders were found in interior positions in the bridge. It is actual testimony to the need for utilisation of advanced inspection methods when inspecting old timber bridges. Simple sounding bores at the end of the log girder in a single location will not properly allow assessment of the girder condition.

**Figure 19. Cavitated timber bridge girder (a, b and c) in place at Costello's Bridge in Mitchell Shire. In addition to the large cavity running 2/3 the length of the log, the annulus SG is significantly reduced. Decay propagated by constant elevated MC in the wood around the metal vertical through bolts was caused by condensation on the through bolt shank and shelf water following the bolt channel into the core of the log. This constant hydration source provided fertile ground for the decay fungal colony to grow. Such excessively decayed, cavitated, reduced SG annulus log girders can be retrofitted utilising keyways and new treated hardwood keys (d and e) and interior injection with fire proof polymers that slowly polymerize as they work their way into all the open cavities in the log. In addition, high strength fiber retrofits (f and g) are applied and diffused to prevent further decay from occurring in the annulus wood. Note the oak bungs in the side of the log plugging the hole where the diffusers are placed in the log annulus (f and g)**
