THE TECHNICAL INVESTIGATION OF THE FIRE AT LONDON'S KING'S CROSS UNDERGROUND STATION

K. Moodie and
S.F. Jagger

Health and Safety Executive,
Research and Laboratory Services Division, Explosion and Flame Laboratory,
Buxton, England

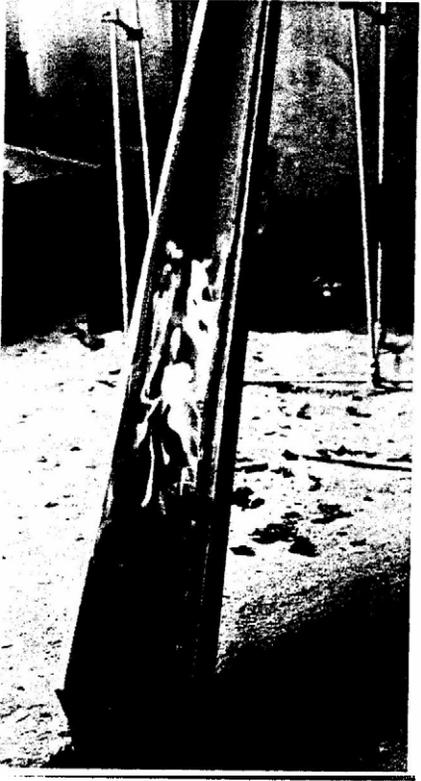
In all of the tests, the advancing flame fronts were observed to remain virtually within the channel and to extend ahead of the visible pyrolysis front, the extent to which seemed to vary with the length of the burning zone. This is illustrated in the sequence of three photos, shown in Figure 6, taken at 3 sec intervals. These also illustrate the inherent nature of the flame structure when it is lying in the channel, namely to curve inwards towards the centre of the channel off the two vertical sides.

Figure 6a. Flame front advancing up an open channel ahead of the burning region.

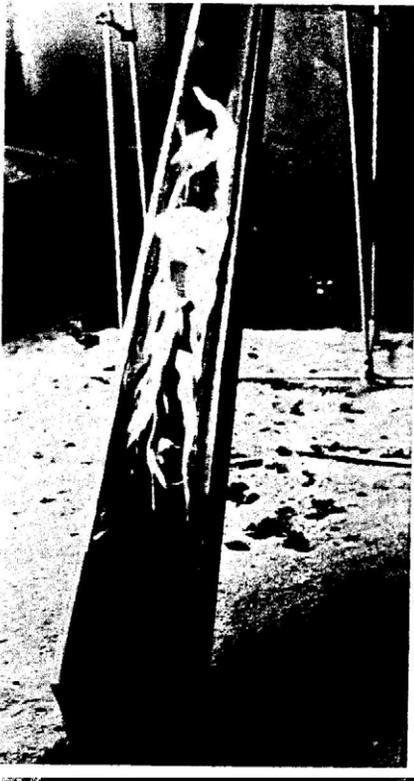
Figure 6b. Flame front position 3 seconds later.

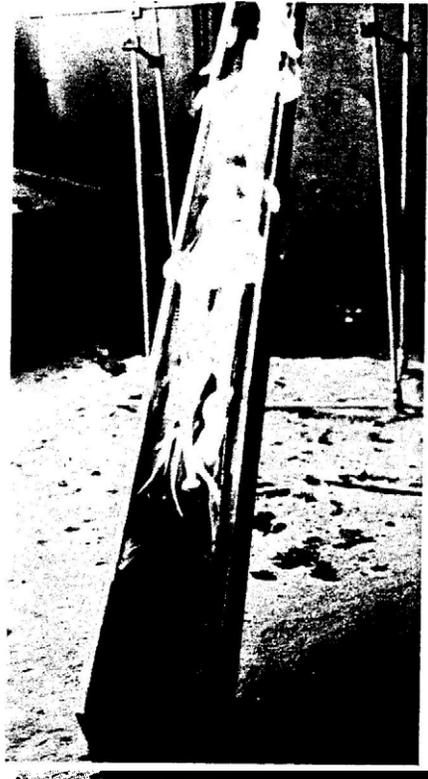
Figure 6c. Flame front position 3 seconds later.

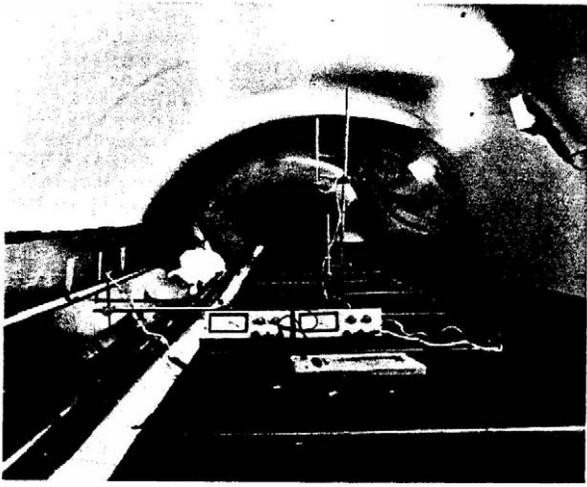
The visual records from the first three tests showed that following ignition (at about the first half metre marker), flame was soon established across the full width of the escalator channel, with the flame front tending to remain low in the channel as the fire began to develop. The fire then progressed up the channel at an exponentially increasing rate of growth. The fire, because it was ignited on the right hand side only in the fourth test, took longer to establish itself across the whole of the escalator section than in the previous three tests (some 9 min), but thereafter it behaved in a similar manner. This is shown, just after ignition of the left hand side, in Figure 8.

Figure 8a. The fire just after ignition of the left hand side (Test No. 4). View from foot of shaft.

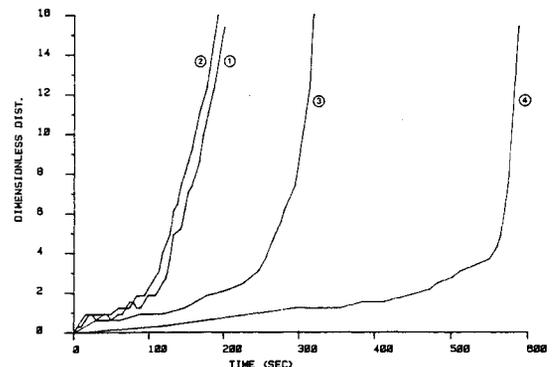
times and in all of the tests the flame fronts within the escalator channel remained ahead of the pyrolysis fronts on the balustrades which were themselves ahead of the pyrolysis fronts on the fascia boards. The rates of advance of the flame fronts taken from the visual records of all four tests, are shown in Figure 9.

Figure 9. Rate of advance of flame up escalator trench (all four 1/3 scale tests).

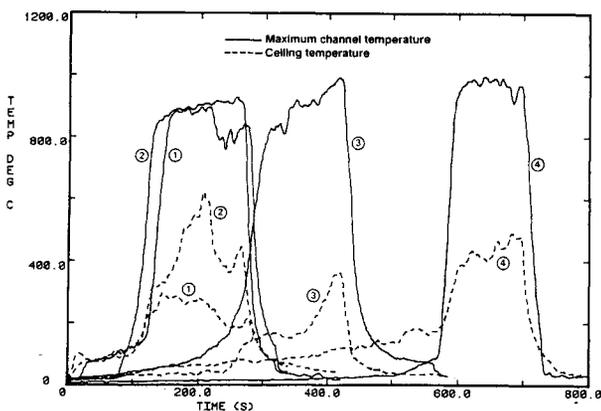
The vertical temperature profiles obtained on the centre lines at all three measuring stations showed that the peak temperatures were between 800-1000 °C within the escalator channel. The corresponding near-ceiling temperatures were lower in all cases but increased progressively in magnitude towards the top of the escalator shaft. The results indicated that sharp temperature fronts were observed at all three measuring stations, which coincided with the visible flame fronts advancing up the channels. Some of these features are illustrated in Figure 11 which shows, for all four tests and at the lowest measuring point, the maximum gas temperatures in the escalator channels and the gas temperatures 25 mm below the tunnel ceiling. Figure 11 also illustrates the degree of

Figure 11. Maximum channel and near-ceiling temperatures from all four 1/3 scale model tests.

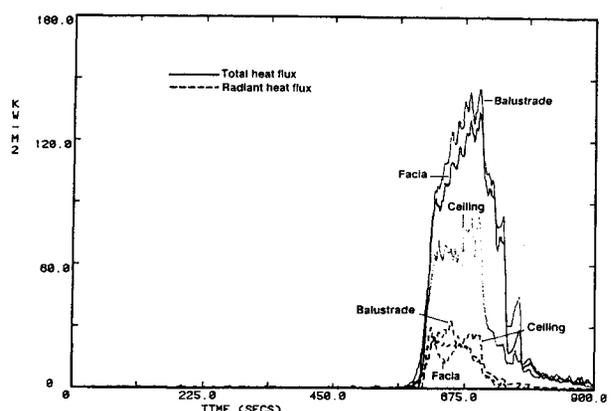
Figure 12. Total and radiant flux measurements in the balustrade, facia, and ceiling (from Test 4).

The total heat fluxes received by the left hand balustrades, fascia panels and the tunnel ceiling were measured at various positions during each test. Typical measurements (from Test 4) are shown in Figure 12 for a position near the top of the shaft. The total heat flux to the ceiling was always much less than that received by the balustrades or fascia panels immediately below. The peak radiant heat fluxes to the ceiling and balustrades were roughly the same and were about 25 kW/m². Thus the substantial increase in total heat flux to the balustrade and fascia was due to an increase in convective heat flux, probably as a result of increased turbulence in the burning region, together with an increase in gas velocities especially near the top of the escalator. The total heat flux on the fascia panel was about 10 percent less than that received by the balustrade. Such heat fluxes imply very rapid onset of pyrolysis in the presence of a flame, with typical preheat times of 10-20 sec.
