A methodology to determine pre-crash fuel quantity from post-crash fire thermal damage to an aircraft structure

N Alvares¹ and AC Fernandez-Pello²

Abstract

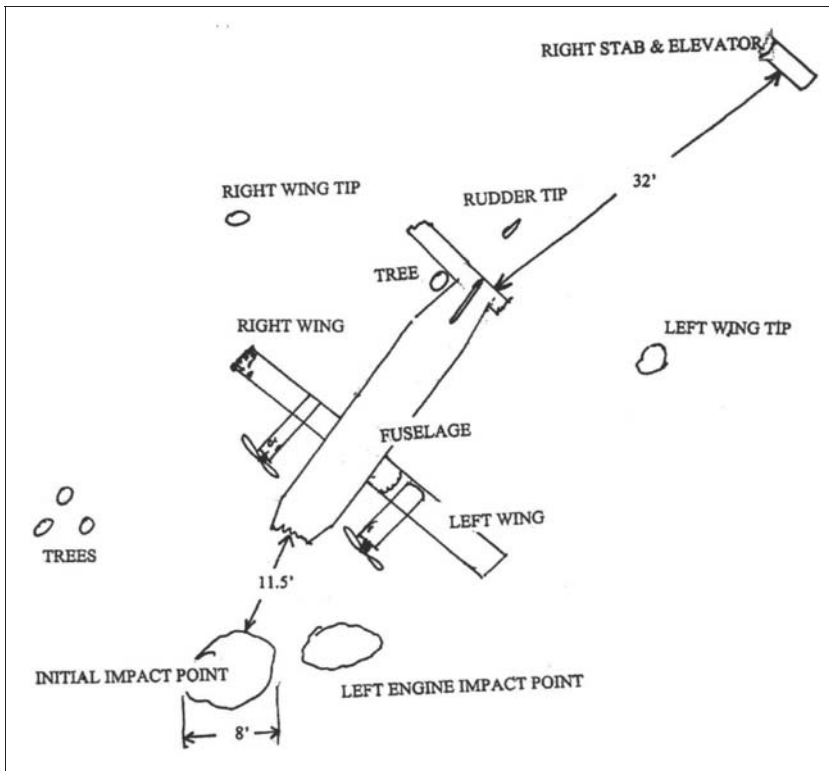
Figure 2. NTSB Structure Group Chairman's factual report wreckage distribution diagram. Reproduced from the NTSB [1].

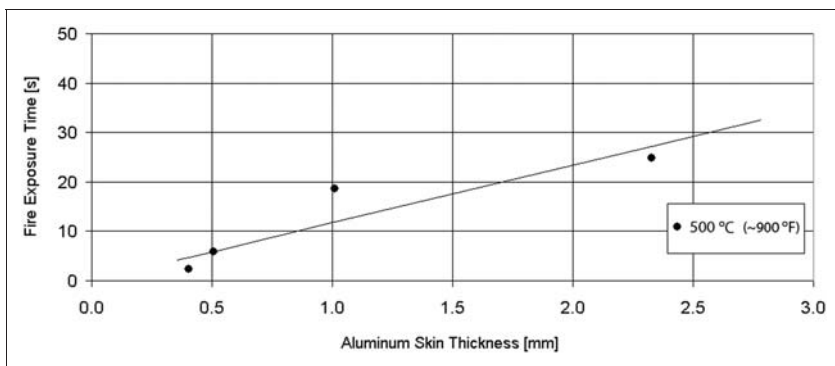
The melted end of this beam was located near the center of the most heavily burned-out (10 m²) area of the aircraft. The average fuel-burning rate for large fuel pool fires is 0.06 kg/m²s. With these data, the amount of fuel required to cause this

Figure 7. Melting time for different thicknesses of aircraft Aluminum as a function of fire exposure time. (6).

Jet fuel is about 802.66 kg/m^3 (6.7 lb/gal.). Therefore, the volume of fuel burned in the 10 m^2 area was 651 L (172 gal.) (assuming that the beam was exposed to radiant flux on one side only).
