## Perforación en aguas profundas

# Deep Water Horizon Accident Timeline

# Eight Barriers Were Breached

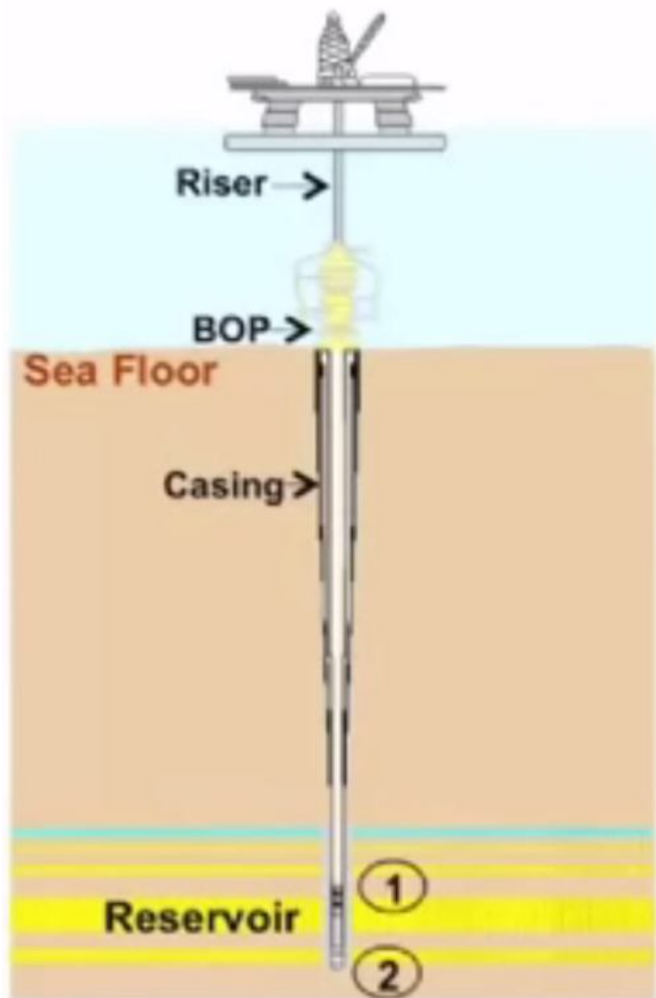
## Well integrity was not established or failed

- ① Annulus cement barrier did not isolate hydrocarbons
- ② Shoe track barriers did not isolate hydrocarbons

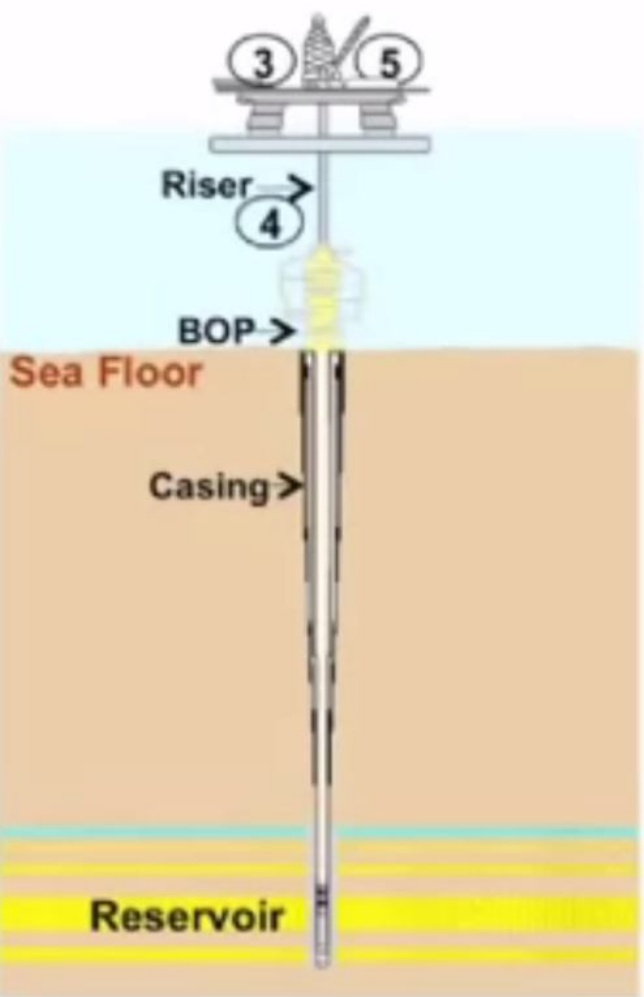
# Eight Barriers Were Breached

## Well integrity was not established or failed

- ① Annulus cement barrier did not isolate hydrocarbons
- ② Shoe track barriers did not isolate hydrocarbons

## Hydrocarbons entered the well undetected and well control was lost

- ③ Negative pressure test was accepted although well integrity had not been established
- ④ Influx was not recognized until hydrocarbons were in riser
- ⑤ Well control response actions failed to regain control of well

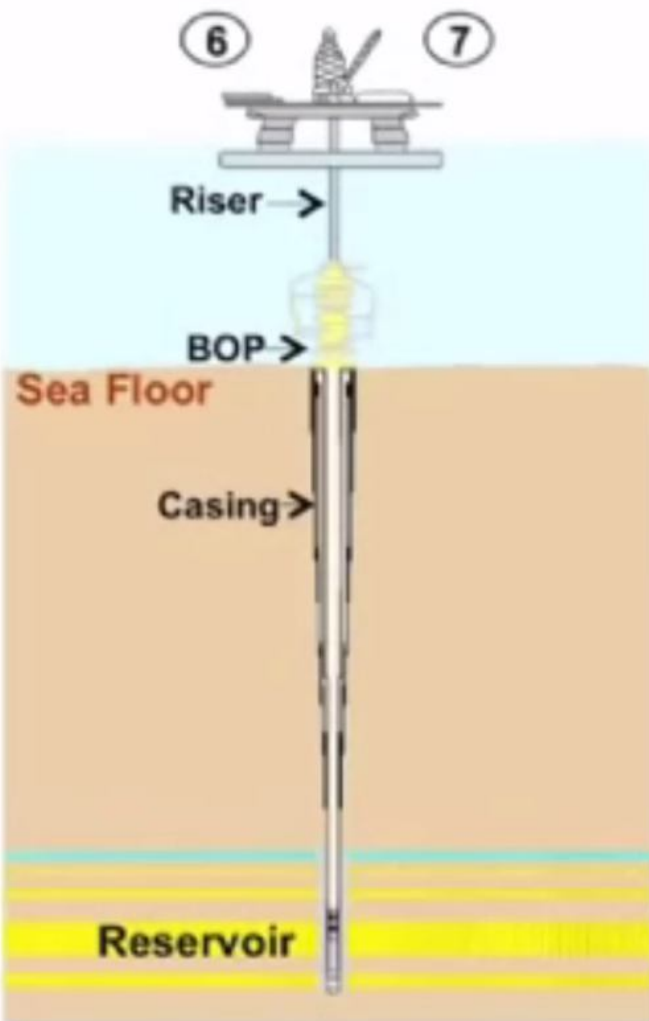
# Eight Barriers Were Breached

## Well integrity was not established or failed

- ① Annulus cement barrier did not isolate hydrocarbons
- ② Shoe track barriers did not isolate hydrocarbons

- ③ Negative pressure test was accepted although well integrity had not been established
- ④ Influx was not recognized until hydrocarbons were in riser
- ⑤ Well control response actions failed to regain control of well

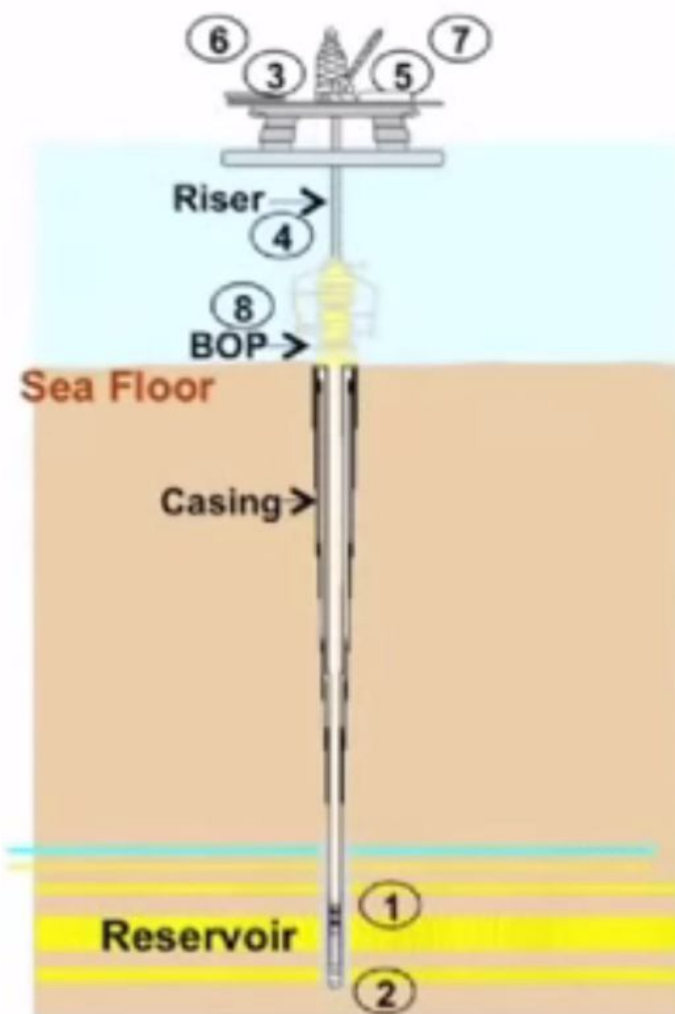
## Well integrity was not established or failed

- ① Annulus cement barrier did not isolate hydrocarbons
- ② Shoe track barriers did not isolate hydrocarbons

## Hydrocarbons entered the well undetected and well control was lost

- ③ Negative pressure test was accepted although well integrity had not been established
- ④ Influx was not recognized until hydrocarbons were in riser
- ⑤ Well control response actions failed to regain control of well

## Hydrocarbons ignited on the *Deepwater Horizon*

- ⑥ Diversion to mud gas separator resulted in gas venting onto rig
- ⑦ Fire and gas system did not prevent hydrocarbon ignition

## Blowout preventer did not seal the well

- ⑧ Blowout preventer (BOP) emergency modes did not seal well
