PLASTIC PIPING DATA COLLECTION INITIATIVE STATUS REPORT

March 24, 2016

Administered by
American Gas Association
400 North Capitol Street, N.W., 4th Floor
Washington, DC 20001
U.S.A.

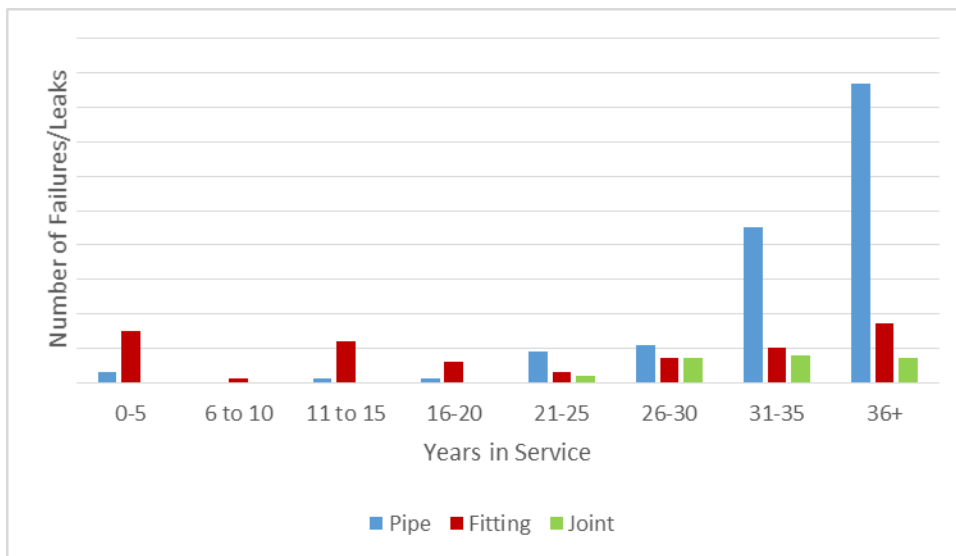
Figure 1. PE3306 Failures by Years in Service, 5 year intervals.

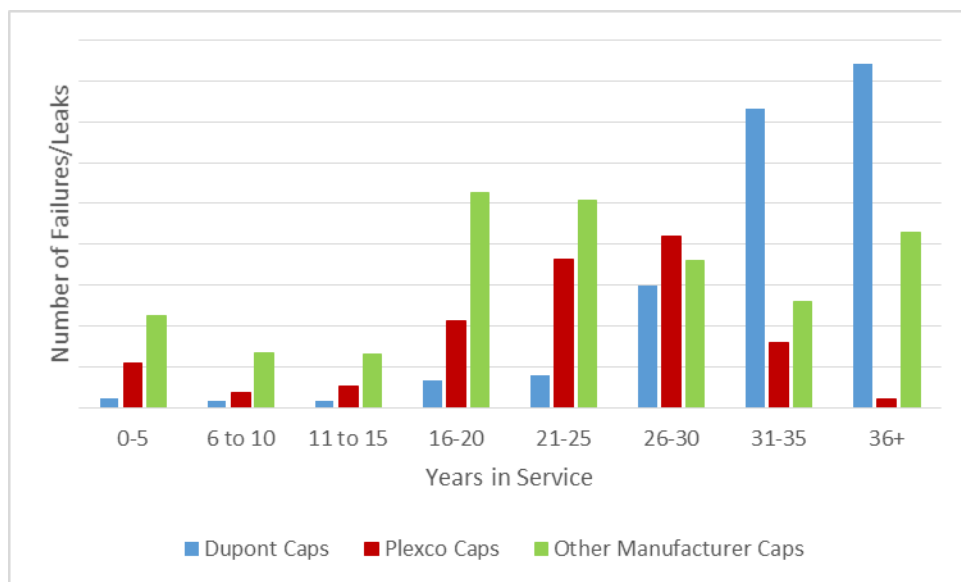
Figure 3 shows the failure/leaks by years in service in 5 year intervals reflecting the performance over time.

Figure 3. Failures/Leaks by Years in Service, 5 Year Intervals.

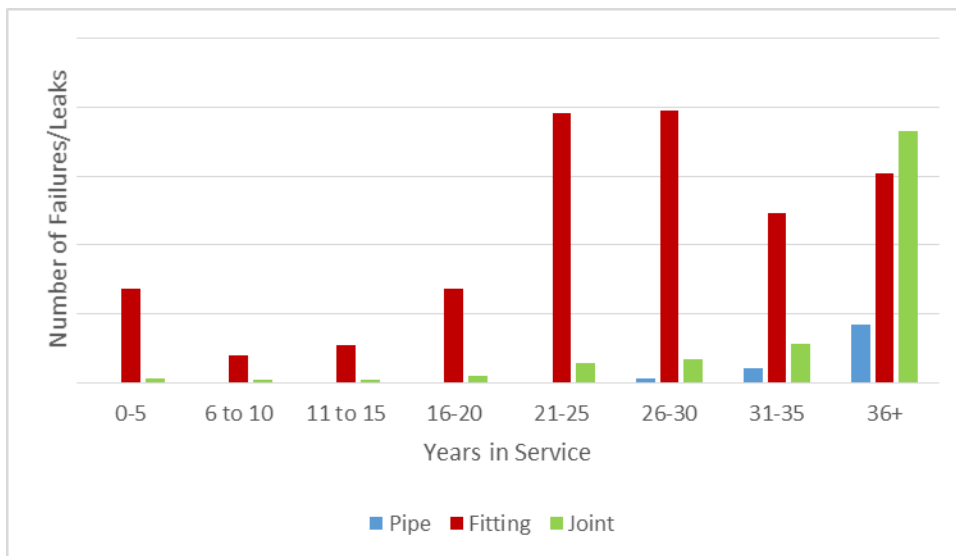
The distribution of failures/leaks for pipe, fittings and joints by years in service is shown in Figure 1.

Figure 1. PVC Failures by Years in Service, 5 year intervals.
