Cargo Tank Corrosion on Tankers

An INTERTANKO Opinion

Dragos Rauta, Technical Director

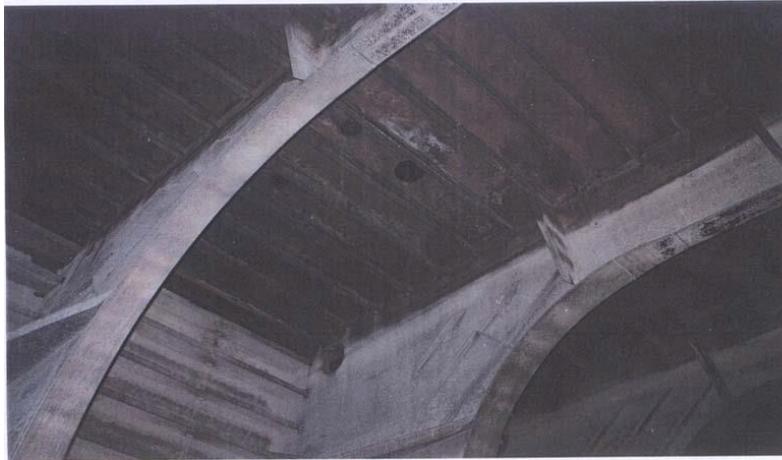
Under deck area of a crude oil cargo tank. The greyish coloured deposit on the bulkheads and the internal structures is elemental sulphur. Note the dark black and red-reddish coloured ullage space at the top which is exposed to the inert gas and or VOC during the loaded passage.

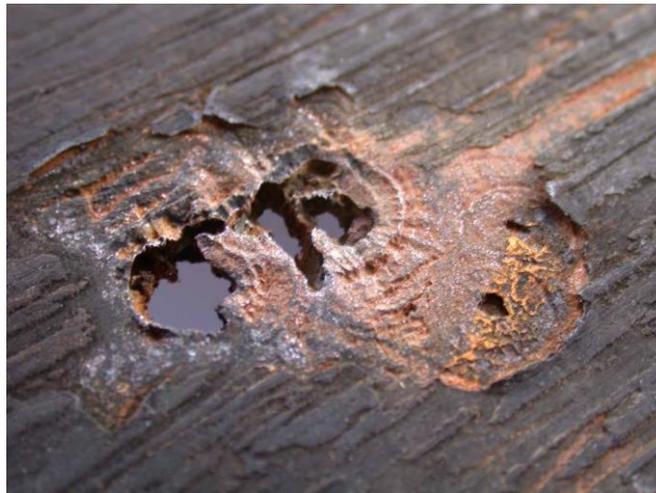
SRB induced corrosion

There are several theorems concerning this question but one of the most popular is that of the corrosion being caused by Sulphate Reducing Bacteria (SRB). These bacteria cause what is known to be Microbial Induced Corrosion (MIC) to the tank bottom plating. This type of corrosion is normally found as deep pitting.

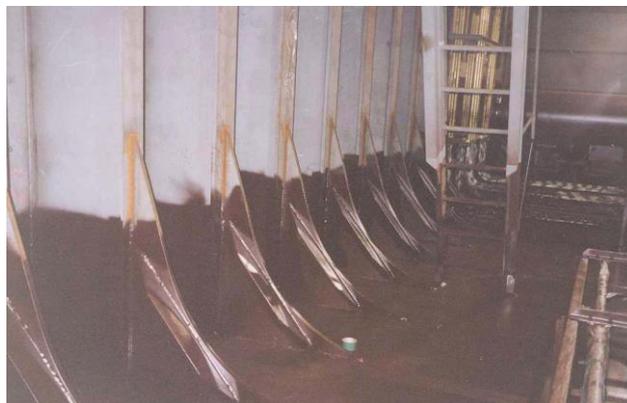
Coated cargo tank bottom

There are a number of options for repairs of existing pitting and prevent further pitting development. Grit blast the bottom plates and pitting, fill the pits with weld metal or clean and fill the pitting with other filler material, and coat the cargo tank bottoms including the bulkheads to a height of about 1 to 2 meters from the tank bottom with a suitable coating. Such repairs are time consuming and costly for an existing tanker. The application of coating on a pitted but repaired crude oil tank bottom surface may not last for the same period of time as had the coating been applied at the new building stage.

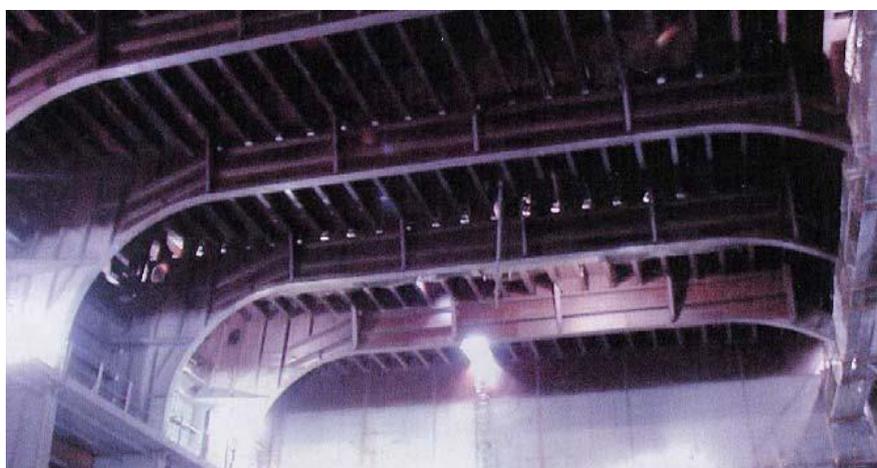
Coated under deck with the inspection platform which is a wider stringer with railings
