Corrosion of Electronic Components by Hydrogen Fluoride

ABSTRACT: Generation of hydrogen fluoride (HF) from fire suppression by some gaseous agents is a major concern, because HF causes corrosion. Without proper precautions, the HF corrosion damage to some electronic facilities can be significant. A study has been carried out to evaluate the corrosion effect of HF on electronic equipment. This article describes details of the corrosion study in terms of test results from corrosion damage assessments. Test results show that surface corrosion on the electronic boards is visible when the test specimen is exposed to HF concentrations above 1000 ppm for 1 h. Test results also show that a video card with many attached components is much more vulnerable to HF corrosion damage than other test boards. The functionality of the video card is affected even at a relatively low HF concentration of 500 ppm.

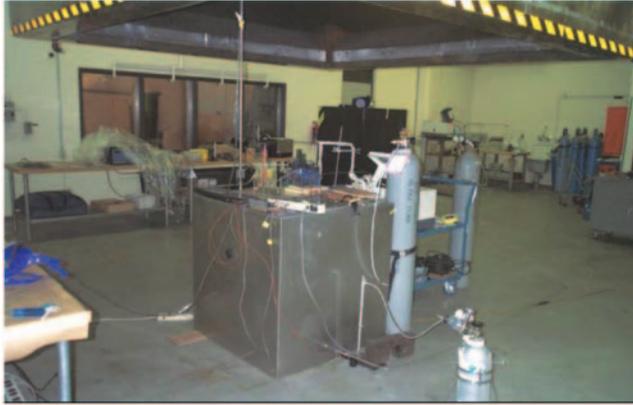
Figure 1. Picture of test setup (The color version of this figure is available online).

The 1 m³ square box was constructed using 20 gauge 316 stainless steel. All joints and wall penetrations of the compartment were sealed to reduce air leakage. The top of the box had a 300 mm × 300 mm opening to allow access to the box. This opening was normally covered with a Lexan window sealed with a polyethylene gasket. There were two holes plugged with rubber corks at mid-height of one side through which a torch flame and hot air were introduced into the test box during some tests. A picture of the test box with instrumentation is shown in Figure 1.

There were five stainless steel tube sample ports; four on the top and one on the lower side. Sample ports on the top of the box were used to insert tubes into the box for pressure measurement and collecting gas samples for Fourier Transform Infrared Spectroscopy (FTIR) measurements as well as for the installation of a pressure relief tube. The side port was used to inject HF into the box. A 6.4 mm diameter (1/4 in.) stainless steel tube for HF injection was welded 50 mm above the bottom of the box along the vertical center line. A three-way valve connected the tube to a flexible Teflon line, which was connected to the needle valve on the HF cylinder. The bypass of the three-way valve was connected to Tygon tubing and ran to the exterior of the test facility.

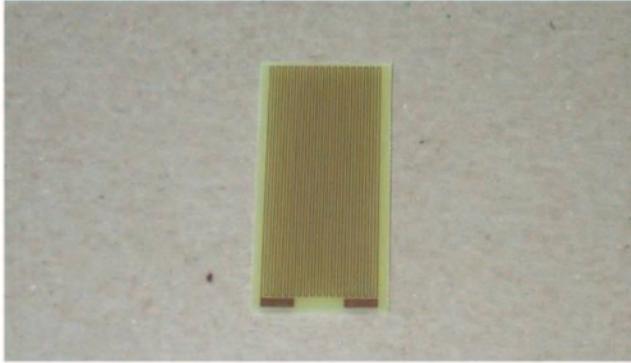
Figure 2. Picture of corrosion detector board, Type 1 (The color version of this figure is available online).

One of the custom-made corrosion detector boards (Type 1) had a continuous copper wire loop, which detects the loss of current due to corrosion of this loop. The Type 1 board was made from 3.175 mm thick board material with 0.036 mm thick copper clad on one side. It was 25.4 mm wide by 55.88 mm long. A continuous trace, 0.305 mm wide copper circuit ran back and forth along the board with 0.305 mm spacing between the rows. Solder tabs were located at either end of the trace for mounting electrical connections to the board. The electrical resistance of a new Type 1 board before any exposure to HF was 4.1 ± 0.1 ohms. During the test, the electrical resistance of the board was continuously measured to detect any onset of corrosion on the board. The copper trace on the board was clean and unprotected prior to testing. Figure 2 shows a picture of the Type 1 corrosion detector board.

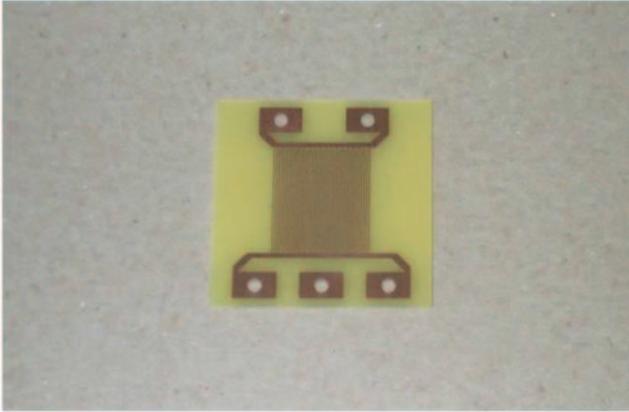
Figure 3. Picture of deposition detector board, Type 2 (The color version of this figure is available online).

loops due to corrosion of the board. The Type 2 board was made from 3.175 mm thick board material with a 0.036 mm thick copper layer on one side. It measured 50.8 mm wide by 50.8 mm long. Parallel traces of 0.318 mm wide copper circuit were put on the board; one copper loop ran along the board from one side and an identical loop ran from the other side such that no electrical connection existed between the two loops. These traces were separated by a 0.318 mm spacing between the loops. Solder tabs were located at either end of the board for mounting the electrical connections. The electrical resistance of a new Type 2 board before any exposure to HF showed an open circuit. During the test, the electrical resistance of the board was continuously monitored to detect any finite resistance between the two loops, which indicates the onset of corrosion on the board. The copper traces on the board were clean and unprotected prior to testing. Figure 3 shows a picture of the Type 2 corrosion detector board.

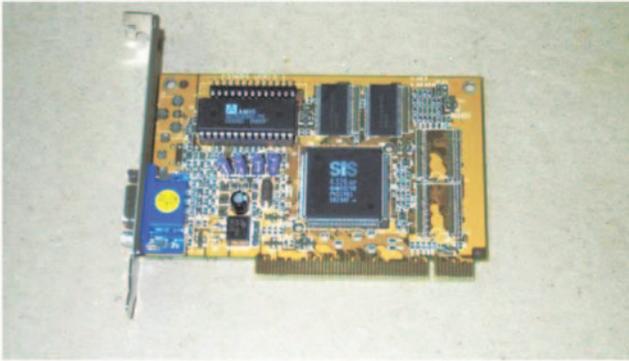
Figure 4. Picture of video card (The color version of this figure is available online).

The computer video card used in the tests was a commercial grade, 5 V peripheral component interconnect video card, SIS brand, model C6326. The video card contained many small components mounted on the surface of the board. This was a newer type of board, which is less rugged than older boards. Older boards had discrete components mounted on the board with pin connections and were very rugged. Newer video cards are more fragile and sensitive to corrosion effects. Surface mounted components were hot air soldered and they were protected by very thin casings rather than the more rugged casing found on older style boards. Corrosion could attack the thin protective layer of the small surface mounted components rather easily and would affect the functionality of those components. A picture of the video card is shown in Figure 4.

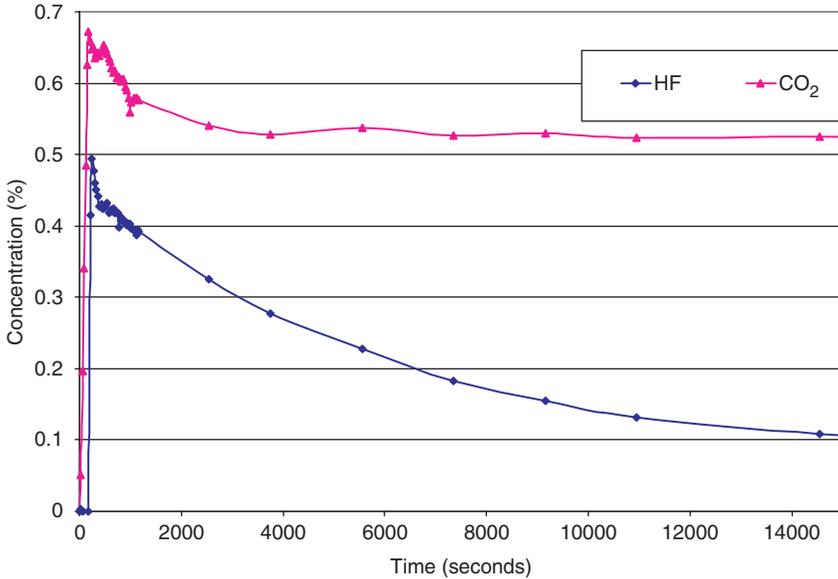
Figure 5. Graph of hydrogen fluoride (HF) and CO₂ concentrations in the test box (The color version of this figure is available online).

First, it was assumed that the reduction in HF concentration was due to box leakage, however, a measurement of CO₂ concentration in the box showed that the test box was air-tight since the CO₂ concentration in the box remained steady with time. A possible explanation for the sharp reduction in the HF concentration with time would be that the HF reacted with moisture and condensed very quickly, thus reducing the HF vapor concentration.

Figure 5 shows the HF and CO₂ concentration changes with time. The figure shows that the CO₂ concentration remains steady while the HF concentration drops sharply, confirming that the test box was not leaky and HF reduction was due to the HF reaction with moisture.

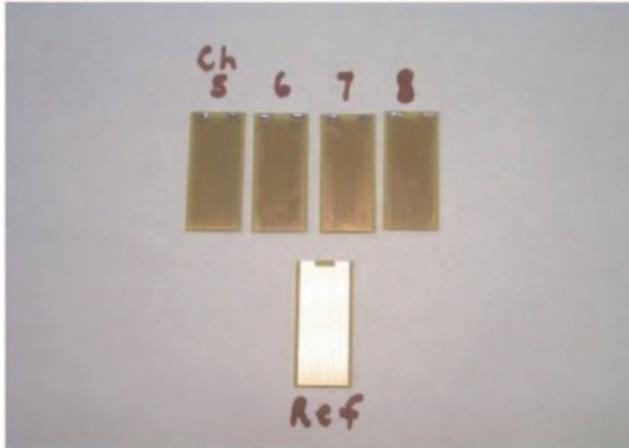
Figure 6. Picture of Type 1 board before and after exposure to hydrogen fluoride (The color version of this figure is available online).

Test results showed that surface corrosion on the electronic boards was visible when the test specimen was exposed to HF concentrations above 1000 ppm for a 1 hour exposure duration. Figures 6 and 7 show pictures of Type 1 and Type 2 corrosion detector boards before and after exposure to HF. Above 5000 ppm, heavy corrosion damage on the specimen surface was noted, and the printed circuit on the surface was also damaged, which affected the functionality of the board. When exposed to HF concentrations of <1000 ppm, no visible corrosion damage on the surface was noted. However, the surface corrosion damage depended not only on the concentration of HF but also depended on the humidity of the surrounding air. When the humidity was high in the test compartment, minor surface corrosion was noted at 1000 ppm HF. However, under very dry conditions, no surface corrosion was noted even at 2500 ppm HF.

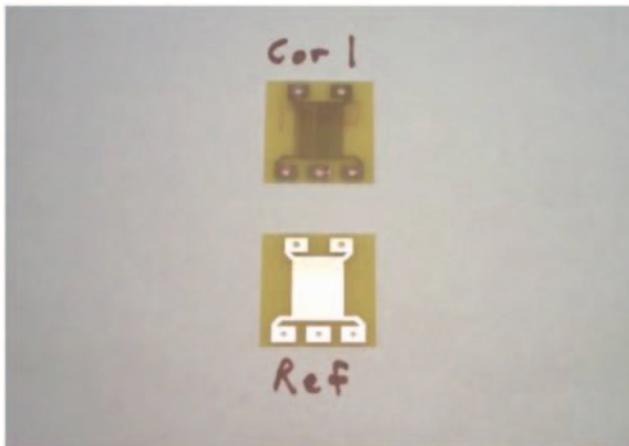
Figure 7. Picture of Type 2 boards before and after exposure to hydrogen fluoride (The color version of this figure is available online).
