Pennsylvania Department of Transportation
Bureau of Municipal Services - Programs and Services
Bituminous Seal Coat w/#7 Aggregate
MS-0340-0005 Technical Sheet

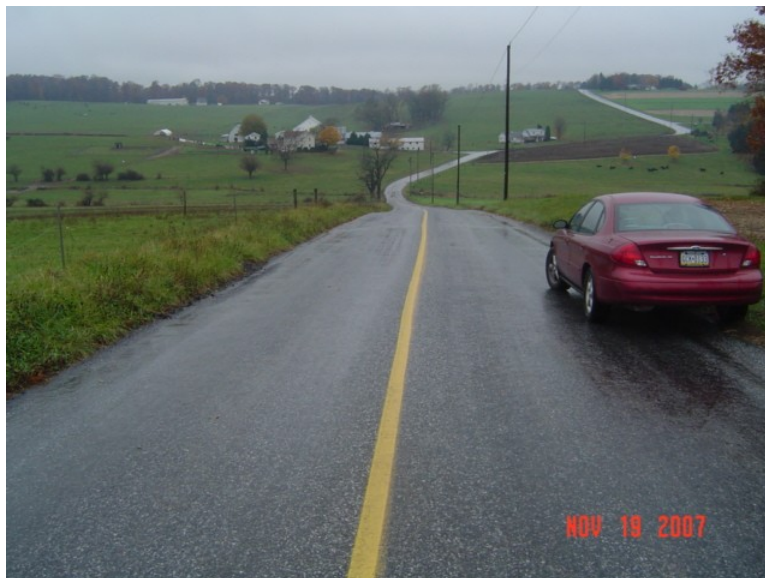
The #7 aggregate is larger than the aggregate normally associated with a Bituminous Seal Coat. The larger aggregate (#7 instead of #8) is intended to hold up better under the constant abuse by the horse's shoes. First is an application of bituminous material followed by an application of coarse aggregate. Do not allow vehicular traffic on the newly completed surface until the material obtains adequate stability and adhesion, and the material is sufficiently cured to prevent distortion. If needed sweep the surface with a power broom to remove loose aggregate before and after opening the road to traffic.

Bituminous Seal Coat with #7 Aggregate was developed for areas with an abundance of Horse and Buggy traffic. In order for the horse shoes to hold up better on paved roads the Amish have their farriers place small knobs (Carbide Calks) in several places on the bottom of the horse's shoe. The damage caused by these calks includes scarring the surface, rutting and potholes. As the Amish community grows so will the damage to the pavement by their horses.
