# ANALYSIS OF THE HAPPYLAND SOCIAL CLUB FIRE WITH HAZARD I

**Richard W. Bukowski, P.E. and Robert C. Spetzler**  
Building and Fire Research Laboratory, NIST  
Gaithersburg, MD 20899

## SUMMARY

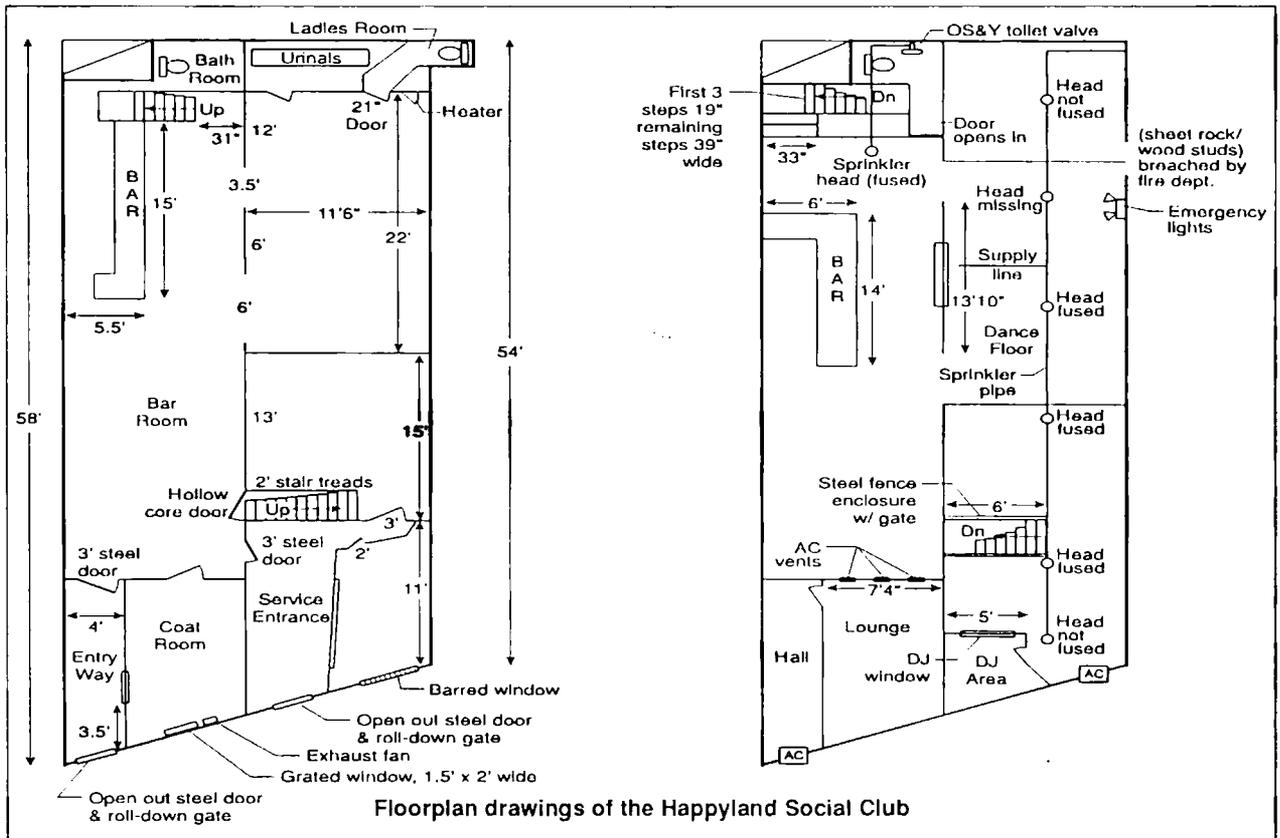
The floorplan drawings obtained from the New York City Fire Department are shown on the next page. Wall finish throughout the interior of the building was 3/16-inch thick wood paneling on furring strips over plaster. The ceilings were low density fiberboard tiles in the first floor entry and bar, and gypsum board elsewhere. The fiberboard tiles were installed on furring strips under the floor joists. Note the partial sprinkler system on the second floor.

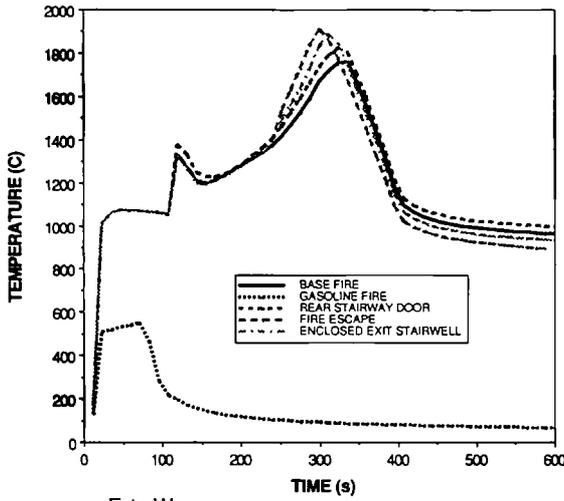
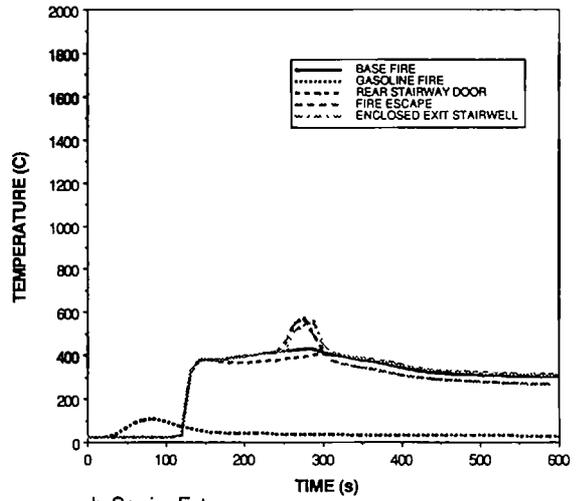
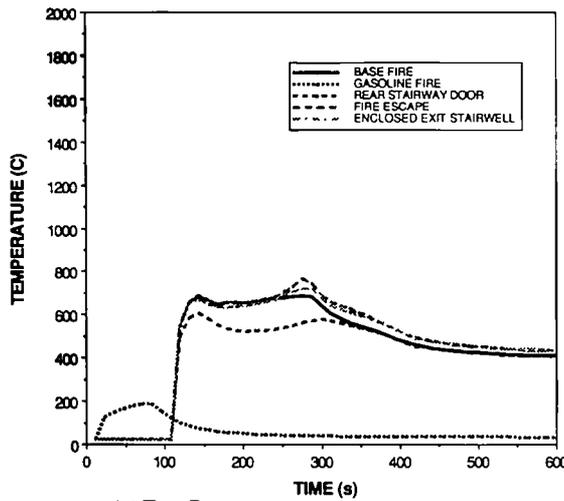
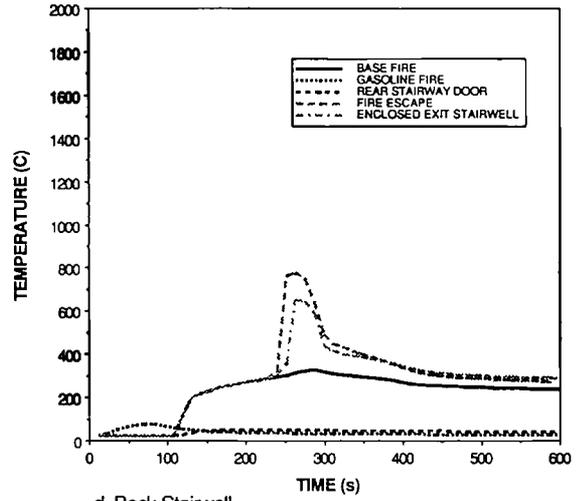
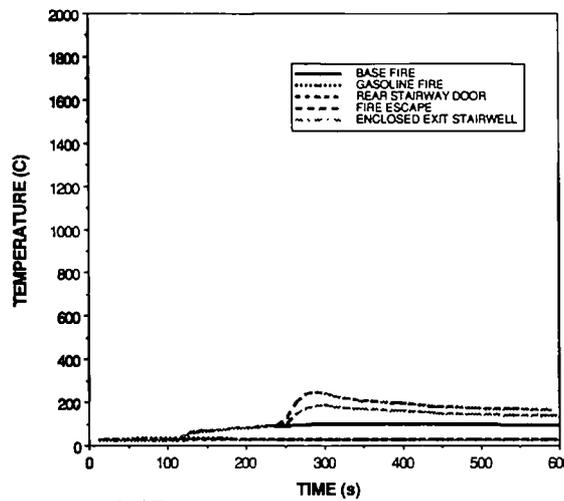
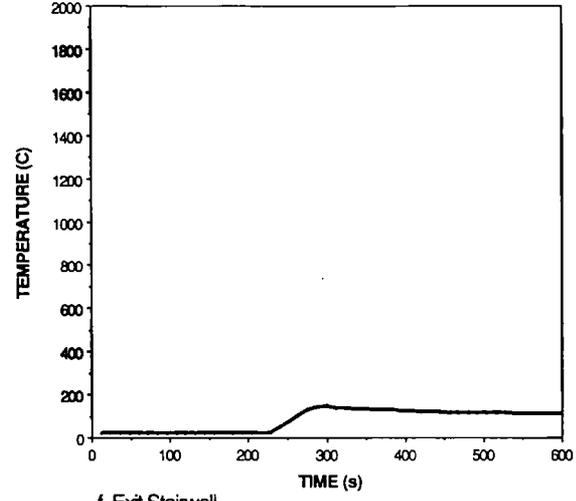
Figure 1. Predicted upper layer temperatures.

a. Entry Way

b. Service Entrance

c. 1st Floor Bar

d. Back Stairwell

e. 2nd Floor

f. Exit Stairwell

It should be noted that the peak upper layer temperatures shown in Figure 1a are too high. Such temperatures reported from experiments rarely exceed 1000°C. Zone models are known to overpredict upper layer temperatures and underpredict lower layer temperatures, because not all mechanisms of energy exchange between layers are included. FAST is no exception, with such overprediction having been estimated at 30–50% under most conditions and higher under severe conditions. Since these overpredictions occur after the times of death, they have little effect on hazard-to-life prediction.

When the noncombustible finish scenario was run in HAZARD I, the results indicated that temperatures (Figure 1), CO (Figure 5), and oxygen concentrations (Figure 4) remained tolerable throughout the fire. Only a person in the entryway would have experienced lethal conditions, from burns. With both doors to the entryway open, the gasoline fire had sufficient air to burn out without producing flames out either door, so ignition of furniture in the bar would be unlikely. But if the fire had involved the contents of the bar (e.g., if the fire was started in the bar), some life loss would be likely, even with noncombustible finish.

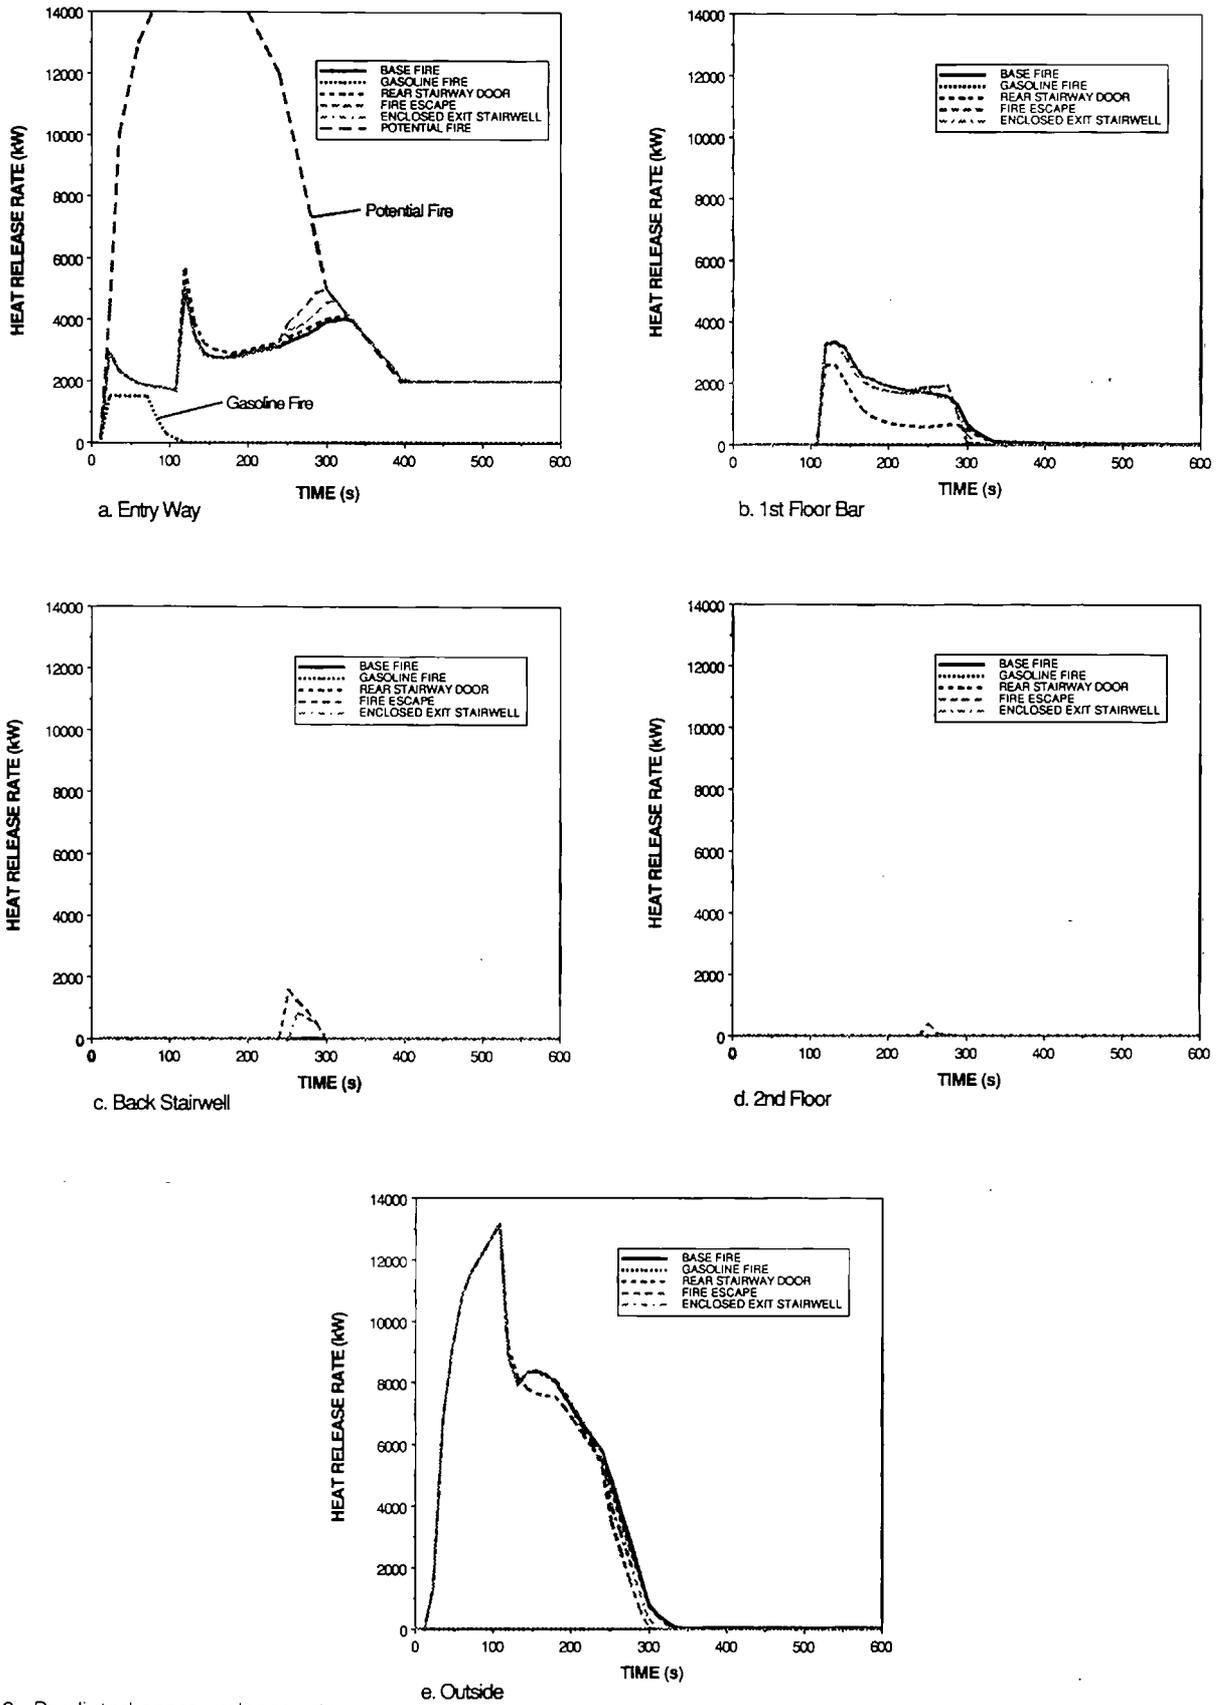
Figure 2. Predicted energy release rates.

procedures in the HAZARD I manual were used. The resulting potential energy release rate profile for the gasoline alone and in combination with the finish materials in the entryway are shown as "GASOLINE FIRE" and "TOTAL POTENTIAL FIRE" in Figure 2a. The difference between the potential rate of heat release and the rates of heat release predicted by HAZARD I for the cases analyzed (except the gasoline fire) results from the impact of the limited air supply. The rate of heat release estimated by HAZARD I for the case where the only combustible material was the gasoline is identical to the potential rate of heat release of the gasoline. This was because the available air supply was sufficient to freely burn all of the gasoline.

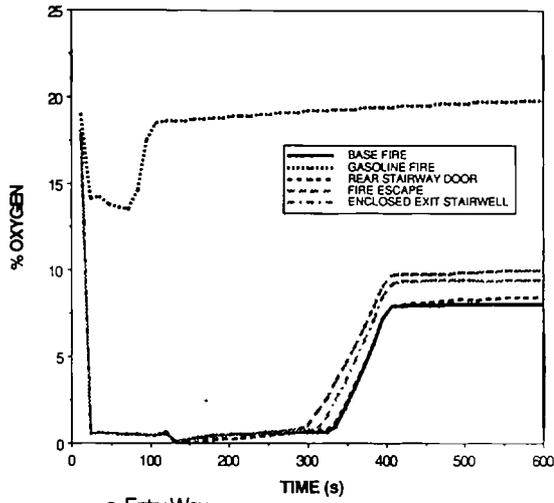
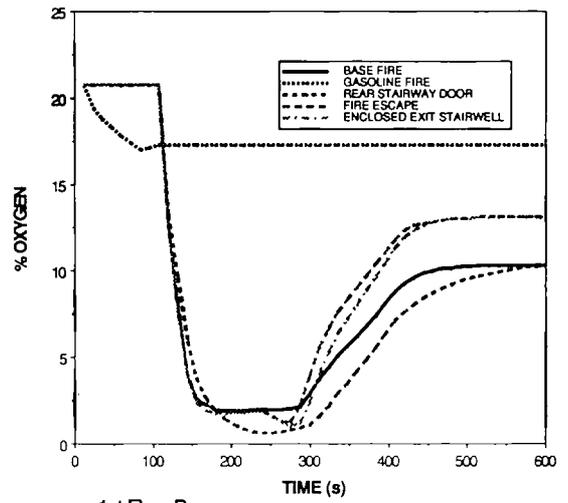
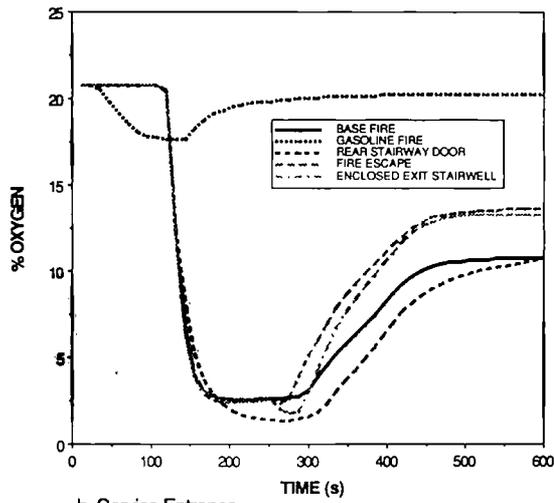
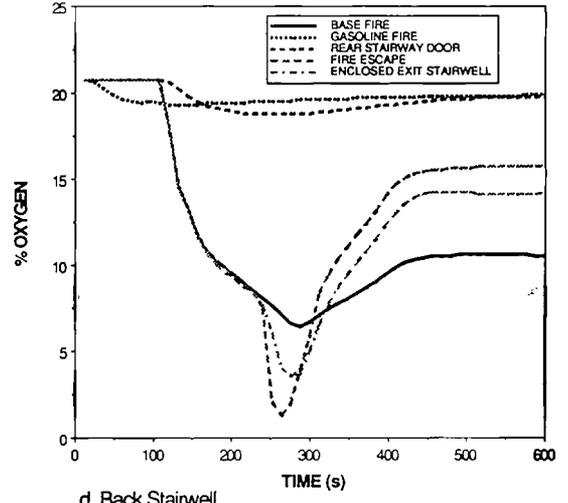
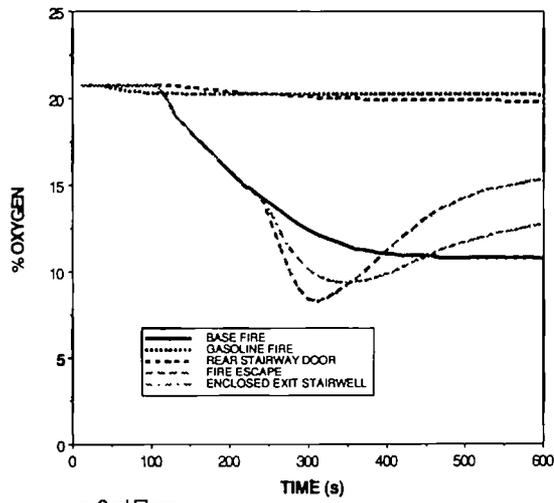
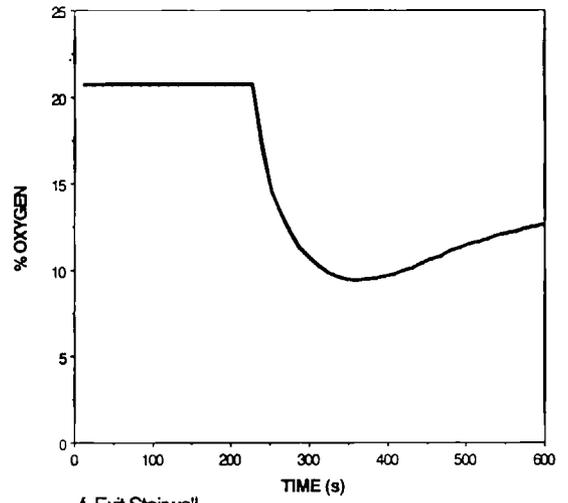
Figure 4. Predicted oxygen concentrations.

a. Entry Way

c. 1st Floor Bar

b. Service Entrance

d. Back Stairwell

e. 2nd Floor

f. Exit Stairwell

The third mitigation strategy involved the addition of an independent, second exit from the upper floor. This would likely be located in the front (street) side as either an exterior, open fire escape with a drop down ladder, or as an interior, enclosed exit stairway descending in the service entry area. The difference between these two is more than just the additional cost of the latter. Opening a second floor door to a fire escape would have changed the ventilation pattern in the building, possibly resulting in a significantly increased flow up the rear stairs to the second floor, making occupant survivability worse. Thus, both arrangements were examined with the model. The results of the predictions showed similar results with respect to each of the examined parameters. In both cases, opening of the egress door on the second floor results in increased flow up the back stairs with an attendant increase in the temperature (Figure 1e) and CO levels (Figure 5e), and decrease in the oxygen on the second floor (Figure 4e). However, these effects were somewhat greater in the case of the fire escape than for the enclosed

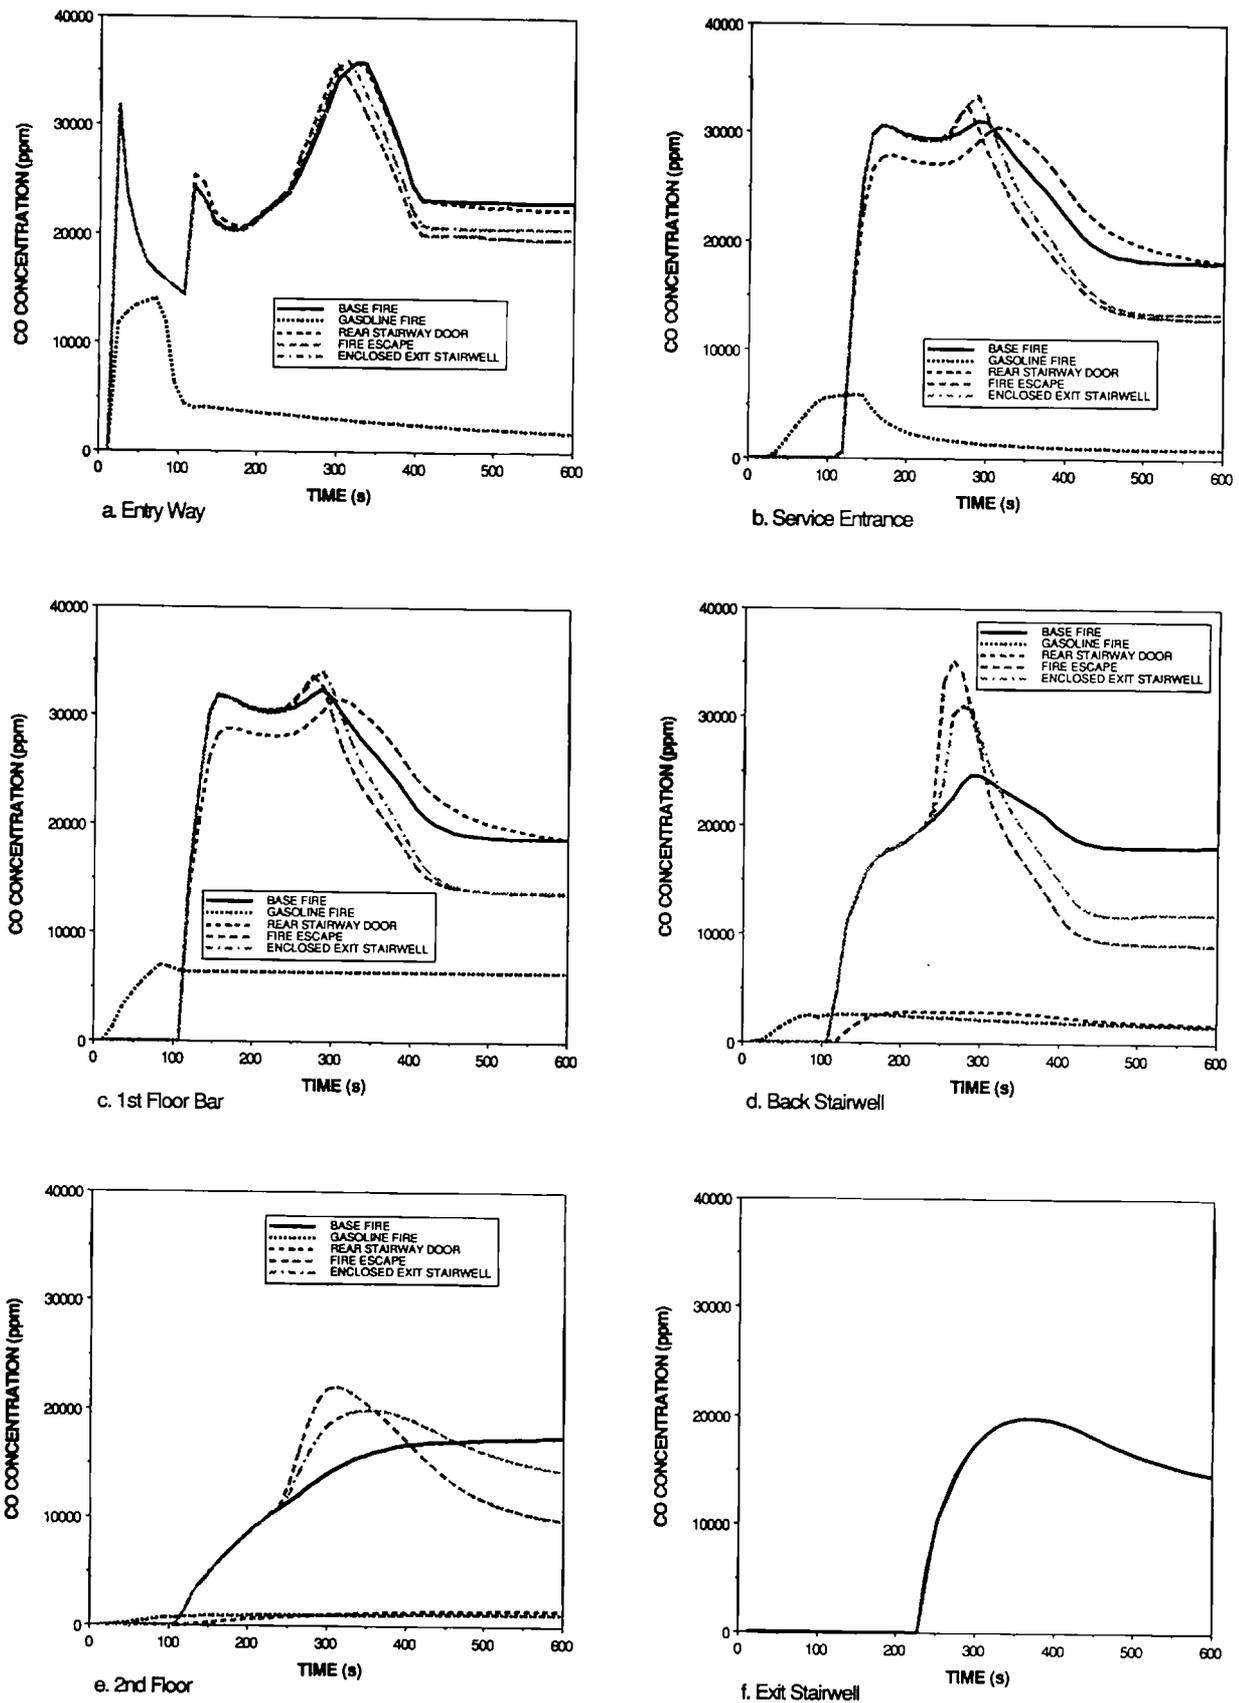
Figure 5. Predicted carbon monoxide concentrations.

To examine this strategy, a (closed) solid wood door at the first floor entry to the stair was assumed. An effective crack width of 1.3 cm (0.5 in) was assumed over the height of the door to represent the gap to the frame. The simulation run for these conditions showed a reduction in the predicted temperatures within the rear stairway and the second floor (Figure 1, d and e), as expected. The temperature of the first floor bar (Figure 1c) was also lower, as less flow up the stairs reduced the ventilation rate through the front door reducing the oxygen (Figure 4, a and c) and the burning rate (Figure 2, a and c) in both the entry and the bar. The CO levels upstairs (Figure 5e) were significantly lower, and the levels on the first floor (Figure 5c) were reduced due to the lower burning rate.
